Project No. 20-0716.01

Re: Structural Observation—24 West Landing, Sanford, NC 27332

FRONT KITCHEN WINDOW MODIFICATION

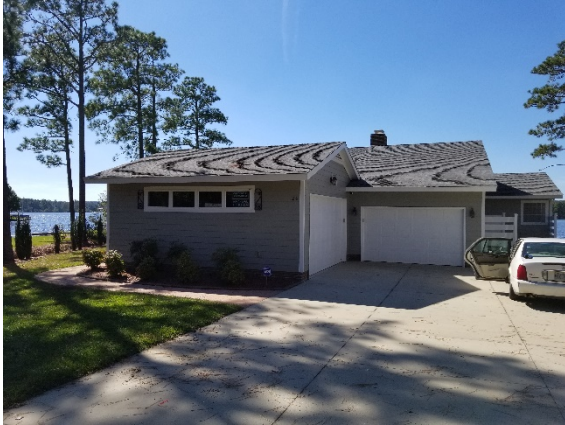
*Picture 1 – 24 West Landing,
Sanford, NC*

At your request, we analyzed the front kitchen window opening that is proposed to be widened to accommodate a larger window at the Sanford residence noted above. Renovation drawings by Robert Mikesell dated 12/2/2005 were provided during a previous site visit. The structure is a conventionally framed, detached, single family residence with raised 1st floor framing over a pier/girder foundation system with perimeter masonry foundation walls (*see picture 1*).

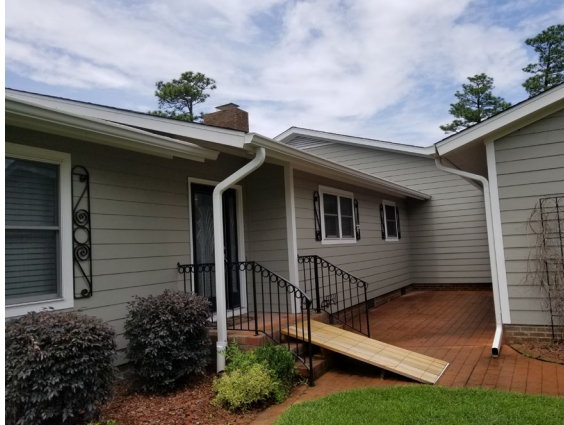
*Picture 2 – Front kitchen window to be widened
(at right of picture)*

- The right window at the front of the kitchen is to be widened to an approximately 64” wide opening. A new beam is to be installed over the new opening (*see picture 2*).
 - The beam should be a (2)2x6 #2 Southern Yellow Pine (SYP) or #2 Spruce Pine Fir (SPF) member. It should be installed with continuous span between end supports and built-up using (2) rows of 10d sinkers at 12” o.c. spacing along the length of the member.
 - Support each end of the beam with (2)2x4 #2 SPF jack studs and one 2x4 king stud.
