December 2, 2020

Project No. 20-0716.01 (Rev1)

Re: Structural Observation—24 West Landing, Sanford, NC 27332

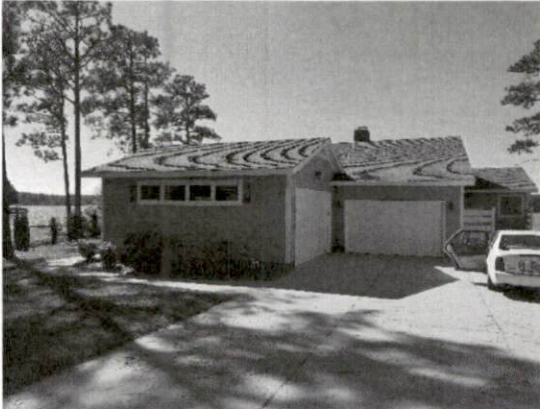
*Picture 1 – 24 West Landing,
Sanford, NC*

At your request, on May 29th, 2020 and on 12/2/2020 we performed a visual structural observation of various interior walls for proposed removal at the Sanford residence noted above. Renovation drawings by Robert Mikesell dated 12/2/2005 were provided on site. The structure is a conventionally framed, two-story, detached, single family residence with raised 1st floor framing over a pier/girder foundation system with perimeter masonry foundation walls (*see picture 1*). △

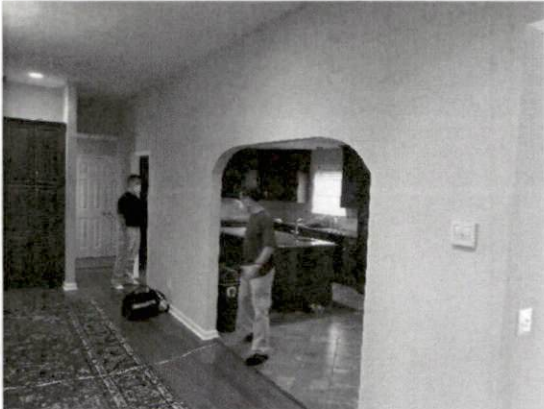
- The 1st floor load bearing wall at the back of the kitchen is to be removed to create a total opening of approximately 18'-4" starting at the edge of the existing door opening that is at the right of the kitchen. The wall provides support for roof and attic loads. A beam that is installed so the bottom of the beam is flush with the bottom of the kitchen ceiling joists is to be added to support structural loads from above (*see picture 2*).

Picture 2 – Back kitchen wall

- The beam should be a (2)1 $\frac{3}{4}$ "x18" LVL (Boise Cascade VersaLam 3100, or better) beam with continuous span between end supports. The beam should be built-up using (3) rows of 16d sinkers at 12" o.c. spacing along the length of the member.

- Fasten the kitchen ceiling joists to the front side of the new beam using Simpson face hangers.
 - Support each end of the beam with (3)2x4 #2 Spruce-Pine-Fir (SPF) studs.

- Investigation into the crawlspace beneath the proposed bearing ends of the beam indicated that the left and right ends of the beam were located over CMU piers that are sufficient to support the new distribution of structural loads. No foundation modifications should be necessary to support the ends of the beam.

- Install tight fit, full depth (3)2x blocking beneath each of the bearing points in the 1st floor framing system for direct transfer of vertical loads to the foundation elements below. The ends of the beam should be aligned over the centerline of the existing masonry piers.

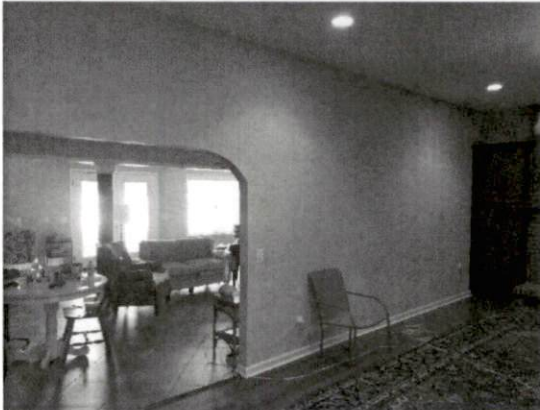
- The 1st floor load bearing wall at the back of the dining room is to be removed to create a total opening of 26'-4". A 2' return wall should be installed around the plumbing line at the left wall of the dining room. The wall provides support for 2nd story floor joists with front-to-back orientation, as well as roof, attic, and wall loads. A beam, installed with the bottom flush to the underside existing of 2nd floor framing, is to be added to support structural loads from above (*see picture 3*).

Picture 3 – Back dining room wall

- The beam should be a (3)1¾"x24" LVL (Boise Cascade VersaLam 3100, or better) beam with continuous span between end supports. The beam should be built-up using (4) rows of 16d sinkers at 12" o.c. spacing along the length of the member.

- Fasten 2nd story floor joists to the back side of the beam using Simpson face hangers.
 - Securely fasten the top of the beam to the dining room ceiling framing.

- Support each end of the beam with (4)2x6 #2 SPF studs.
 - Investigation in the crawlspace revealed masonry piers were installed beneath the ends of the beam with footings that were sufficient to support the new distribution of structural loads. No additional foundation modifications are necessary for this beam.

- Install tight fit, full depth (4)2x blocking beneath each of the bearing points in the 1st floor framing system for direct transfer of vertical loads to the foundation elements below.

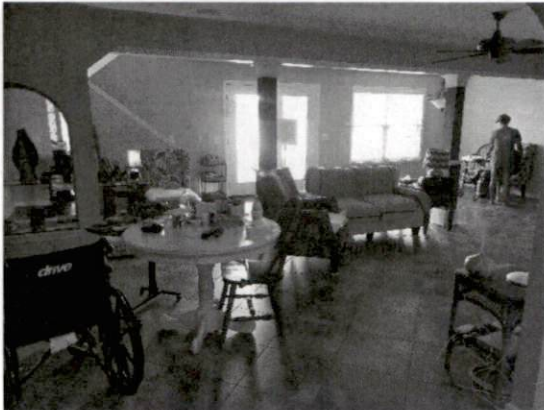
- The posts in the sunroom and the beam they support are to be removed to create a total opening of approximately 24'-0" starting at the right wall of the sunroom. The wall provides support for 2nd story floor joists with front-to-back orientation, as well as roof, attic, and wall loads. A beam, installed flush to the underside of the 2nd floor sheathing, is to be added to support structural loads from above (*see picture 4*).

Picture 4 – Posts and dropped beam

- The beam should be a W10x88 steel beam (Fy=50ksi) that is installed within the 2nd floor system. The left end should bear on the back end of the header to the hallway that is at the left side of the stairs and the right end of the beam should bear on the right wall of the sunroom. Install with tight fit 2x filler within the web on both sides of the beam for face hanger attachment. Fasten the web filler at the beam with ¾" diameter through-bolts with nut and washer at 12" o.c. for the length of the beam.

- In order to facilitate the installation of the beam, the member may be shipped in sections and connected at the ends using a Complete Penetration Joint (CPJ) weld. All welds to be completed by a certified AWS welder.

- Fasten 2nd story floor joists on both sides of the beam to the web-filler using Simpson face hangers.
 - Support the right end of the beam with a 3½"x7" PSL 1.8E ParaLam post with and additional (2)2x4 #2 SPF studs built-up against each face of the post. The stud pack should be strapped together at 1/3 points using Simpson CS-16 straps.

- The end 3½ inches of the steel beam should have full bearing on the existing wall top plates. Fasten the bottom flange of the

steel beam to the top of the wall plates using (2) 1/2" diameter x 4" long lag screws.

- Widen the foundation wall at the location of this point load by adding a solid-filled 8" CMU pilaster that is at least two times as wide as it is tall. Mortar and anchor new pilaster to the cleaned inside face of the foundation wall using (2) grouted stainless steel brick ties at each pilaster course. The pilaster should be installed on the existing footing projection

- Install tight fit, full depth (8)2x blocking beneath this bearing point for direct transfer of vertical loads to the foundation element below.
- Support the left end of the beam with a (2)1 1/4"x9 1/4" Boise Cascade VersaLam 3100 header that should be span over the hallway opening.

- Support the back end of this header with (4)2x4 #2 SPF jack studs and a 2x4 king stud on each face of the beam.
 - Support the front end of the header with (3)2x4 #2 SPF jack studs and a 2x4 king stud.

- The wall top plates at the right end of the beam should be conventionally lapped with the wall top plate that is along the back wall of the master bedroom.

- Investigation in the crawlspace beneath the proposed bearing ends of the beam and header indicated that the concrete footings that support the foundation at these areas are sufficient to support the new distribution of structural loads.

- Install tight fit, full depth 2x blocking beneath each of the bearing points in the 1st floor framing system for direct transfer of vertical loads to the foundation elements below.
