**SOIL/SITE EVALUATION
 for ON-SITE WASTEWATER SYSTEM**

Owner: Grappler Applicant:
 Address: 21361 NC 24-27
 Proposed Facility: SFD
 Location of Site:

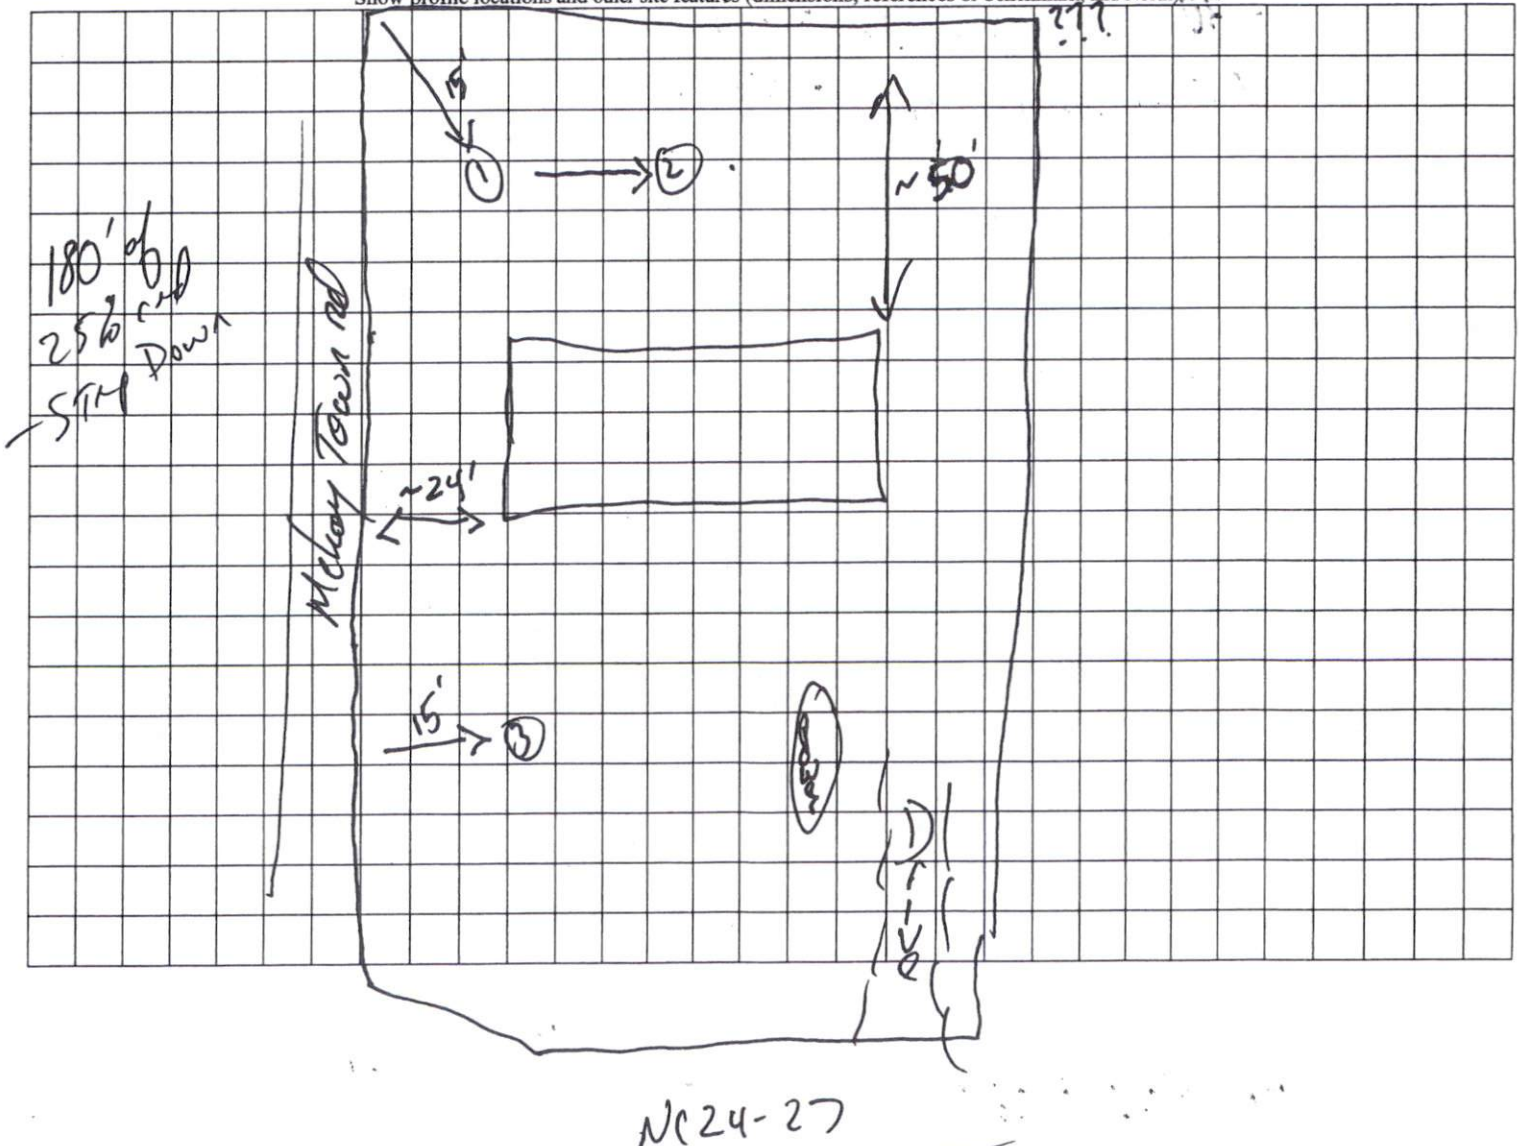
Show profile locations and other site features (dimensions, references or benchmark, and North).

9-9-21
 (Not Enough room)

9-21-21
 House Moved & System & repair
 Area Now Available
