Richard Van Gorp
81 Bayview Rd
Lillington, NC

4 Season addition

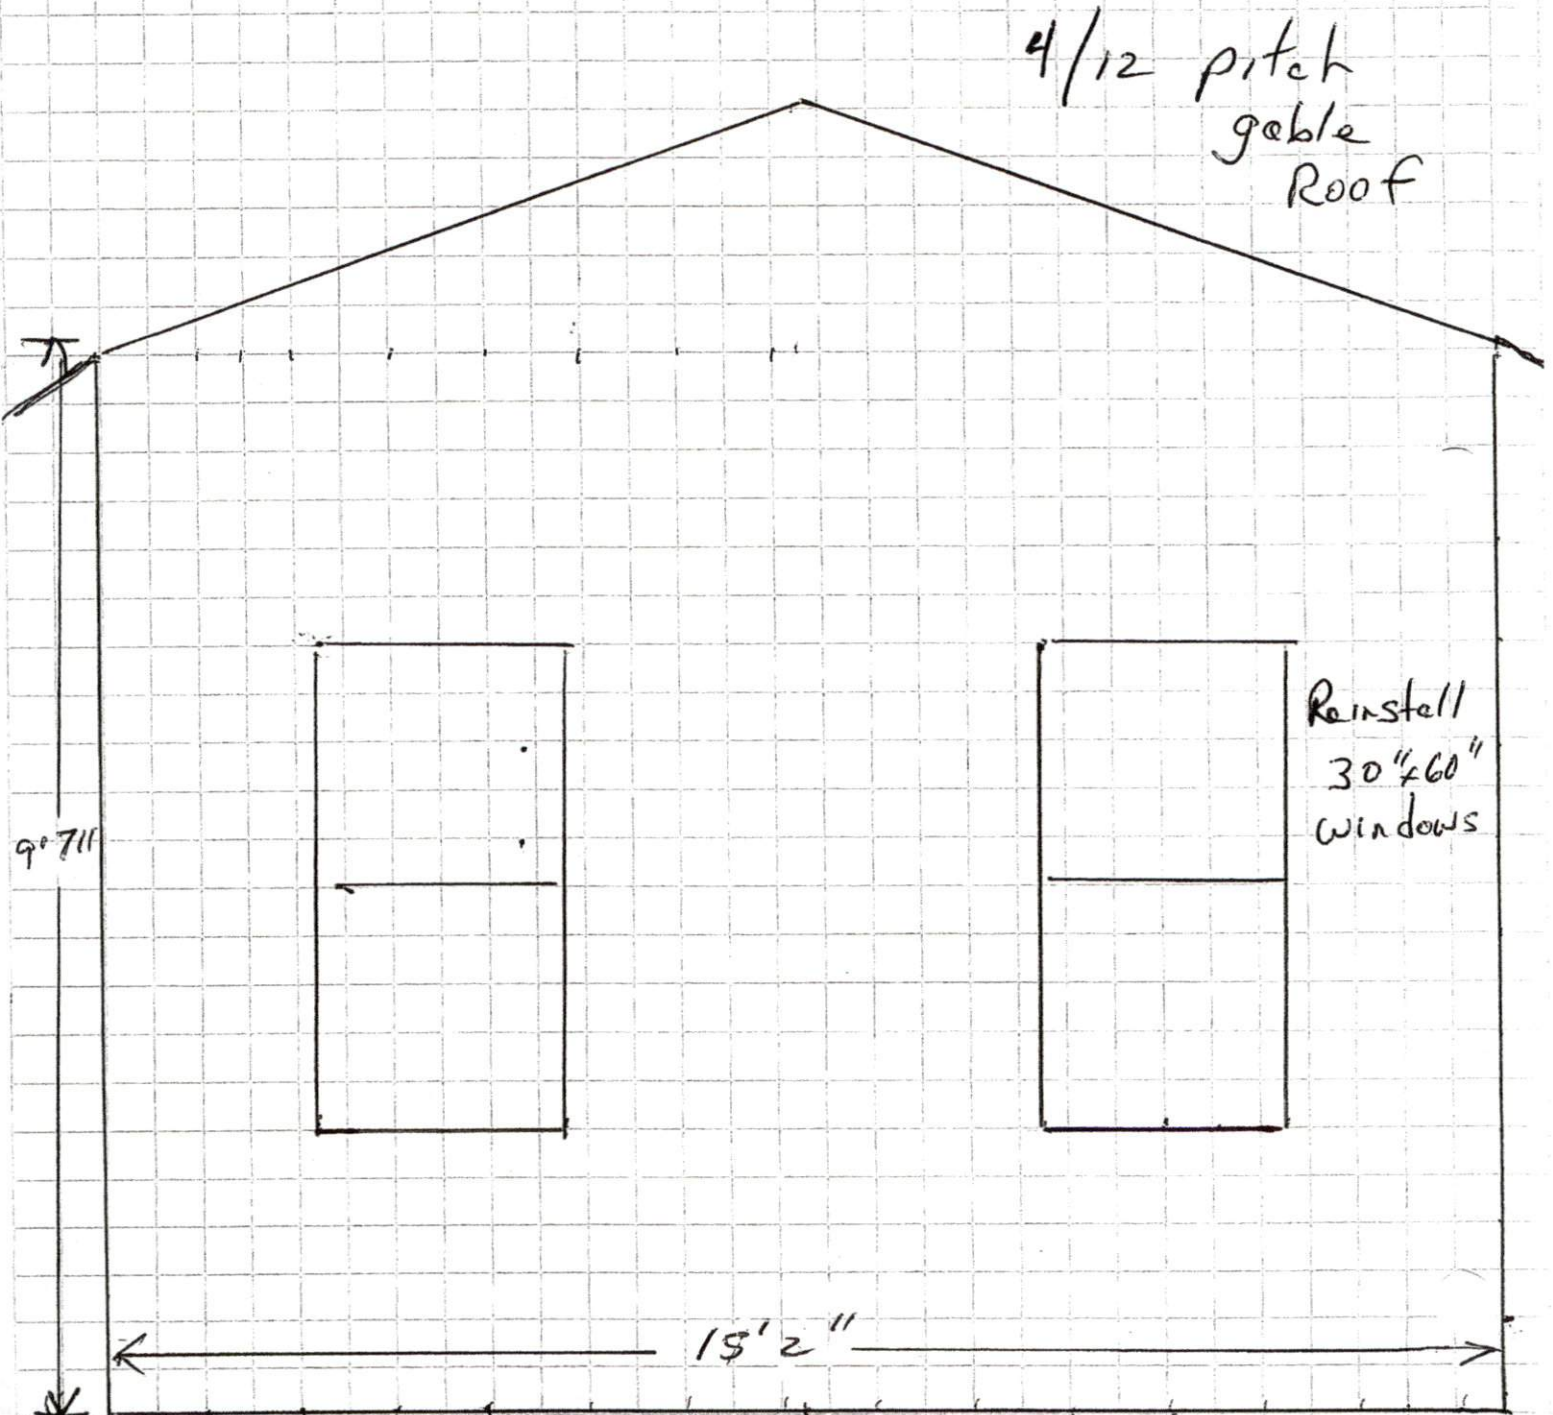
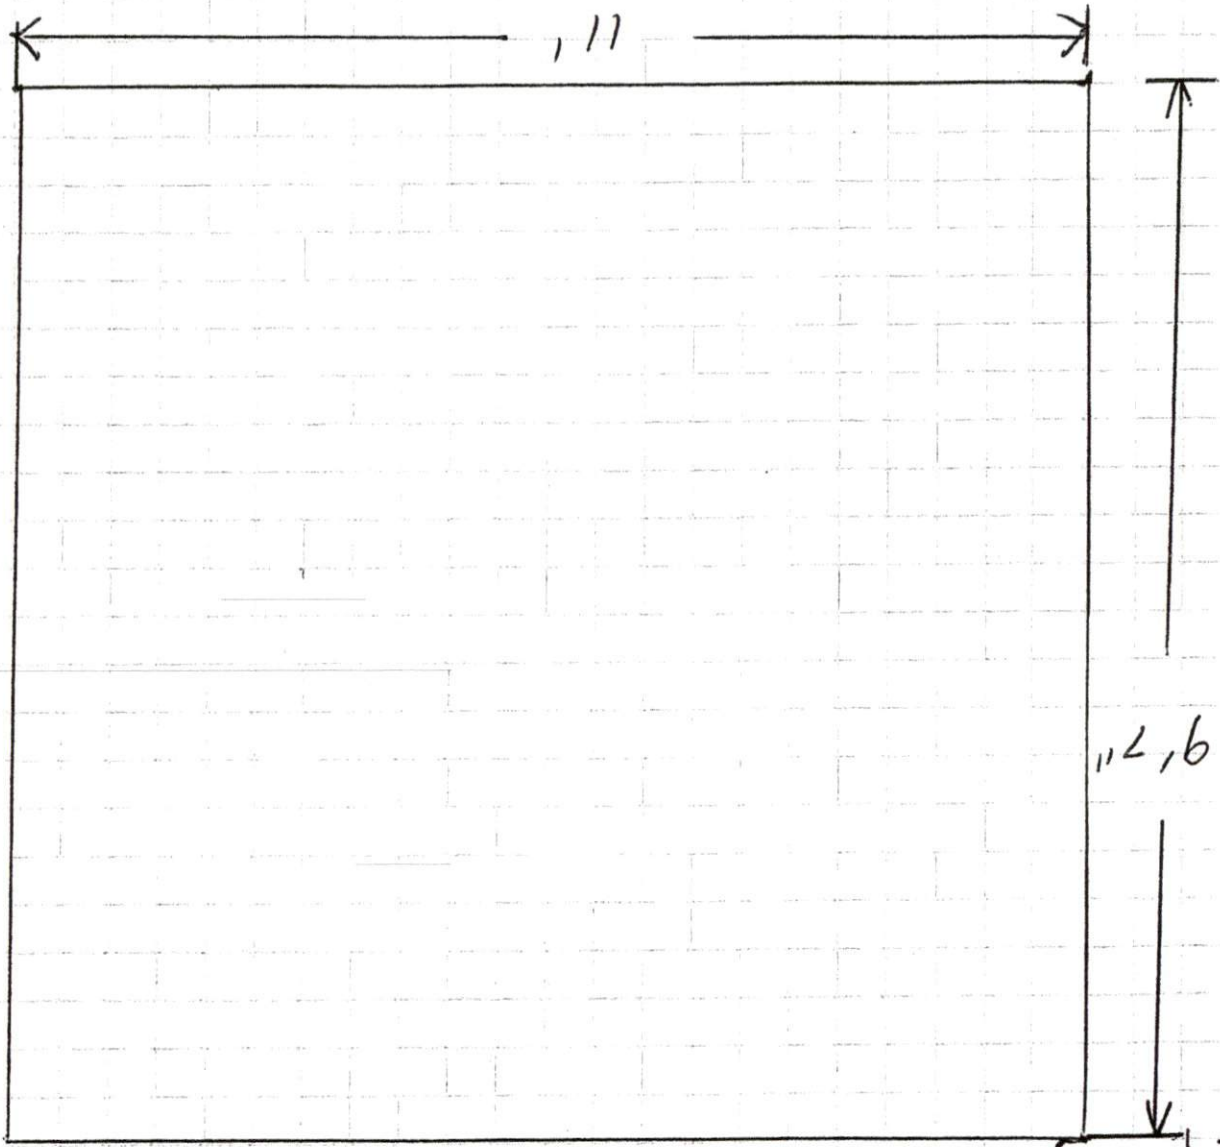
South View

Roof ridge

East view

12" overhangs

West View

12" overhang Roof Ridge

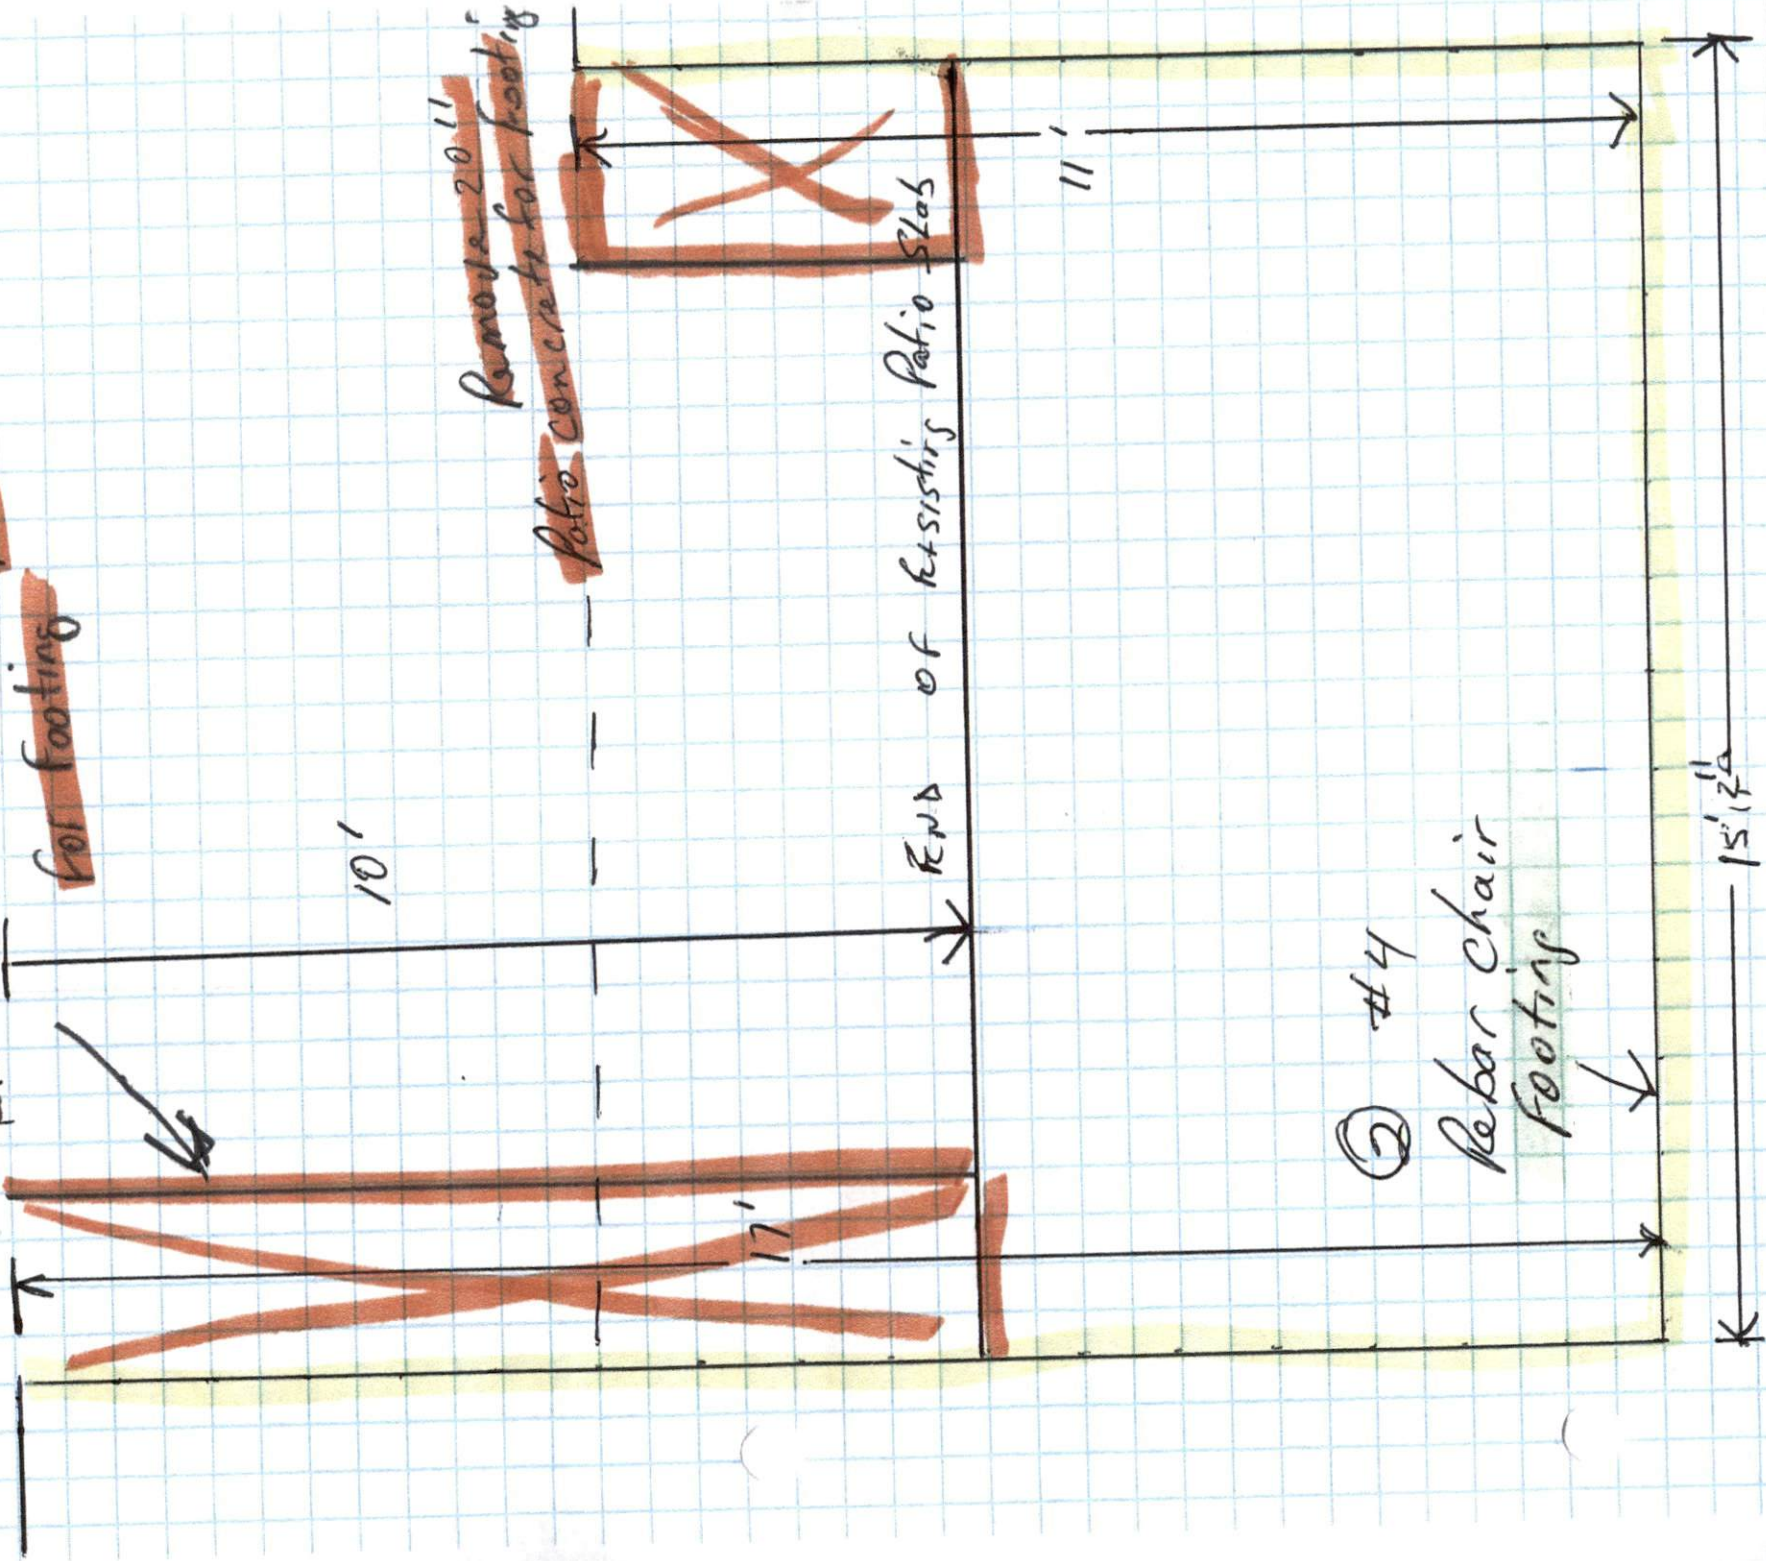
Foundation Needed

Remove 20" concrete patio for footing
