Reference: Engineering Services
8559 Old US Hwy 421
Lillington, NC 27546
TE&D Project No.: DRB2301-0159-A

As requested by the client, a representative of Tyndall Engineering & Design, PA (TE&D) was on-site to observe the following items:

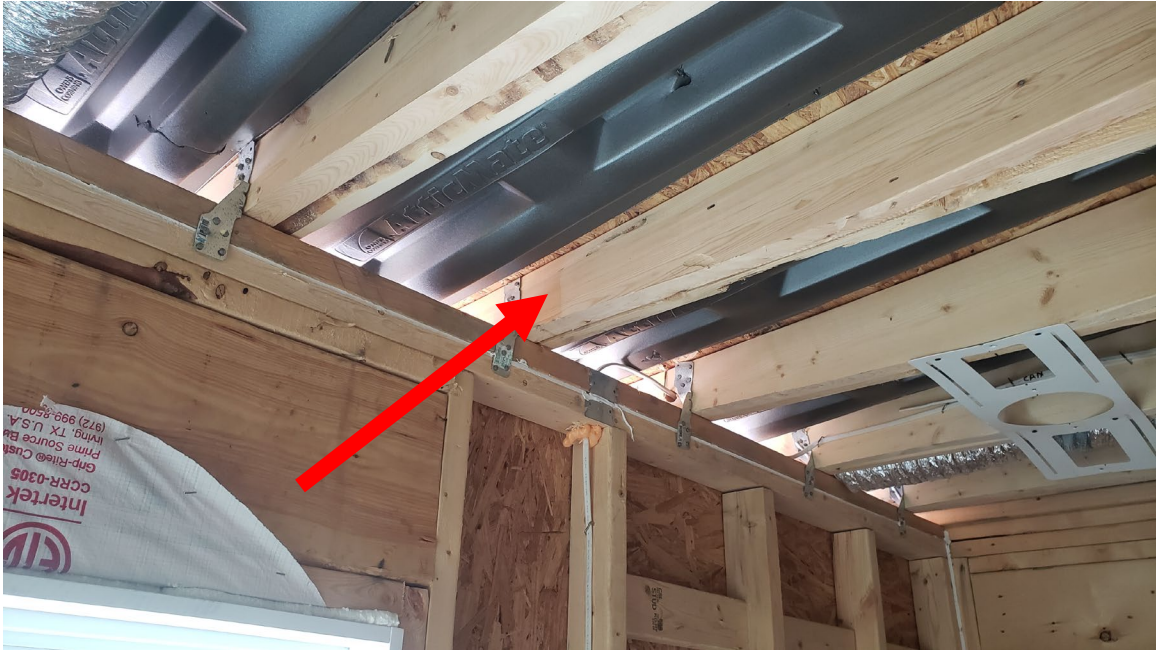
Item 1 Example

1. We observed approximately 3-1/4" of material remaining of the existing 2 x 6 at 16" o.c. rafters bearing at the rear-left exterior wall. Based on our observations and analysis, the notched rafters are not a structural concern and are adequate to support the anticipated loading conditions. No action required.
2. We observed approximately 2" of material remaining of the existing 2 x 6 at 16" o.c. rafters bearing at the rear-left exterior wall. Based on our observations and analysis, the notched rafters are not a structural concern and are adequate to support the anticipated loading conditions. No action required.
