HMHendrick Enterprises, Inc.

Re: Foundation Observation for Property Located at 145 Mickey Rouse Ln Cameron, NC 28326

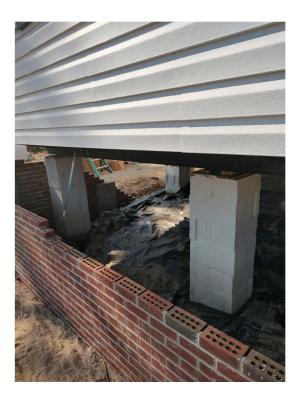
Photo 1: Typical pier placement/ orientation at high side

The piers greater than 36", but below 67" in height, (the tallest observed pier measuring at approximately 48" as noted above), was correctly constructed utilizing double stacked piers, again oriented and interlocked correctly, and with cap blocks per the governing regulations, (3.7.5).

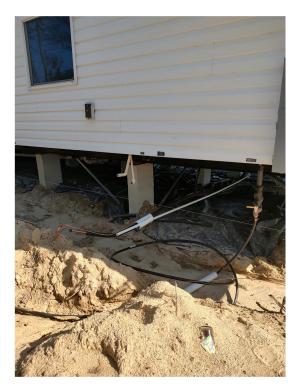
Photo 2: Typical pier placement/ orientation at low side

The piers below 36" in height were acceptably constructed out of single-stack CMU piers, oriented correctly, and with cap blocks as outlined in the Manufactured Home Regulations, (3.7.4).
