HM Hendrick Enterprises, Inc.

April 11, 2024

Re: Foundation Observation for Property Located at
67 Coastal Ct.
Sanford, NC 27332

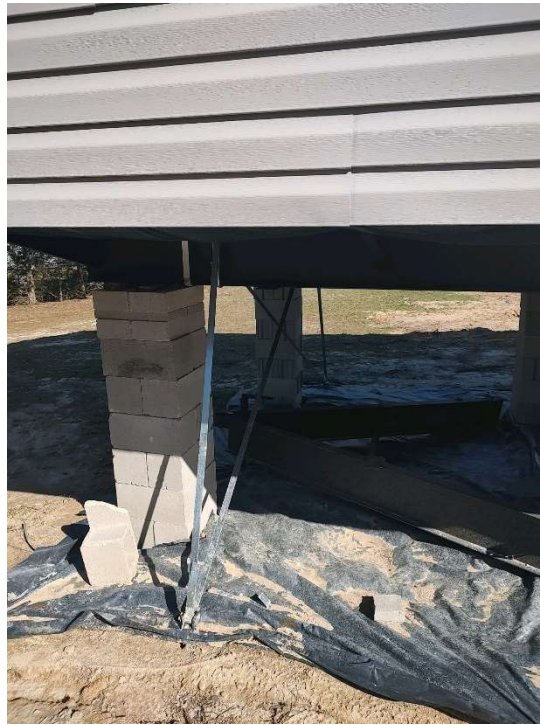
The piers greater than 36”, but below 67” in height, (the tallest observed pier measuring at approximately 56” as noted above), was correctly constructed utilizing double stacked piers, again oriented and interlocked correctly, and with cap blocks per the governing regulations, (3.7.5).

Site Photo 1: Tallest pier above grade, (double-stacked CMU w/ lateral bracing)

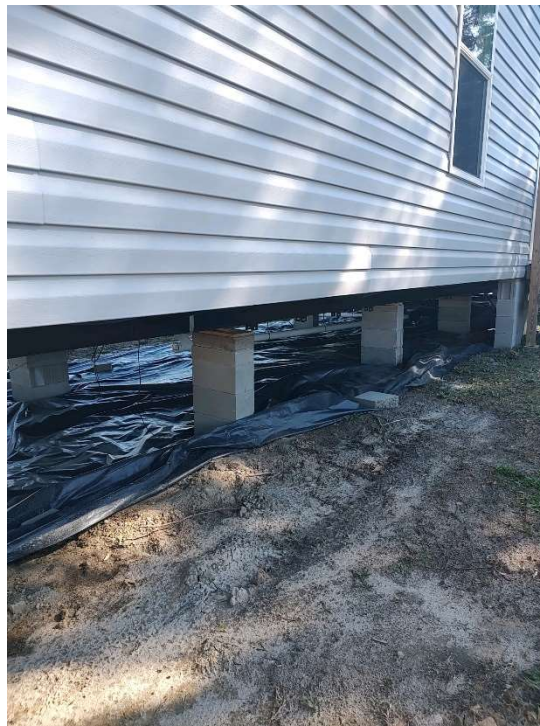
All piers were noted to bear on ABS bearing pads, and the piers below 36” in height were acceptably constructed out of single-stack CMU piers, oriented correctly, and with cap blocks as outlined in the Manufactured Home Regulations, (3.7.4).

Site Photo 2: Typical pier construction (single-stacked CMU)
