**COUNTY OF HARNETT DEMOLITION APPLICATION**

Subject: Asbestos Containing Building Material Survey  
630 Spence Mill Rd. Fuquay-Varina, NC

**Photos of 5 Bay Equipment Shelter, Garage, Shop W/ Attached Lean-Too's, Well, and Septic/Storage Tank Structure, Collapsed Barn, Shed, Tobacco Barn, Inspected:**  
630 Spence Mill Rd. Fuquay-Varina, NC

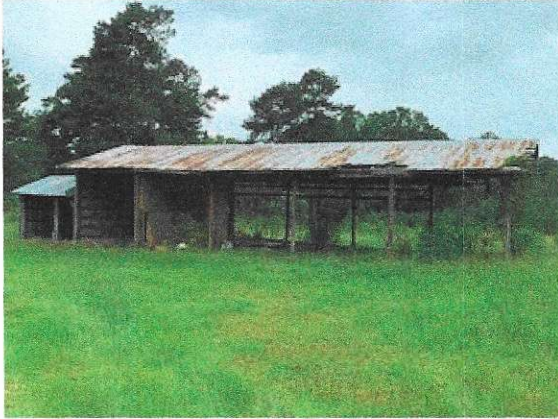
5 Bay Equipment Shelter

After reviewing data from the samples taken, none of the materials were found to contain asbestos for the 5 Bay Equipment Shelter, Shop / W Attached Lean-Too's, Collapsed Barn.

Material	General Location	Type and Percentage of Asbestos Present	Approximate Amount
None

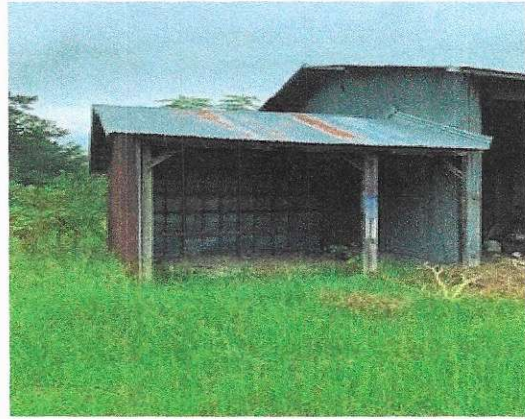
Garage

**\*Note: There were no suspected asbestos containing materials identified for Garage, Shed, Tobacco Barn, Well, Septic/Water Storage Tank.**

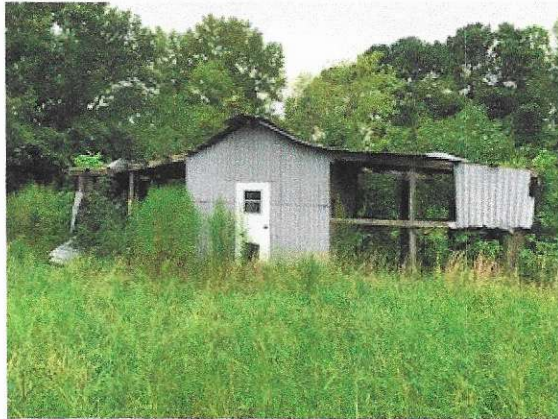
Shop W/ Attached Lean-Too's

Material	General Location	Type and Percentage of Asbestos Present	Approximate Amount
None

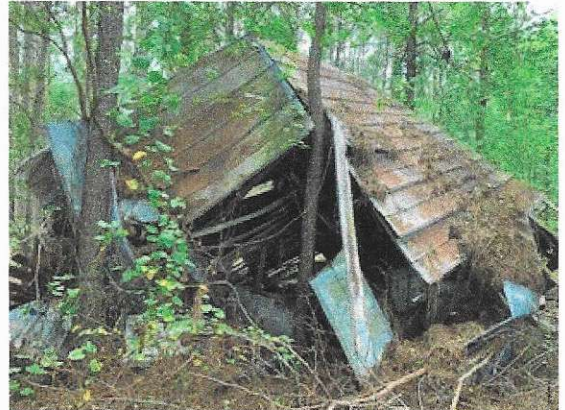
Collapsed Barn

Material	General Location	Type and Percentage of Asbestos Present	Approximate Amount
None
