**FIELD REPORT**

Project **125 Boston Harbor Home**  
 Location **Cameron, NC**  
 Client **Mr. Clyde Knoll**  
 Contractor **None Listed**

The undersigned arrived on site, as requested, to observe conditions of porch pier excavations. A total of 10 excavations (planned depth was 3 feet below adjacent grade) were observed. Using a steel-tipped rod, the bottom of the excavations were probed to determine stability. Several excavations had standing water. Below are our observations of each location, also shown on the attached site plan:

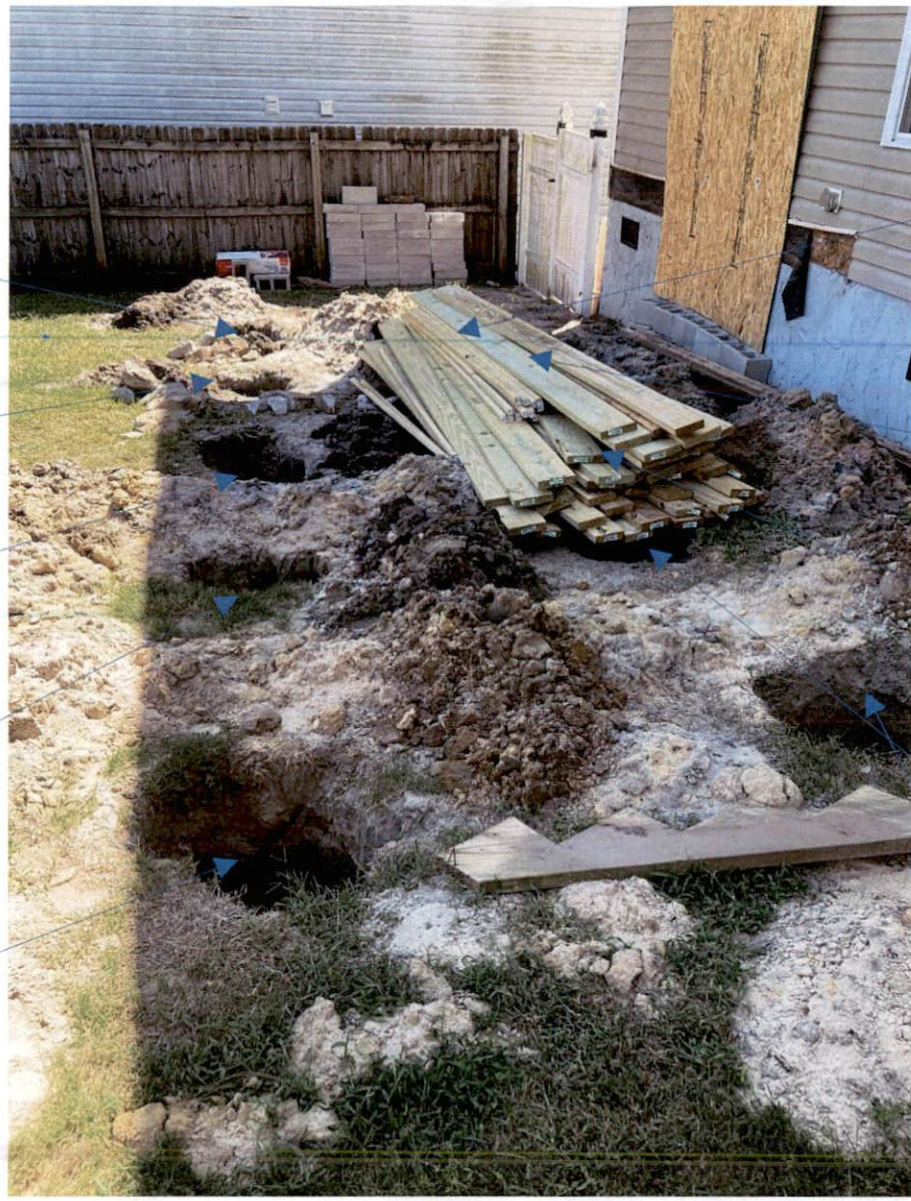
Andrew Gomez  
9/17/2025  
125 Boston Harbor,  
Cameron, NC 283261  
Proj #: 7515  
W/O # 87228

Excavations 1 and 4 - pump out water prior to pouring concrete.

Excavations 2, 6, 7, and 10 - undercut 1 foot below bottom of planned foundation elevation and replace with 57 stone wrapped in non-woven geotextile fabric.

Excavations 3, 5, 8, and 9 - undercut 2 feet below bottom of planned foundation elevation and replace with 57 stone wrapped in non-woven geotextile fabric.
