APPLICANT NAME \_\_\_\_\_

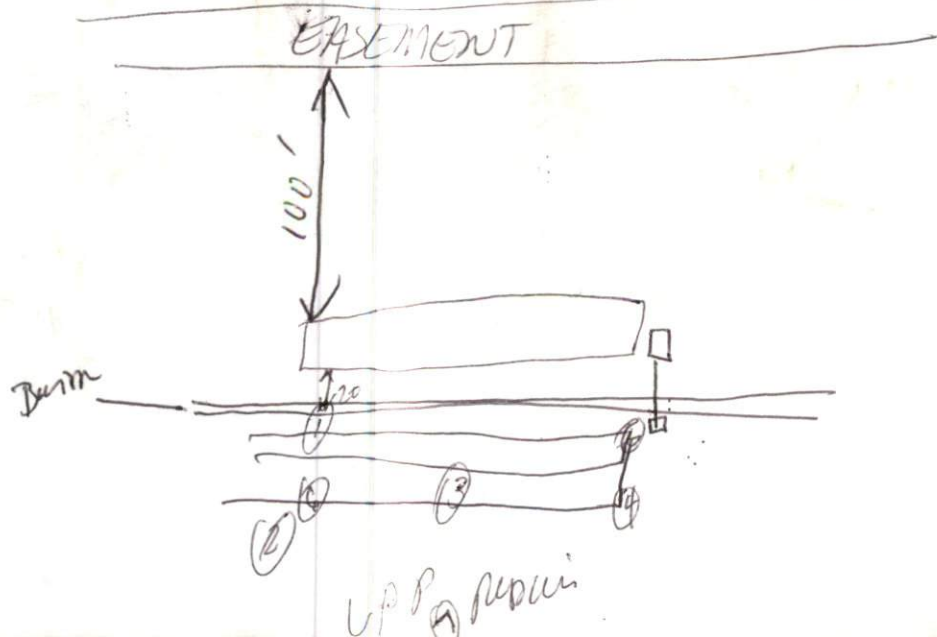
System laid out  
3x100' lines  
18'-24" (top 2 lines)  
18" deep (bottom line)

Repair 50'  
below initial  
system below  
next burm.

remove trees - no soil
