Application for Repair

Lot 17, Lafayette Meadows Subdivision

Septic System Inspection Report

193 Long Meadow Lane Fuquay-Varina, N.C. 27526

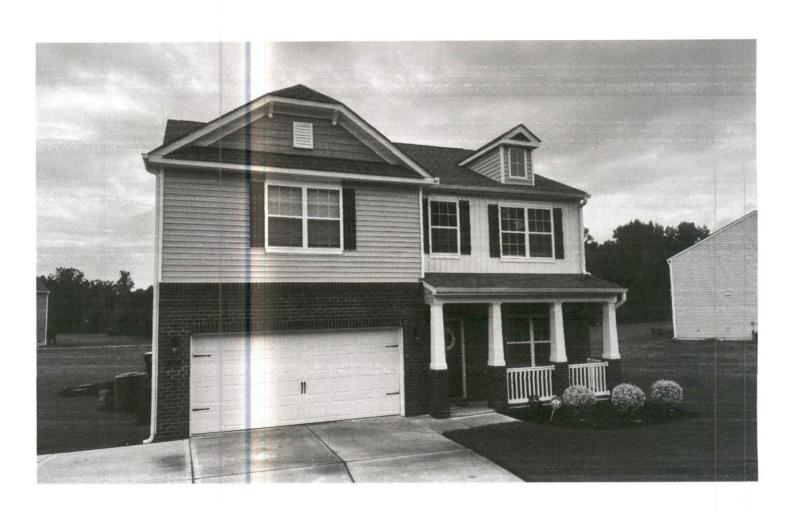
On September 30, 2024, Lynn Environmental Consulting personnel inspected the septic system serving a residence located at 193 Long Meadow Lane in Fuquay-Varina, North Carolina. A copy of the original septic permit was obtained from Harnett County Environmental Health Department. The septic system is permitted for a 4-bedroom home. The residence is served by public water supply. A copy of the septic permit, inspection checklist, and pictures taken during inspection follow this report.
