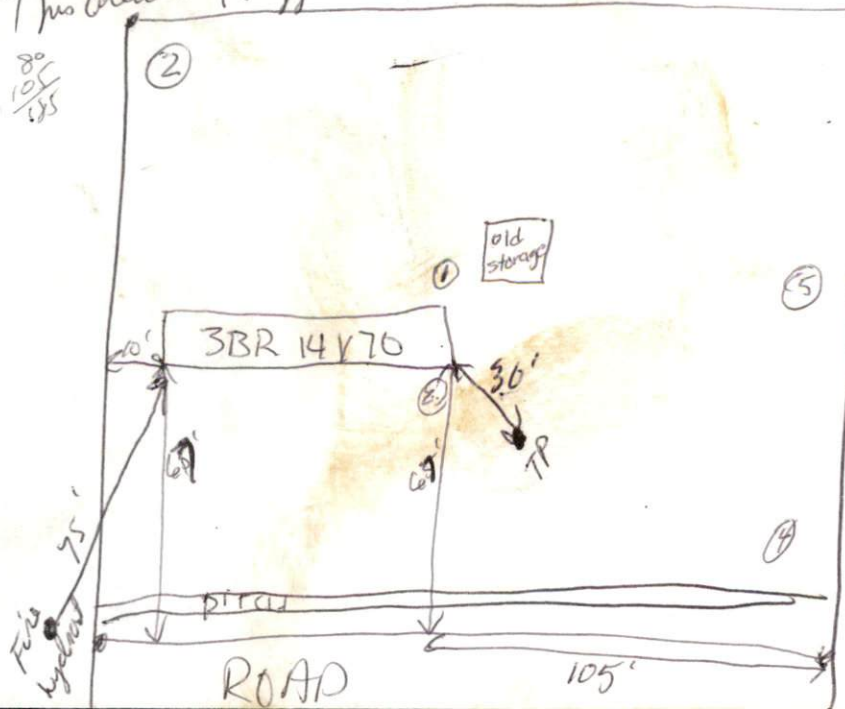
This area is flagged out. Does not match map!

- ① wet to touch - bench drain & elevate with
- ② wet to touch
- ③ wet to touch
- ④ wet to touch
- ⑤ wet to touch
- Need to verify prop. lines & corners 20 Jan 99 UPL
