SITE/SOIL EVALUATION FOR ON SITE

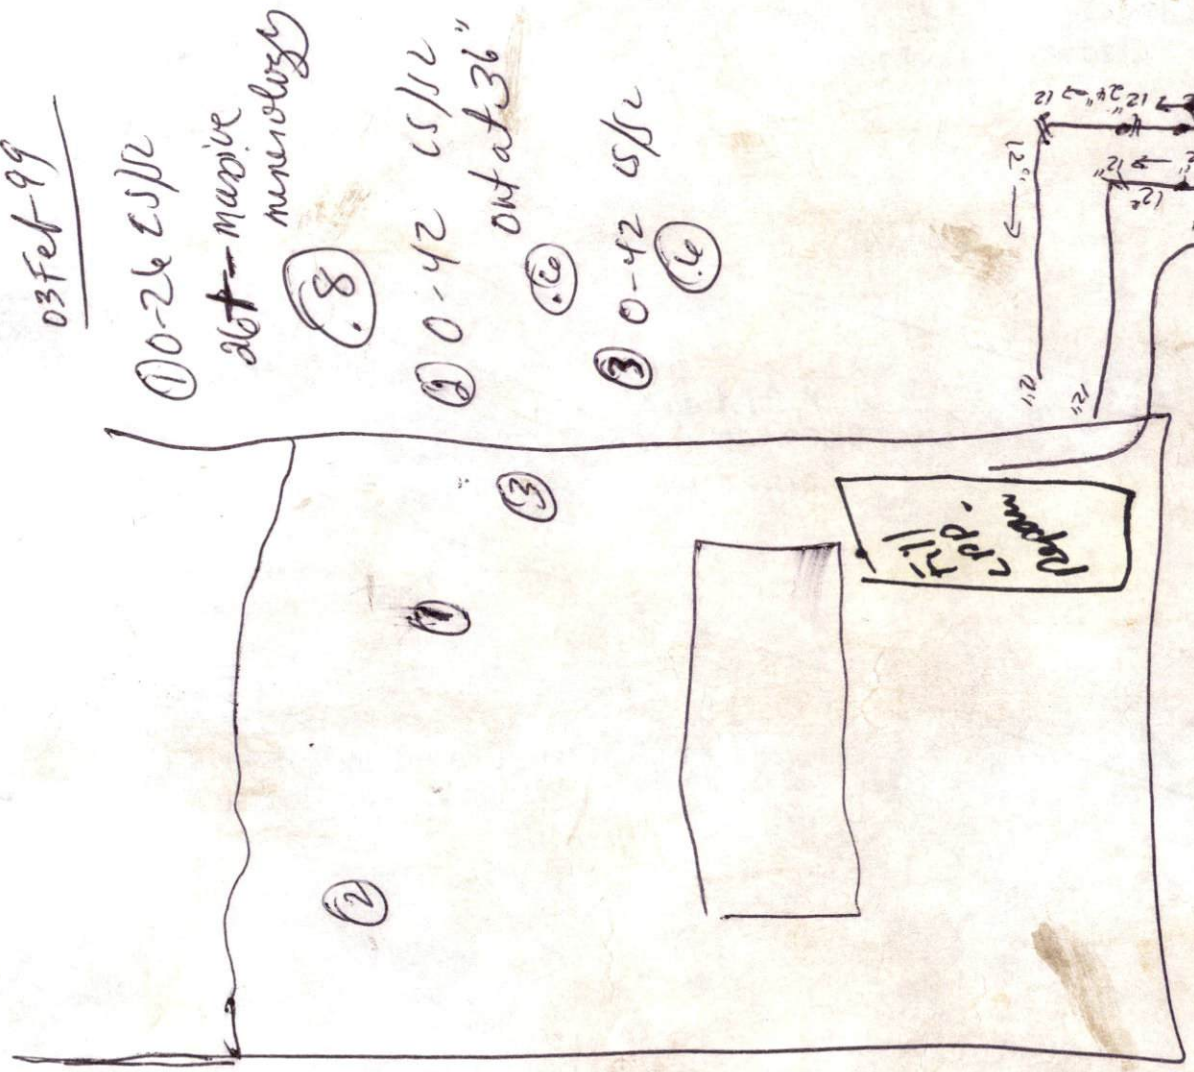
① 0-26 CS/IL
abt massive
mineralogy

② 0-42 CS/IL
out at 36"

③ 0-42 CS/IL

met on-site

12" swell & lay dirt
on the low side
of swell
200' feet !!

→ clear 50' back from wood line to the tall timber (poplar trees)
