ATTACH 2x SCAB OF THE SAME SIZE AND GRADE AS THE BROKEN MEMBER TO EACH FACE OF THE TRUSS (CENTER ON BREAK OR SPLICE) WITH 10d (0.131" X 3") NAILS (TWO ROWS FOR 2x4, THREE ROWS FOR 2x6) SPACED 4" O.C. AS SHOWN. STAGGER NAIL SPACING FROM FRONT FACE AND BACK FACE FOR A NET 0-2-0 O.C. SPACING IN THE MAIN MEMBER. USE A MIN. 0-3-0 MEMBER END DISTANCE.

DO NOT USE REPAIR FOR JOINT SPLICES

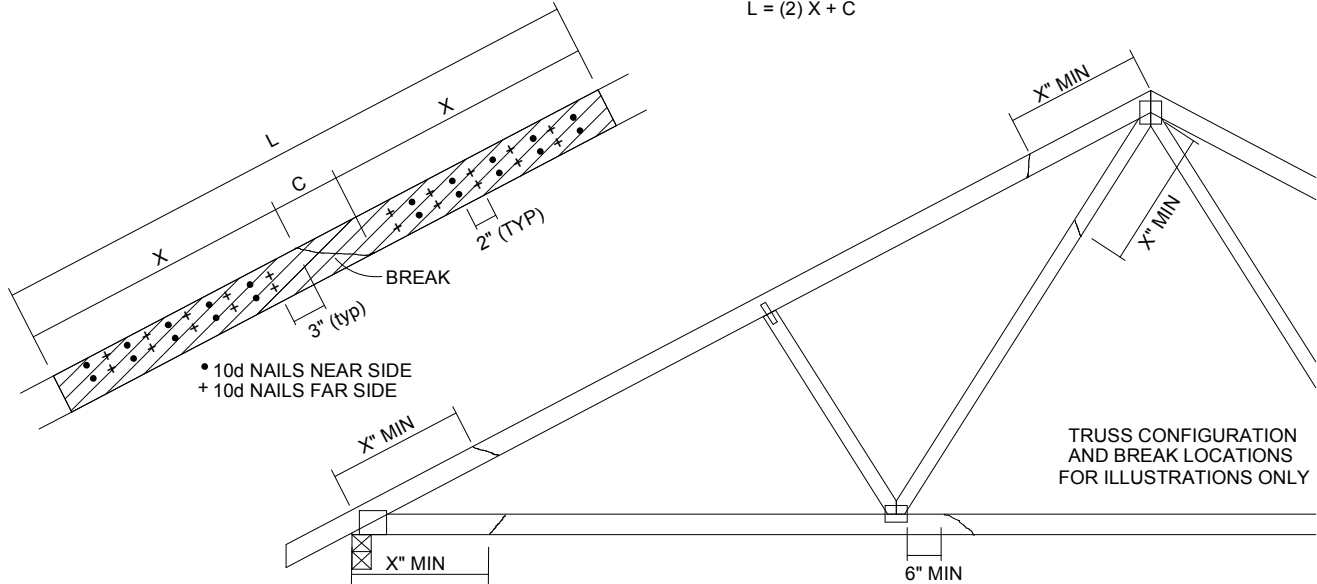
THE LENGTH OF THE BREAK (C) SHALL NOT EXCEED 12". (C=PLATE LENGTH FOR SPLICE REPAIRS) THE MINIMUM OVERALL SCAB LENGTH REQUIRED (L) IS CALCULATED AS FOLLOWS:  
 $L = (2) X + C$

THE LOCATION OF THE BREAK MUST BE GREATER THAN OR EQUAL TO THE REQUIRED X DIMENSION FROM ANY PERIMETER BREAK OR HEEL JOINT AND A MINIMUM OF 6" FROM ANY INTERIOR JOINT (SEE SKETCH ABOVE)

TOTAL NUMBER OF NAILS EACH SIDE OF BREAK *		X INCHES	MAXIMUM FORCE (lbs) 15% LOAD DURATION							
			SP		DF		SPF		HF	
2x4	2x6		2x4	2x6	2x4	2x6	2x4	2x6	2x4	2x6
20	30	24"	1706	2559	1561	2342	1320	1980	1352	2028
26	39	30"	2194	3291	2007	3011	1697	2546	1738	2608
32	48	36"	2681	4022	2454	3681	2074	3111	2125	3187
38	57	42"	3169	4754	2900	4350	2451	3677	2511	3767
44	66	48"	3657	5485	3346	5019	2829	4243	2898	4347

\* DIVIDE EQUALLY FRONT AND BACK
