ATTACH 2x SCAB OF THE SAME SIZE AND GRADE AS THE BROKEN MEMBER TO EACH FACE OF THE TRUSS (CENTER ON BREAK OR SPLICE) WITH 10d (0.131" X 3") NAILS (TWO ROWS FOR 2x4, THREE ROWS FOR 2x6) SPACED 4" O.C. AS SHOWN. STAGGER NAIL SPACING FROM FRONT FACE AND BACK FACE FOR A NET 0-2-0 O.C. SPACING IN THE MAIN MEMBER. USE A MIN. 0-3-0 MEMBER END DISTANCE.

DO NOT USE REPAIR FOR JOINT SPLICES

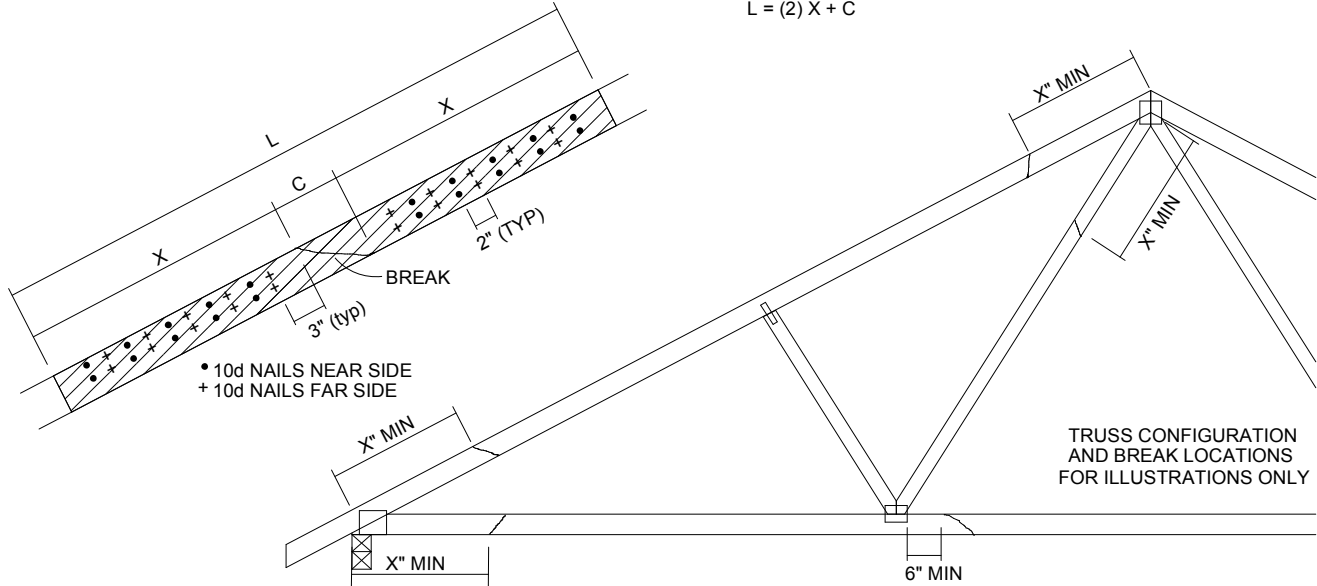
THE LENGTH OF THE BREAK (C) SHALL NOT EXCEED 12". (C=PLATE LENGTH FOR SPLICE REPAIRS)  
THE MINIMUM OVERALL SCAB LENGTH REQUIRED (L) IS CALCULATED AS FOLLOWS:  
 $L = (2) X + C$

THE LOCATION OF THE BREAK MUST BE GREATER THAN OR EQUAL TO THE REQUIRED X DIMENSION FROM ANY PERIMETER BREAK OR HEEL JOINT AND A MINIMUM OF 6" FROM ANY INTERIOR JOINT (SEE SKETCH ABOVE)

TOTAL NUMBER OF NAILS EACH SIDE OF BREAK *		X INCHES	MAXIMUM FORCE (lbs) 15% LOAD DURATION							
			SP		DF		SPF		HF	
2x4	2x6		2x4	2x6	2x4	2x6	2x4	2x6	2x4	2x6
20	30	24"	1706	2559	1561	2342	1320	1980	1352	2028
26	39	30"	2194	3291	2007	3011	1697	2546	1738	2608
32	48	36"	2681	4022	2454	3681	2074	3111	2125	3187
38	57	42"	3169	4754	2900	4350	2451	3677	2511	3767
44	66	48"	3657	5485	3346	5019	2829	4243	2898	4347

\* DIVIDE EQUALLY FRONT AND BACK
