Project Name: Quail Glen - Lot 58 Date: 3 / 14 / 2020 GTA Rep: Payton Guerrero
 Project No.: 200385N058 Client: Ryan Homes Weather: Sunny Temperature: 62 °F

Lot 58- 31 Bellini Drive (Permit No.: 2001-0065)

FOUNDATION OBSERVATION REPORT

Date: 3 / 14 / 2020
Photo Page No. 1

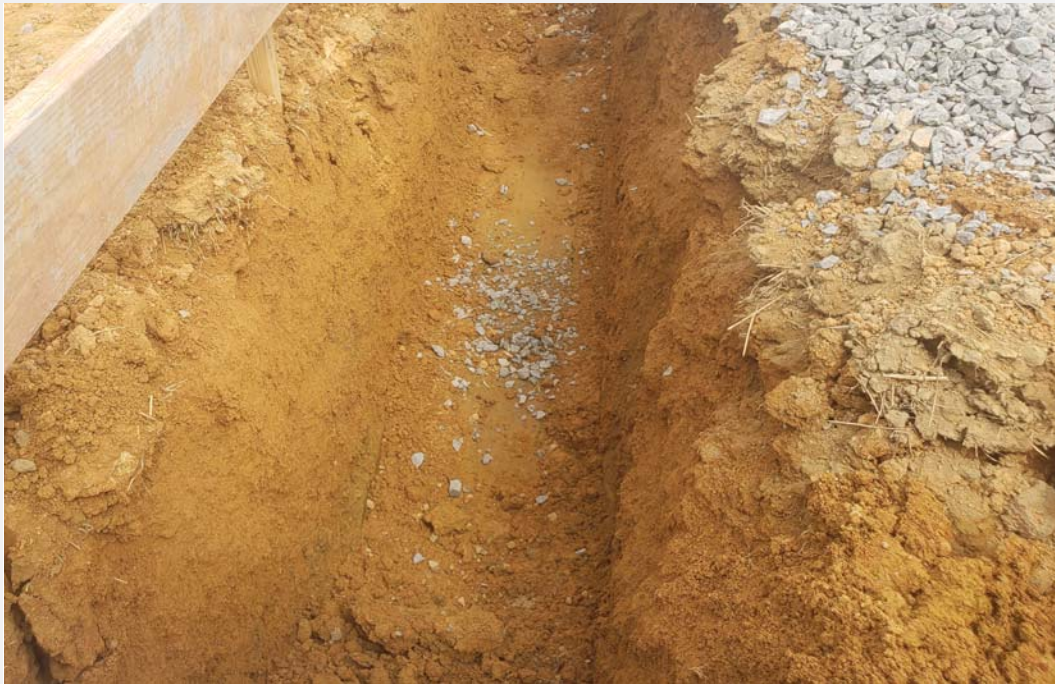
Lot 58

Utilizing the approved construction drawings, foundation excavations (turn-down footings and grade-beams) observed on this date, appeared to have been excavated to the specified depth and size. The foundation excavations were observed to be free of loose soil, debris, and water.

Also, GTA observed a 6-Mil vapor barrier had been placed in slab areas. Additionally, GTA observed insulation board along the perimeter of the exterior walls. The vapor barrier and insulation board placement observed, appeared to be in general accordance with the approved project drawings.
