Reference: Engineering Services  
2695 Darroch Rd.  
Harnett County, NC  
Project No.: 2001-020703

- 1) Address the in-situ bearing conditions of the existing footing excavation prior to concrete placement.

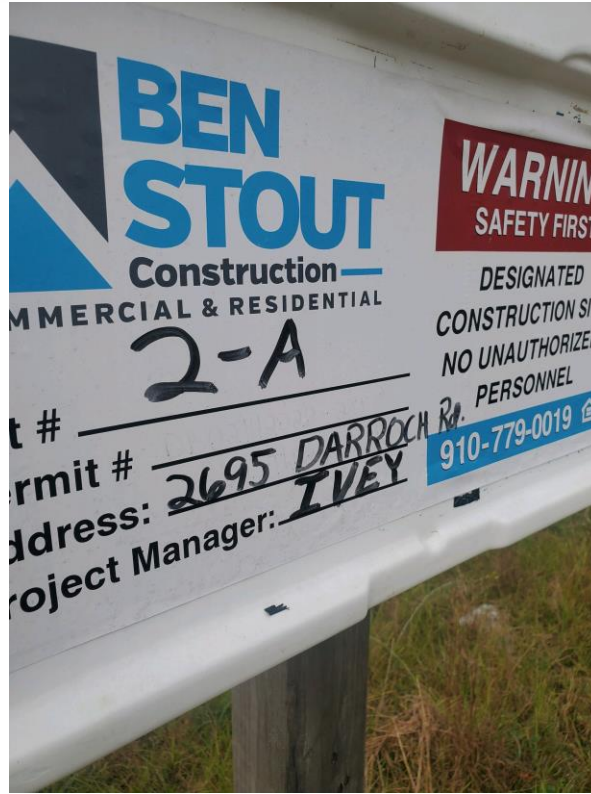
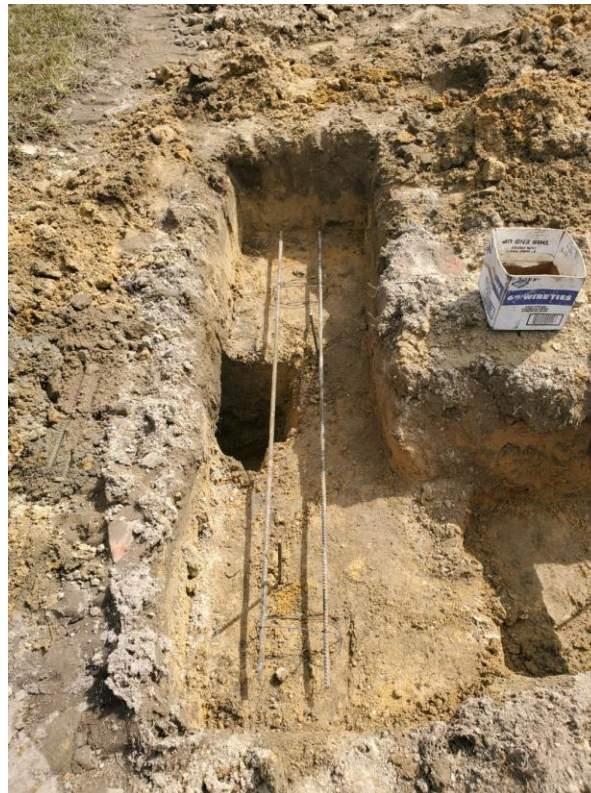
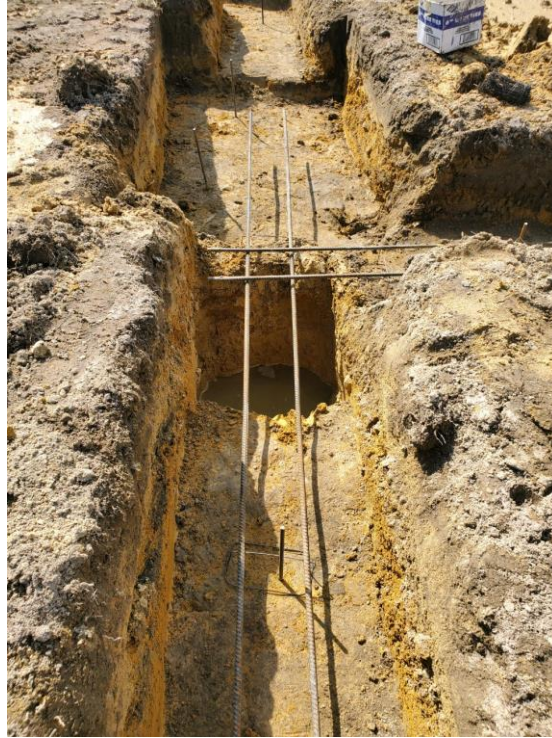
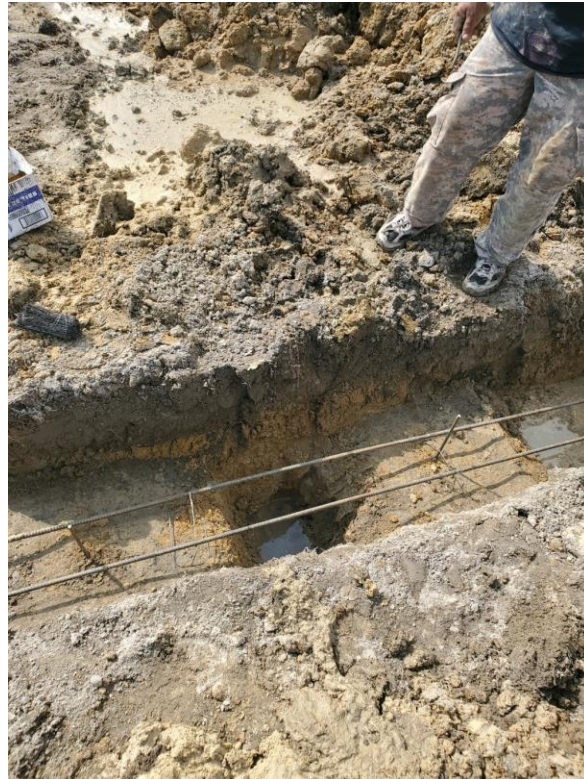
- 1) Based on our conversations with the contractor and supplemental analyses, it TE&D's understanding that the existing footing excavations had areas of shallow standing water at the time of the previous municipality inspection due to the presence of random "stump holes" in the front portion of the footing. The "stump holes" sections had been over-excavated and reinforced with two (2) #4 rebars at the time of TE&D's October 16, 2020 afternoon analyses of the footing excavations. **The existing reinforced footing and bearing conditions were deemed adequate to support the anticipated loading conditions (i.e. 2000 psf net design bearing pressure).** The reader is referred to the attached photographs for supplemental information.
