ATTACH 2x SCAB OF THE SAME SIZE AND GRADE AS THE BROKEN MEMBER TO EACH FACE OF THE TRUSS (CENTER ON BREAK OR SPLICE) WITH 10d (0.131" X 3") NAILS (TWO ROWS FOR 2x4, THREE ROWS FOR 2x6) SPACED 4" O.C. AS SHOWN. STAGGER NAIL SPACING FROM FRONT FACE AND BACK FACE FOR A NET 0-2-0 O.C. SPACING IN THE MAIN MEMBER. USE A MIN. 0-3-0 MEMBER END DISTANCE.

DO NOT USE REPAIR FOR JOINT SPLICES

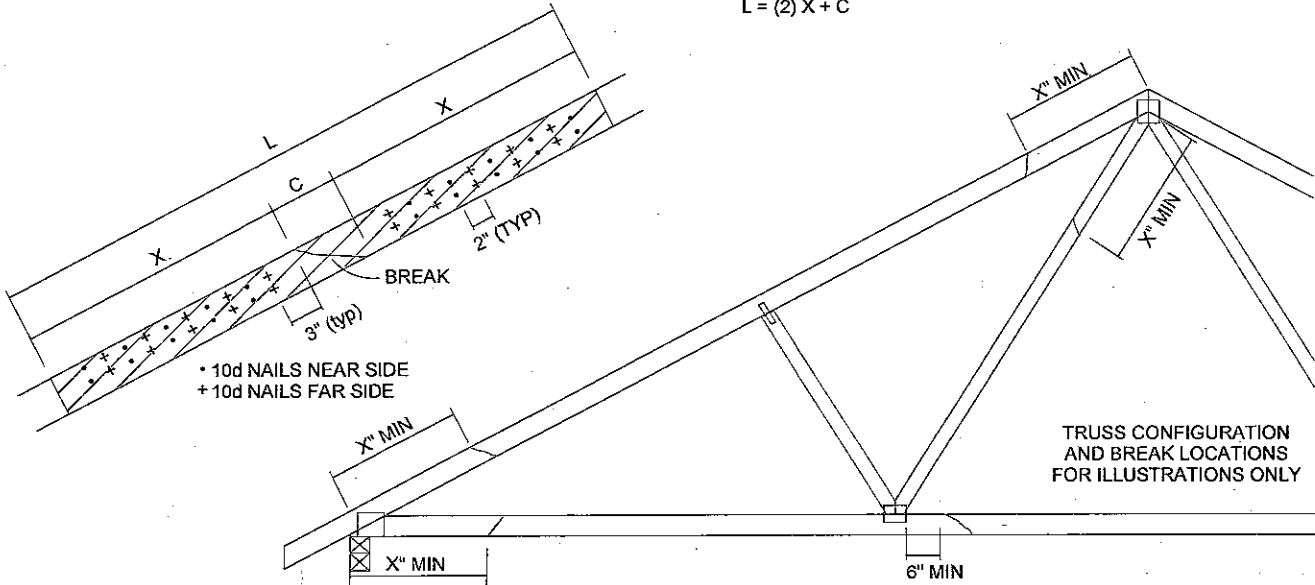
THE LENGTH OF THE BREAK (C) SHALL NOT EXCEED 12". (C=PLATE LENGTH FOR SPLICE REPAIRS) THE MINIMUM OVERALL SCAB LENGTH REQUIRED (L) IS CALCULATED AS FOLLOWS:
 $L = (2) X + C$

THE LOCATION OF THE BREAK MUST BE GREATER THAN OR EQUAL TO THE REQUIRED X DIMENSION FROM ANY PERIMETER BREAK OR HEEL JOINT AND A MINIMUM OF 6" FROM ANY INTERIOR JOINT (SEE SKETCH ABOVE)

TOTAL NUMBER OF NAILS EACH SIDE OF BREAK *		X INCHES	MAXIMUM FORCE (lbs) 15% LOAD DURATION							
			SP		DF		SPF		HF	
2x4	2x6		2x4	2x6	2x4	2x6	2x4	2x6	2x4	2x6
20	30	24"	1706	2559	1561	2342	1320	1980	1352	2028
26	39	30"	2194	3291	2007	3011	1697	2546	1738	2608
32	48	36"	2681	4022	2454	3681	2074	3111	2125	3187
38	57	42"	3169	4754	2900	4350	2451	3677	2511	3767
44	66	48"	3657	5485	3346	5019	2829	4243	2898	4347

* DIVIDE EQUALLY FRONT AND BACK
