MISSING PLATE REPAIR DETAIL

MII WEB PLATE

MiTek USA, Inc. Page 1 of 1

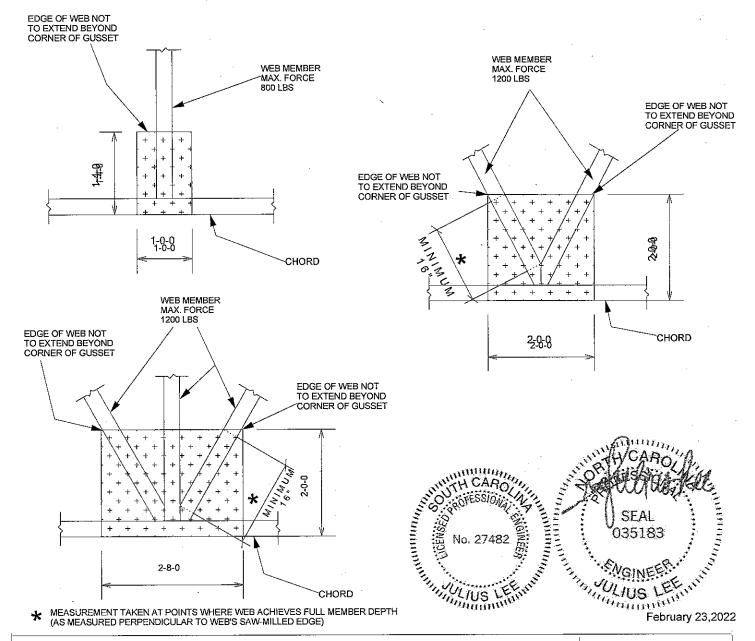
1, ALL MATERIAL IS 2x4

- THIS DETAIL IS APPLICABLE FOR DESIGNS WITH DOLS. OF 1.15 OR 1.25 AND LUMBER SPECIES SP, DF, HF, OR SPF.
- 3. DETAIL SHALL BE USED FOR CONDITIONS OF A MISSING OR LOOSE CONNECTOR PLATE ONLY.
- CHORD MATERIAL IS CONTINUOUS THROUGH JOINT, THERE IS NO MAXIMUM CHORD FORCE AND NO SPLICE PERMITTED.
- 5. REFER TO MITEK DESIGN DRAWING FOR WEB FORCES.

ATTACH 1/2" PLYWOOD OR OSB GUSSET (15/32" RATED SHEATHING 32/16 EXP 1) TO EACH FACE OF TRUSS WITH (0.131" X MIN 2.5") NAILS IN 3 ROWS SPACED @ 4" O.C. NAILS TO BE DRIVEN FROM BOTH FACES. STAGGER SPACING FROM FRONT TO BACK FACE FOR A NET 2" O.C. SPACING IN THE TRUSS. USE 2" MEMBER END DISTANCE.
