Reference: Engineering Services
133 Old Buies Creek Rd.
Lillington, NC 27546
TE&D Project No.: 2001-020789

- 1) Analyze and inspect the piers missing suitable projection and center third alignment.

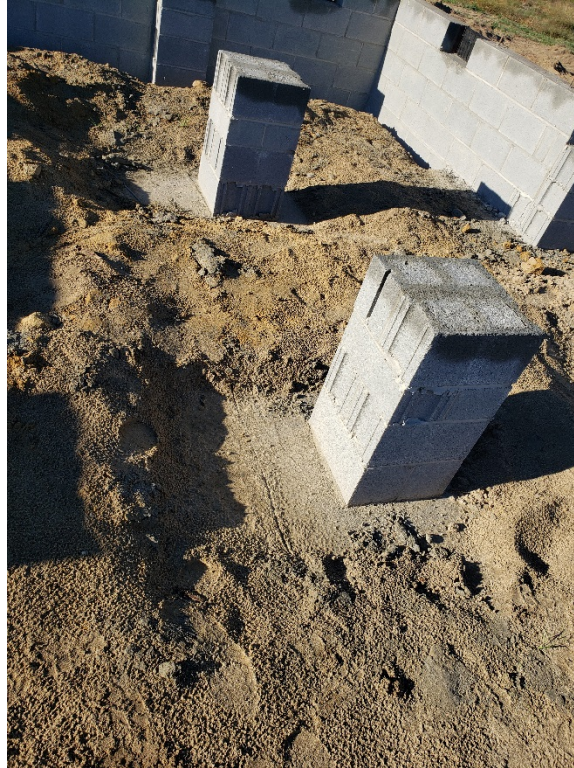
The piers outside of center third were also inspected. Based on our observations, analysis, footing geometry, and the soil bearing capacity, the “as-built” piers and footings will provide the required support for the anticipated loading conditions.

Example of Piers outside Center Third of Footings

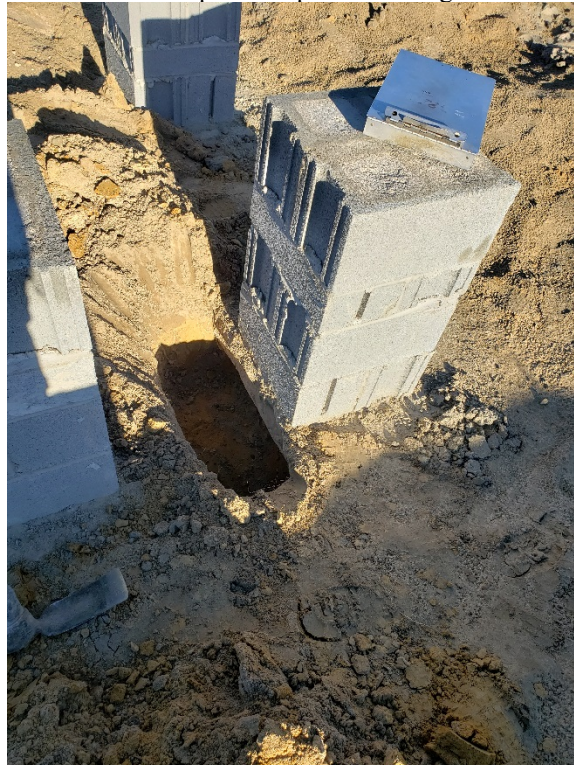
- 1) The piers missing projection were repaired per our direction. At each location, a minimum 8” wide trench was excavated past the bottom of the footing and extended 4” under the footing. The newly added sections of concrete will provide the required support for the anticipated loading conditions.

Example of Repaired Footing

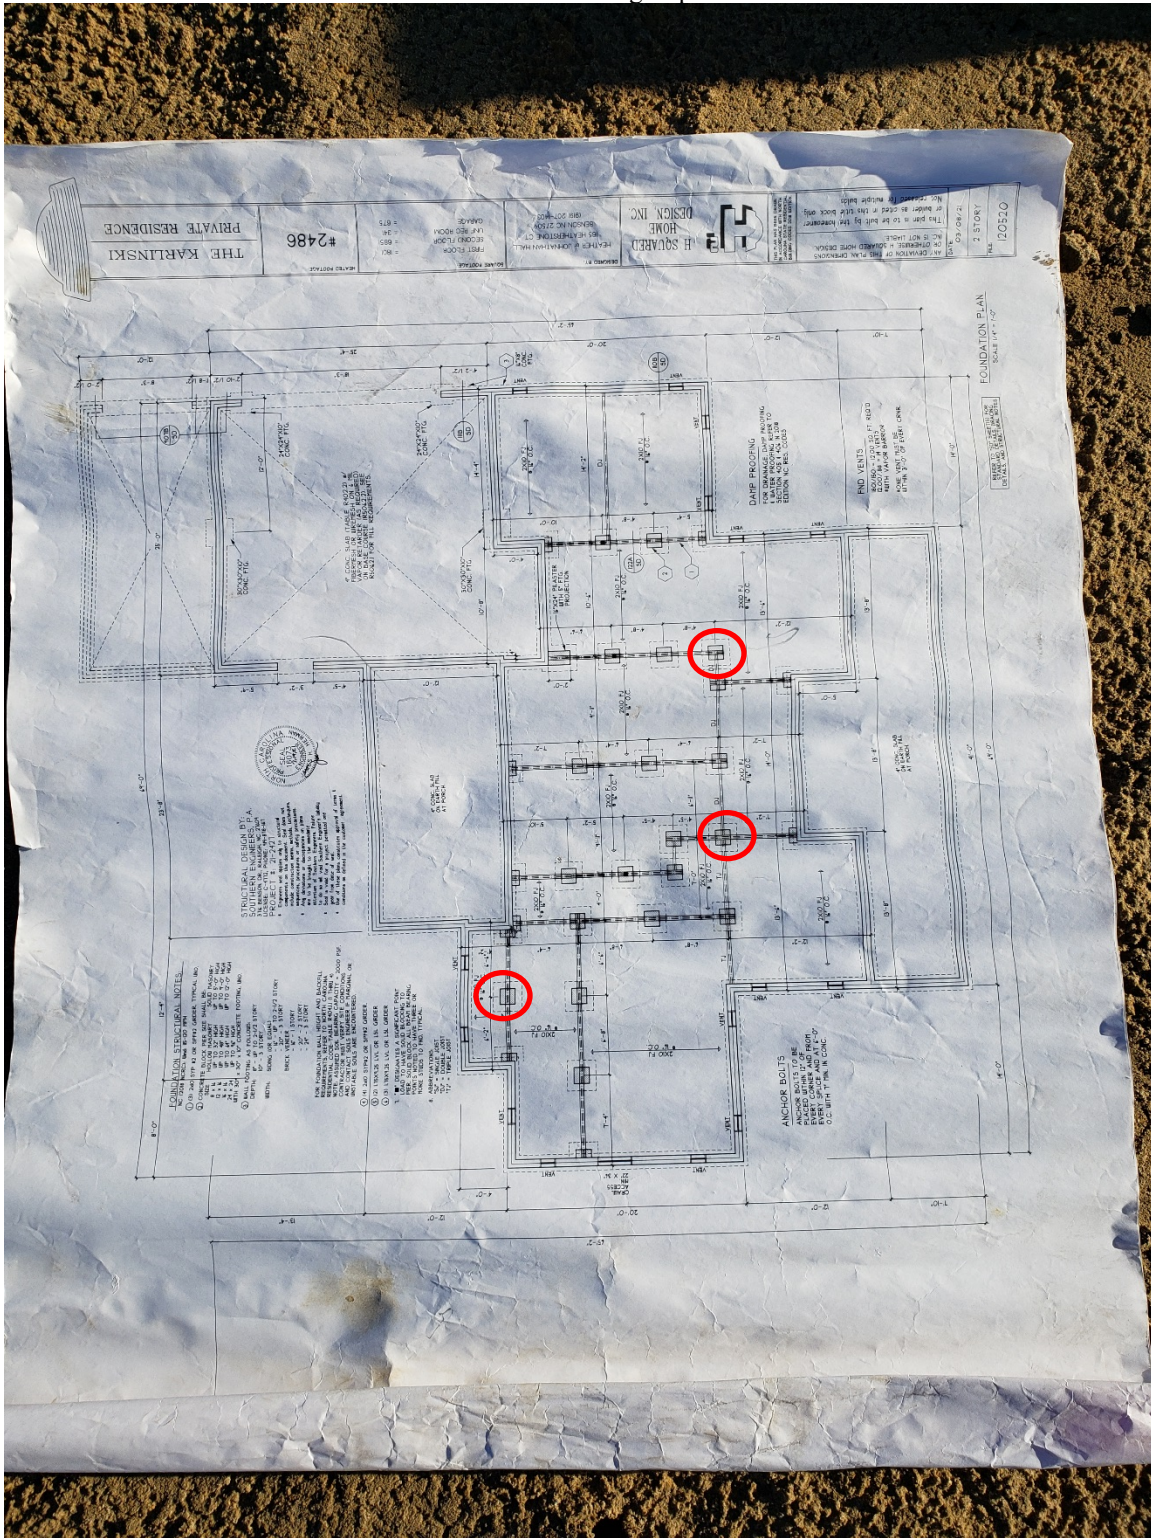
Location of Footing Repairs
