RE: Daily Field Report for 10/08/2021
1235 Cypress Road (CMT) Cameron, NC
Building & Earth Project No : RD210792

Field Observations Report

Project Name: **1235 Cypress Road (CMT) Cameron, NC** Project Number: **RD210792**
Client Name: **A & G Residential** Placement#: **FO-1**
Contractor: **A & G Residential** Technician: **Bruce Rohr**
Monitoring: **Shallow Footing Testing**

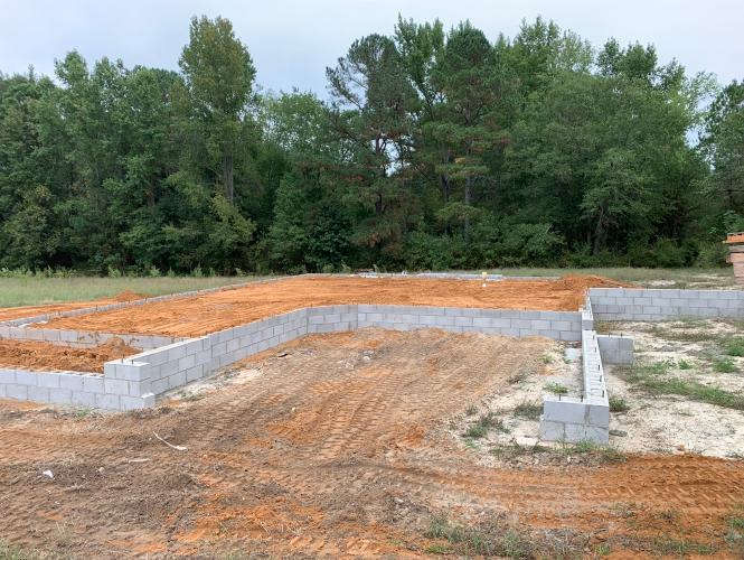
| Picture ID | Lot |
|---|---|
| 33569 | |

The lot is relatively flat. Building locations are referenced from the street looking at the front of the residence. Maximum relief across the lot is approximately 1/2 feet. Surface water runoff appears to drain behind the lot.

The site has been stripped of surface cover and topsoil. It appears that 4 inches of topsoil has been removed from the building pad area.

Structural fill has been placed at the site to level the building pad. Based on our observations, we understand the pad has been filled according to the following:

| Picture ID | Lot |

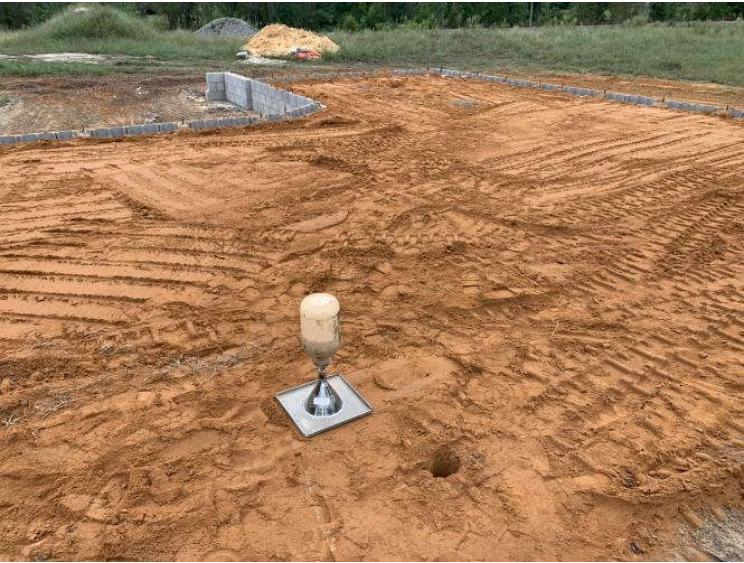
| Picture ID | DCP 1 + Sandcone |
|---|--|
| 33571 | |

DCP Testing: Our representative performed Dynamic Cone Penetration (DCP) testing in general accordance with ASTM STP-399 at 2 representative locations to a depth of 36 inches. Our representative did not observe water within the DCP boreholes as noted below.

Test 1: [Back Right Corner]

Soil density testing was performed using the sand cone method of compaction in general accordance with ASTM D1556. The results of our tests are attached as ST-1.

| Picture ID | DCP 1 + Sandcone |

| Test # | IDs | | Test Type | Location | Probe Depth (in) | Elev. (ft) | Dry Density(pcf) | % Moisture | % Compaction | Result |
|---|---|---|---|---|---|---|---|---|---|---|
| 1 | FSG-Bldg | 19-0187-04 | ASTMD1556 | Finished Subgrade Soils -Building : Back right corner Next to DCP 1 : | | FSG | 113.3 | 13.2 | 95% | PASS |
