ATTACH 2x SCAB OF THE SAME SIZE AND GRADE AS THE BROKEN MEMBER TO EACH FACE OF THE TRUSS (CENTER ON BREAK OR SPLICE) WITH 10d (0.131" X 3") NAILS (TWO ROWS FOR 2x4, THREE ROWS FOR 2x6) SPACED 4" O.C. AS SHOWN. STAGGER NAIL SPACING FROM FRONT FACE AND BACK FACE FOR A NET 0-2-0 O.C. SPACING IN THE MAIN MEMBER. USE A MIN. 0-3-0 MEMBER END DISTANCE.

THE LENGTH OF THE BREAK (C) SHALL NOT EXCEED 12". (C=PLATE LENGTH FOR SPLICE REPAIRS)

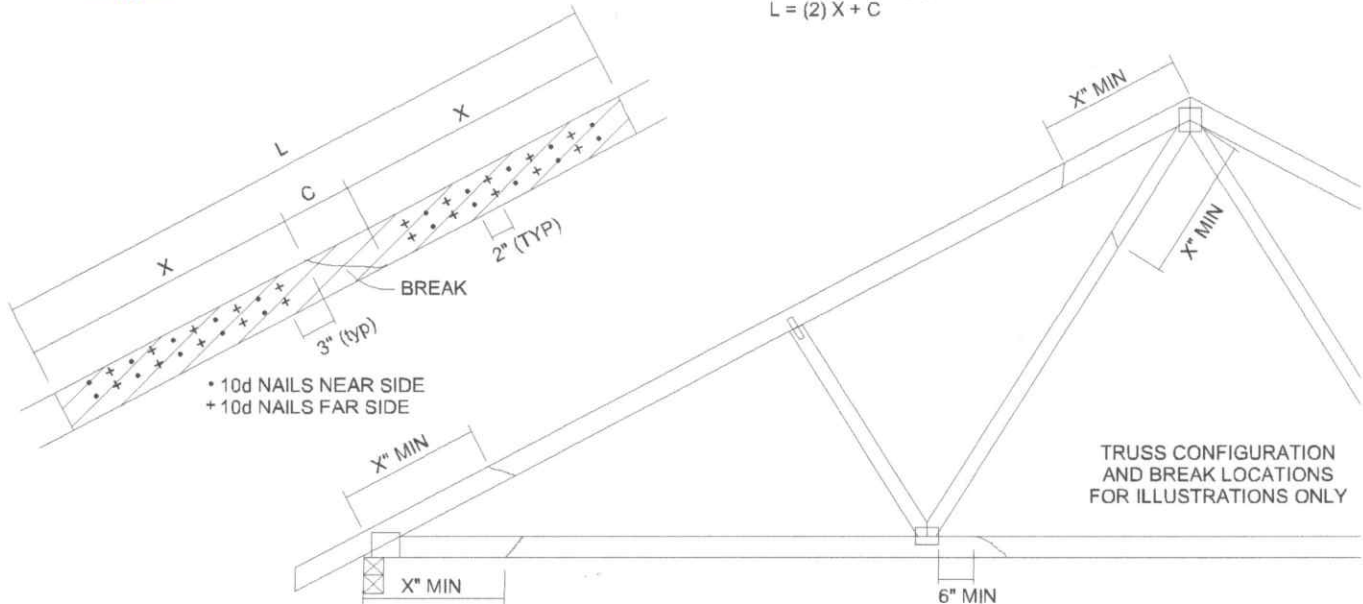
THE MINIMUM OVERALL SCAB LENGTH REQUIRED (L) IS CALCULATED AS FOLLOWS:

$$L = (2) X + C$$

THE LOCATION OF THE BREAK MUST BE GREATER THAN OR EQUAL TO THE REQUIRED X DIMENSION FROM ANY PERIMETER BREAK OR HEEL JOINT AND A MINIMUM OF 6" FROM ANY INTERIOR JOINT (SEE SKETCH ABOVE)

TOTAL NUMBER OF NAILS EACH SIDE OF BREAK *		X INCHES	MAXIMUM FORCE (lbs) 15% LOAD DURATION							
			SP		DF		SPF		HF	
2x4	2x6		2x4	2x6	2x4	2x6	2x4	2x6	2x4	2x6
20	30	24"	1706	2559	1561	2342	1320	1980	1352	2028
26	39	30"	2194	3291	2007	3011	1697	2546	1738	2608
32	48	36"	2681	4022	2454	3681	2074	3111	2125	3187
38	57	42"	3169	4754	2900	4350	2451	3677	2511	3767
44	66	48"	3657	5485	3346	5019	2829	4243	2898	4347

\* DIVIDE EQUALLY FRONT AND BACK

DO NOT USE REPAIR FOR JOINT SPLICES
