40 tarelton drive
 Fuquay Vairina
 lot 116

January 25, 2023

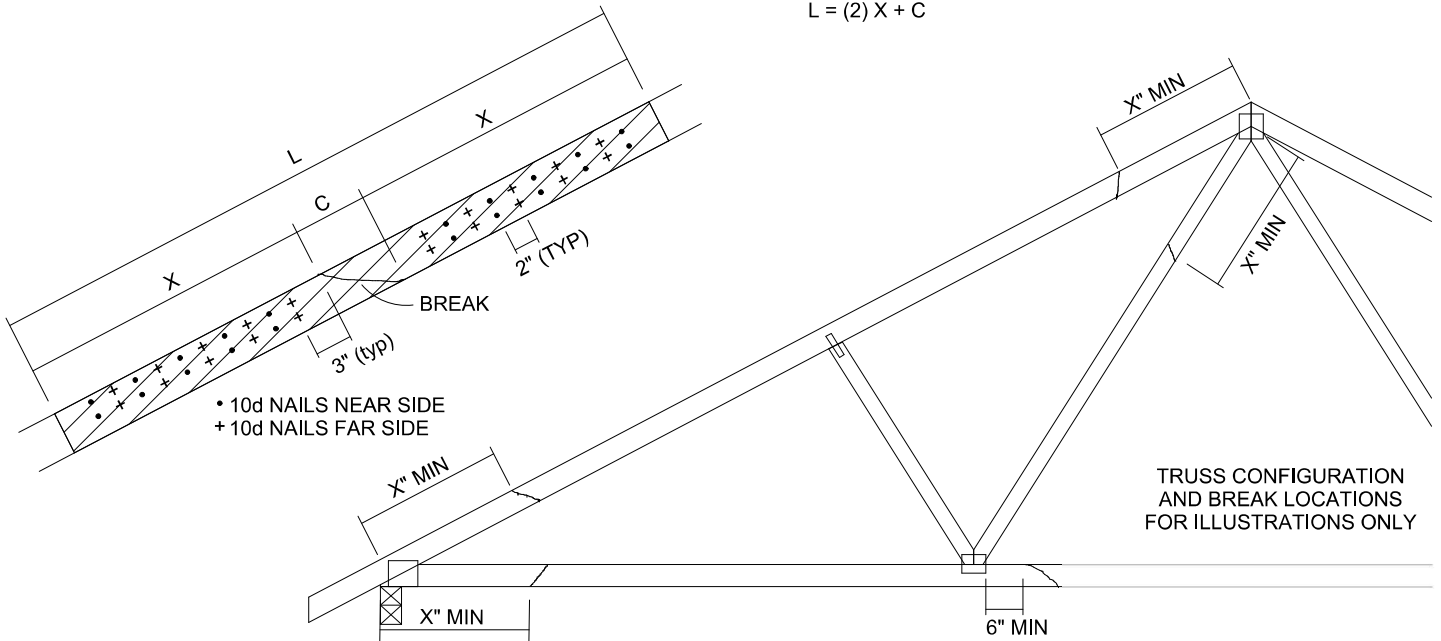
ATTACH 2x SCAB OF THE SAME SIZE AND GRADE AS THE BROKEN MEMBER TO EACH FACE OF THE TRUSS (CENTER ON BREAK OR SPLICE) WITH 10d (0.131" X 3") NAILS (TWO ROWS FOR 2x4, THREE ROWS FOR 2x6) SPACED 4" O.C. AS SHOWN. STAGGER NAIL SPACING FROM FRONT FACE AND BACK FACE FOR A NET 0-2-0 O.C. SPACING IN THE MAIN MEMBER. USE A MIN. 0-3-0 MEMBER END DISTANCE.

THE LENGTH OF THE BREAK (C) SHALL NOT EXCEED 12". (C=PLATE LENGTH FOR SPLICE REPAIRS)
 THE MINIMUM OVERALL SCAB LENGTH REQUIRED (L) IS CALCULATED AS FOLLOWS:
 $L = (2) X + C$

THE LOCATION OF THE BREAK MUST BE GREATER THAN OR EQUAL TO THE REQUIRED X DIMENSION FROM ANY PERIMETER BREAK OR HEEL JOINT AND A MINIMUM OF 6" FROM ANY INTERIOR JOINT (SEE SKETCH ABOVE)

TOTAL NUMBER OF NAILS EACH SIDE OF BREAK *		X INCHES	MAXIMUM FORCE (lbs) 15% LOAD DURATION							
			SP		DF		SPF		HF	
2x4	2x6		2x4	2x6	2x4	2x6	2x4	2x6	2x4	2x6
20	30	24"	1706	2559	1561	2342	1320	1980	1352	2028
26	39	30"	2194	3291	2007	3011	1697	2546	1738	2608
32	48	36"	2681	4022	2454	3681	2074	3111	2125	3187
38	57	42"	3169	4754	2900	4350	2451	3677	2511	3767
44	66	48"	3657	5485	3346	5019	2829	4243	2898	4347

* DIVIDE EQUALLY FRONT AND BACK

DO NOT USE REPAIR FOR JOINT SPLICES
