ATTACH 2x SCAB OF THE SAME SIZE AND GRADE AS THE BROKEN MEMBER TO EACH FACE OF THE TRUSS (CENTER ON BREAK OR SPLICE) WITH 10d (0.131" X 3") NAILS (TWO ROWS FOR 2x4, THREE ROWS FOR 2x6) SPACED 4" O.C. AS SHOWN. STAGGER NAIL SPACING FROM FRONT FACE AND BACK FACE FOR A NET 0-2-0 O.C. SPACING IN THE MAIN MEMBER. USE A MIN. 0-3-0 MEMBER END DISTANCE.

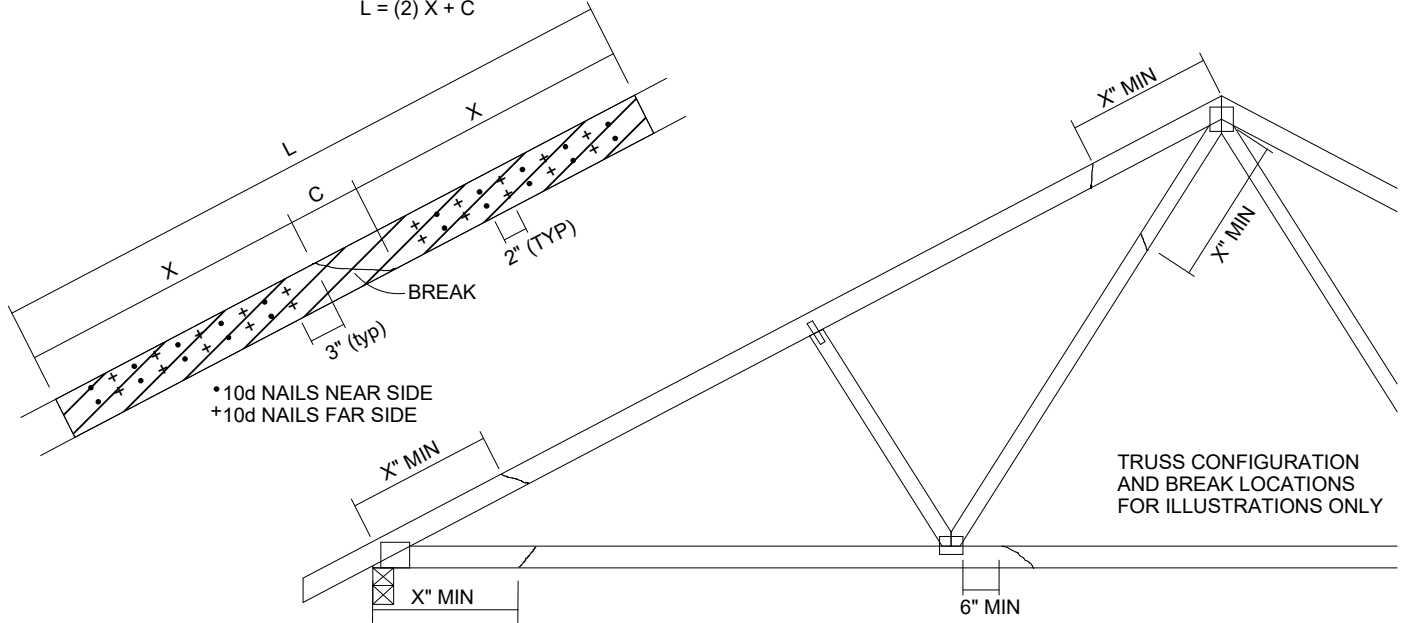
THE LENGTH OF THE BREAK (C) SHALL NOT EXCEED 12". (C=PLATE LENGTH FOR SPLICE REPAIRS)
 THE MINIMUM OVERALL SCAB LENGTH REQUIRED (L) IS CALCULATED AS FOLLOWS:
 $L = (2) X + C$

THE LOCATION OF THE BREAK MUST BE GREATER THAN OR EQUAL TO THE REQUIRED X DIMENSION FROM ANY PERIMETER BREAK OR HEEL JOINT AND A MINIMUM OF 6" FROM ANY INTERIOR JOINT (SEE SKETCH ABOVE)

TOTAL NUMBER OF NAILS EACH SIDE OF BREAK *		X INCHES	MAXIMUM FORCE (lbs) 15% LOAD DURATION							
			SP		DF		SPF		HF	
2x4	2x6		2x4	2x6	2x4	2x6	2x4	2x6	2x4	2x6
20	30	24"	1706	2559	1561	2342	1320	1980	1352	2028
26	39	30"	2194	3291	2007	3011	1697	2546	1738	2608
32	48	36"	2681	4022	2454	3681	2074	3111	2125	3187
38	57	42"	3169	4754	2900	4350	2451	3677	2511	3767
44	66	48"	3657	5485	3346	5019	2829	4243	2898	4347

* DIVIDE EQUALLY FRONT AND BACK

DO NOT USE REPAIR FOR JOINT SPLICES
