STANDARD REPAIR DETAIL FOR BROKEN CHORDS, WEBS AND DAMAGED OR MISSING CHORD SPLICE PLATES

MII-REP01A1

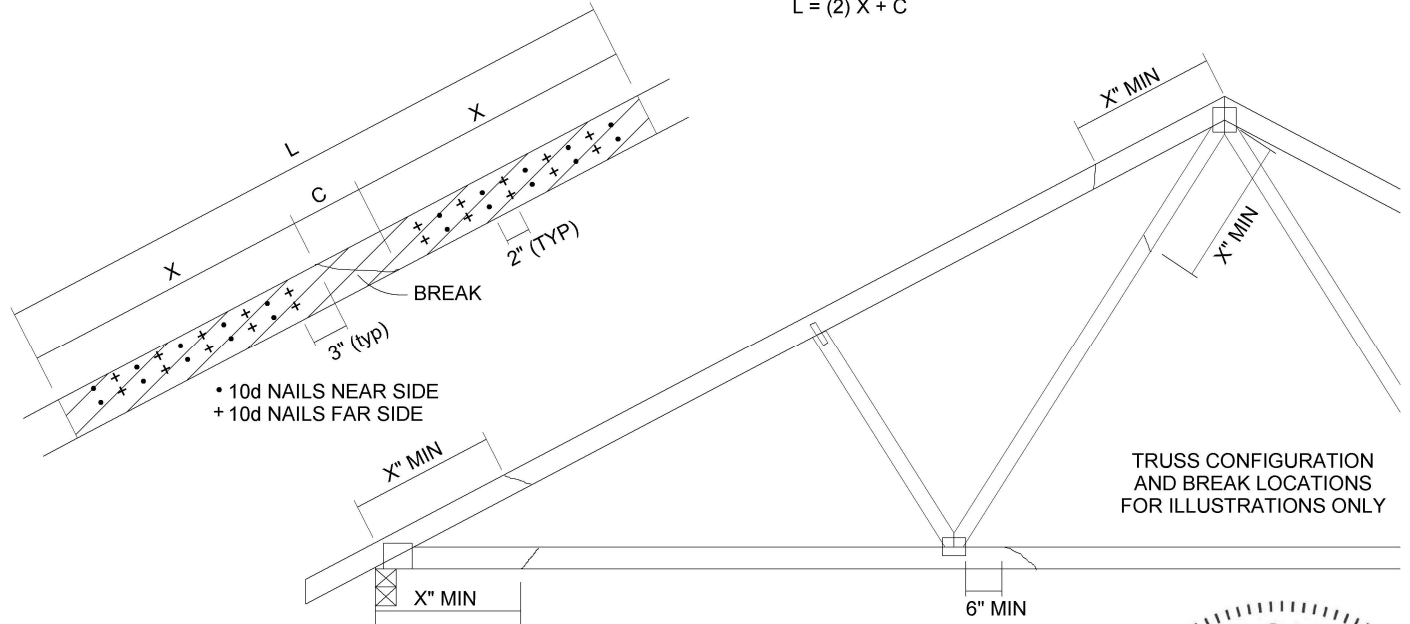
ATTACH 2x SCAB OF THE SAME SIZE AND GRADE AS THE BROKEN MEMBER TO EACH FACE OF THE TRUSS (CENTER ON BREAK OR SPLICE) WITH 10d (0.131" X 3") NAILS (TWO ROWS FOR 2x4, THREE ROWS FOR 2x6) SPACED 4" O.C. AS SHOWN. STAGGER NAIL SPACING FROM FRONT FACE AND BACK FACE FOR A NET 0-2-0 O.C. SPACING IN THE MAIN MEMBER. USE A MIN. 0-3-0 MEMBER END DISTANCE.

THE LENGTH OF THE BREAK (C) SHALL NOT EXCEED 12". (C=PLATE LENGTH FOR SPLICE REPAIRS)
 THE MINIMUM OVERALL SCAB LENGTH REQUIRED (L) IS CALCULATED AS FOLLOWS:
 $L = (2) X + C$

THE LOCATION OF THE BREAK MUST BE GREATER THAN OR EQUAL TO THE REQUIRED X DIMENSION FROM ANY PERIMETER BREAK OR HEEL JOINT AND A MINIMUM OF 6" FROM ANY INTERIOR JOINT (SEE SKETCH ABOVE)

TOTAL NUMBER OF NAILS EACH SIDE OF BREAK *		X INCHES	MAXIMUM FORCE (lbs) 15% LOAD DURATION							
			SP		DF		SPF		HF	
2x4	2x6		2x4	2x6	2x4	2x6	2x4	2x6	2x4	2x6
20	30	24"	1706	2559	1561	2342	1320	1980	1352	2028
26	39	30"	2194	3291	2007	3011	1697	2546	1738	2608
32	48	36"	2681	4022	2454	3681	2074	3111	2125	3187
38	57	42"	3169	4754	2900	4350	2451	3677	2511	3767
44	66	48"	3657	5485	3346	5019	2829	4243	2898	4347

* DIVIDE EQUALLY FRONT AND BACK

DO NOT USE REPAIR FOR JOINT SPLICES
