MISSING PLATE REPAIR DETAIL	MII WEB PLATE
--	------------------------------------	----------------------

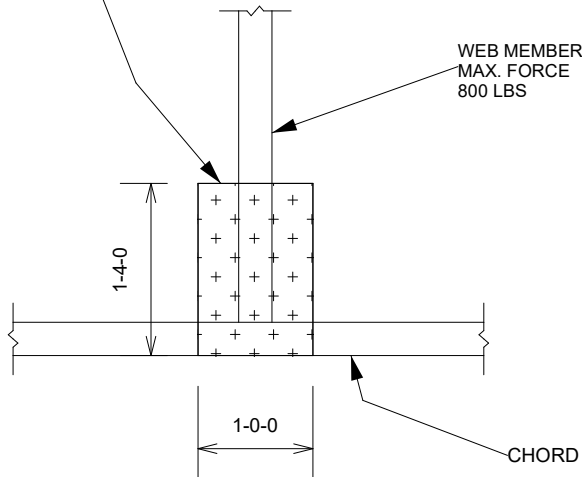
ATTACH 1/2" PLYWOOD OR OSB GUSSET (15/32" RATED SHEATHING 32/16 EXP 1) TO EACH FACE OF TRUSS WITH (0.131" X MIN 2.5") NAILS IN 3 ROWS SPACED @ 4" O.C. NAILS TO BE DRIVEN FROM BOTH FACES. STAGGER SPACING FROM FRONT TO BACK FACE FOR A NET 2" O.C. SPACING IN THE TRUSS. USE 2" MEMBER END DISTANCE.

EDGE OF WEB NOT TO EXTEND BEYOND CORNER OF GUSSET

WEB MEMBER MAX. FORCE 1200 LBS

1. ALL MATERIAL IS 2x4
2. THIS DETAIL IS APPLICABLE FOR DESIGNS WITH DOLS. OF 1.15 OR 1.25 AND LUMBER SPECIES SP, DF, HF, OR SPF.
3. DETAIL SHALL BE USED FOR CONDITIONS OF A MISSING OR LOOSE CONNECTOR PLATE ONLY.
4. CHORD MATERIAL IS CONTINUOUS THROUGH JOINT, THERE IS NO MAXIMUM CHORD FORCE AND NO SPLICE PERMITTED.
5. REFER TO MITEK DESIGN DRAWING FOR WEB FORCES.
