STANDARD REPAIR DETAIL FOR BROKEN CHORDS, WEBS AND DAMAGED OR MISSING CHORD SPLICE PLATES

MII-REP01A1

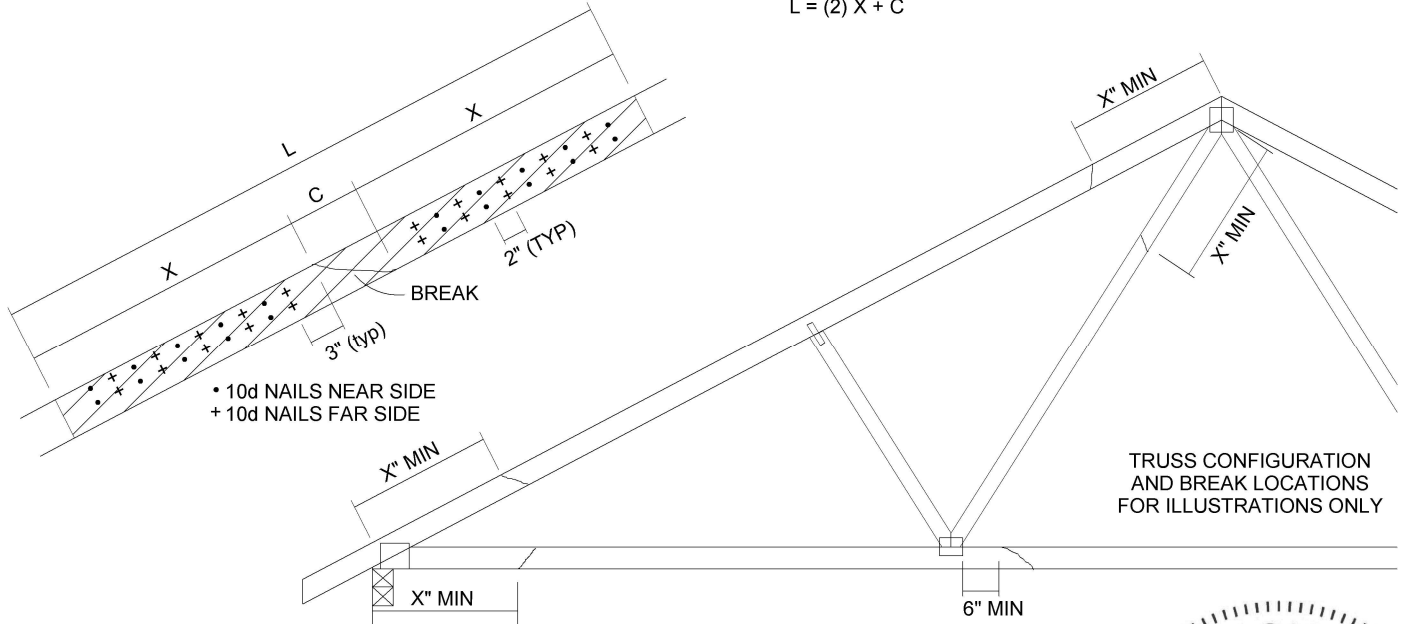
ATTACH 2x SCAB OF THE SAME SIZE AND GRADE AS THE BROKEN MEMBER TO EACH FACE OF THE TRUSS (CENTER ON BREAK OR SPLICE) WITH 10d (0.131" X 3") NAILS (TWO ROWS FOR 2x4, THREE ROWS FOR 2x6) SPACED 4" O.C. AS SHOWN. STAGGER NAIL SPACING FROM FRONT FACE AND BACK FACE FOR A NET 0-2-0 O.C. SPACING IN THE MAIN MEMBER. USE A MIN. 0-3-0 MEMBER END DISTANCE.

THE LENGTH OF THE BREAK (C) SHALL NOT EXCEED 12". (C=PLATE LENGTH FOR SPLICE REPAIRS)  
 THE MINIMUM OVERALL SCAB LENGTH REQUIRED (L) IS CALCULATED AS FOLLOWS:  
 $L = (2) X + C$

THE LOCATION OF THE BREAK MUST BE GREATER THAN OR EQUAL TO THE REQUIRED X DIMENSION FROM ANY PERIMETER BREAK OR HEEL JOINT AND A MINIMUM OF 6" FROM ANY INTERIOR JOINT (SEE SKETCH ABOVE)

TOTAL NUMBER OF NAILS EACH SIDE OF BREAK *		X INCHES	MAXIMUM FORCE (lbs) 15% LOAD DURATION							
			SP		DF		SPF		HF	
2x4	2x6		2x4	2x6	2x4	2x6	2x4	2x6	2x4	2x6
20	30	24"	1706	2559	1561	2342	1320	1980	1352	2028
26	39	30"	2194	3291	2007	3011	1697	2546	1738	2608
32	48	36"	2681	4022	2454	3681	2074	3111	2125	3187
38	57	42"	3169	4754	2900	4350	2451	3677	2511	3767
44	66	48"	3657	5485	3346	5019	2829	4243	2898	4347

\* DIVIDE EQUALLY FRONT AND BACK

DO NOT USE REPAIR FOR JOINT SPLICES
