ATTACH 2x SCAB OF THE SAME SIZE AND GRADE AS THE BROKEN MEMBER TO EACH FACE OF THE TRUSS (CENTER ON BREAK OR SPLICE) WITH 10d (0.131" X 3") NAILS (TWO ROWS FOR 2x4, THREE ROWS FOR 2x6) SPACED 4" O.C. AS SHOWN. STAGGER NAIL SPACING FROM FRONT FACE AND BACK FACE FOR A NET 0-2-0 O.C. SPACING IN THE MAIN MEMBER. USE A MIN. 0-3-0 MEMBER END DISTANCE.

DO NOT USE REPAIR FOR JOINT SPLICES

WARNING - Verify design parameters and READ NOTES ON THIS AND INCLUDED MITEK REFERENCE PAGE MII-7473 rev. 5/19/2020 BEFORE USE.

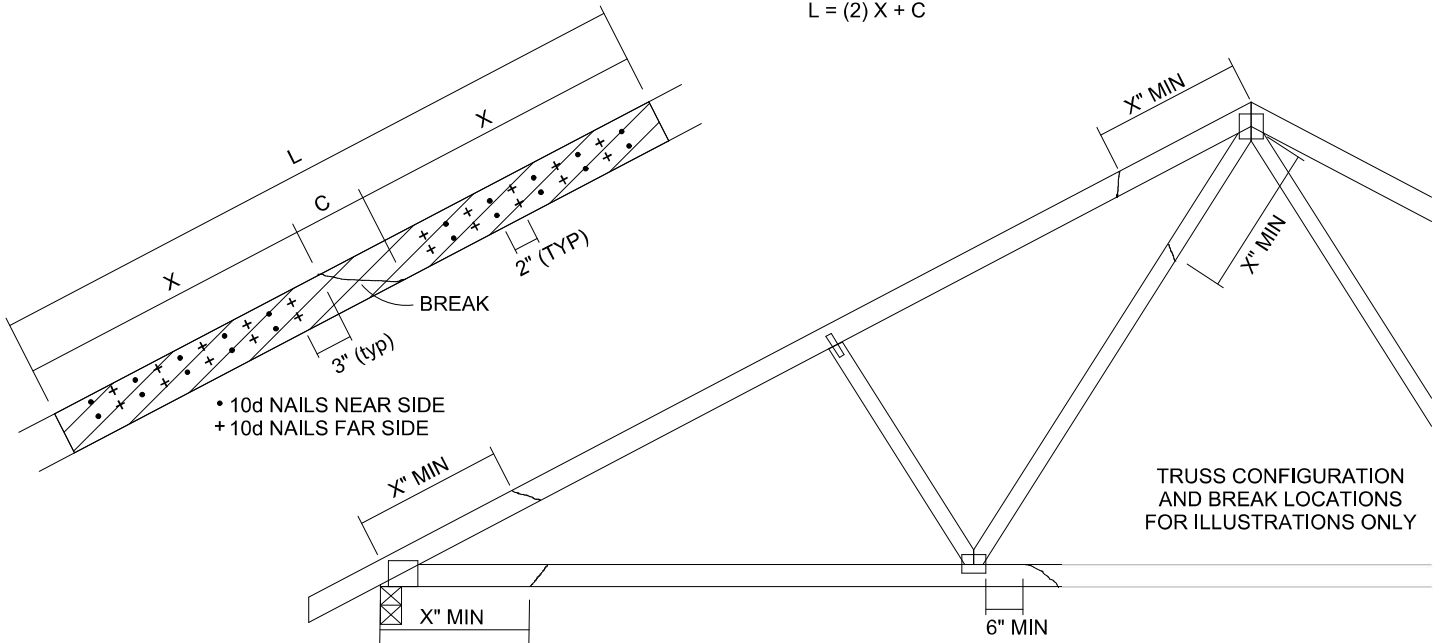
THE LENGTH OF THE BREAK (C) SHALL NOT EXCEED 12". (C=PLATE LENGTH FOR SPLICE REPAIRS)
 THE MINIMUM OVERALL SCAB LENGTH REQUIRED (L) IS CALCULATED AS FOLLOWS:
 $L = (2) X + C$

THE LOCATION OF THE BREAK MUST BE GREATER THAN OR EQUAL TO THE REQUIRED X DIMENSION FROM ANY PERIMETER BREAK OR HEEL JOINT AND A MINIMUM OF 6" FROM ANY INTERIOR JOINT (SEE SKETCH ABOVE)

TOTAL NUMBER OF NAILS EACH SIDE OF BREAK *		X INCHES	MAXIMUM FORCE (lbs) 15% LOAD DURATION							
			SP		DF		SPF		HF	
2x4	2x6		2x4	2x6	2x4	2x6	2x4	2x6	2x4	2x6
20	30	24"	1706	2559	1561	2342	1320	1980	1352	2028
26	39	30"	2194	3291	2007	3011	1697	2546	1738	2608
32	48	36"	2681	4022	2454	3681	2074	3111	2125	3187
38	57	42"	3169	4754	2900	4350	2451	3677	2511	3767
44	66	48"	3657	5485	3346	5019	2829	4243	2898	4347

* DIVIDE EQUALLY FRONT AND BACK
