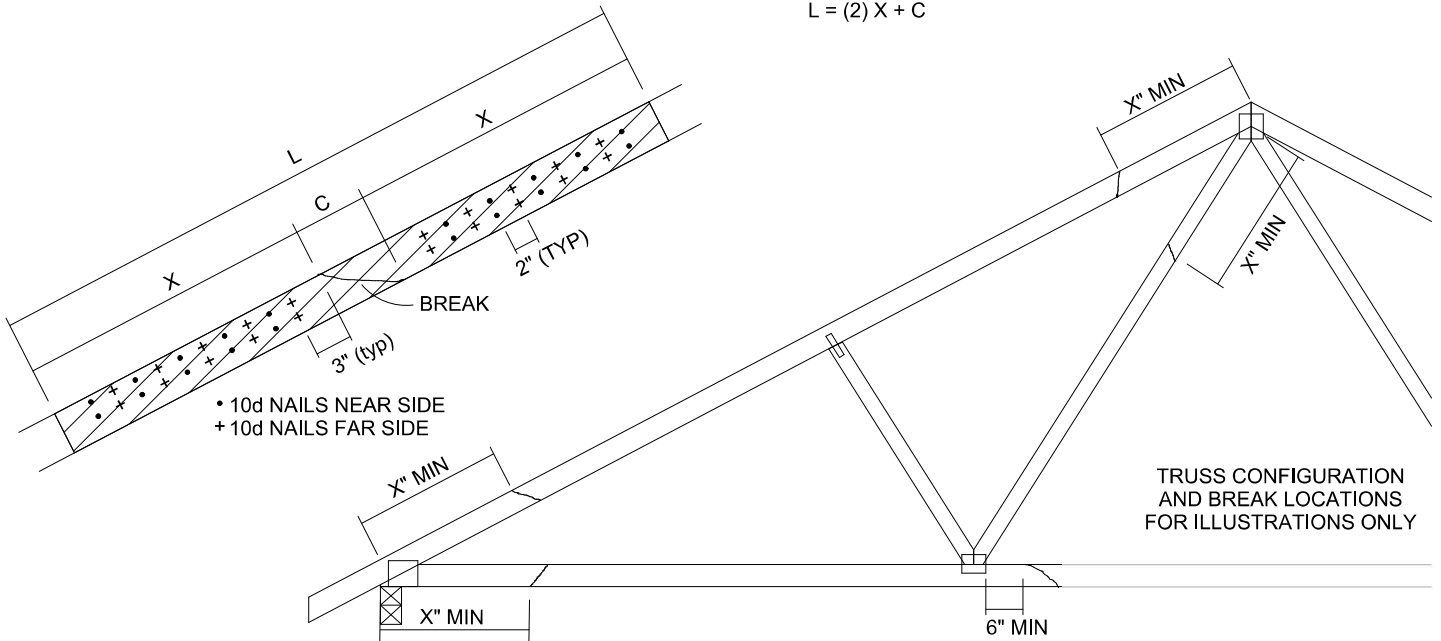
ATTACH 2x SCAB OF THE SAME SIZE AND GRADE AS THE BROKEN MEMBER TO EACH FACE OF THE TRUSS (CENTER ON BREAK OR SPLICE) WITH 10d (0.131" X 3") NAILS (TWO ROWS FOR 2x4, THREE ROWS FOR 2x6) SPACED 4" O.C. AS SHOWN. STAGGER NAIL SPACING FROM FRONT FACE AND BACK FACE FOR A NET 0-2-0 O.C. SPACING IN THE MAIN MEMBER. USE A MIN. 0-3-0 MEMBER END DISTANCE.

THE LENGTH OF THE BREAK (C) SHALL NOT EXCEED 12". (C=PLATE LENGTH FOR SPLICE REPAIRS)
 THE MINIMUM OVERALL SCAB LENGTH REQUIRED (L) IS CALCULATED AS FOLLOWS:
 $L = (2) X + C$

THE LOCATION OF THE BREAK MUST BE GREATER THAN OR EQUAL TO THE REQUIRED X DIMENSION FROM ANY PERIMETER BREAK OR HEEL JOINT AND A MINIMUM OF 6" FROM ANY INTERIOR JOINT (SEE SKETCH ABOVE)

TOTAL NUMBER OF NAILS EACH SIDE OF BREAK *		X INCHES	MAXIMUM FORCE (lbs) 15% LOAD DURATION							
			SP		DF		SPF		HF	
2x4	2x6		2x4	2x6	2x4	2x6	2x4	2x6	2x4	2x6
20	30	24"	1706	2559	1561	2342	1320	1980	1352	2028
26	39	30"	2194	3291	2007	3011	1697	2546	1738	2608
32	48	36"	2681	4022	2454	3681	2074	3111	2125	3187
38	57	42"	3169	4754	2900	4350	2451	3677	2511	3767
44	66	48"	3657	5485	3346	5019	2829	4243	2898	4347

* DIVIDE EQUALLY FRONT AND BACK

DO NOT USE REPAIR FOR JOINT SPLICES
