RE: **Lot 124 HLN**  
ECS Job # **33:6230-D**

Permits:  
Location: **41 Sugarberry PI**  
**Spring Lake, NC 28390**

## FIELD REPORT

Remarks **Recommendations**

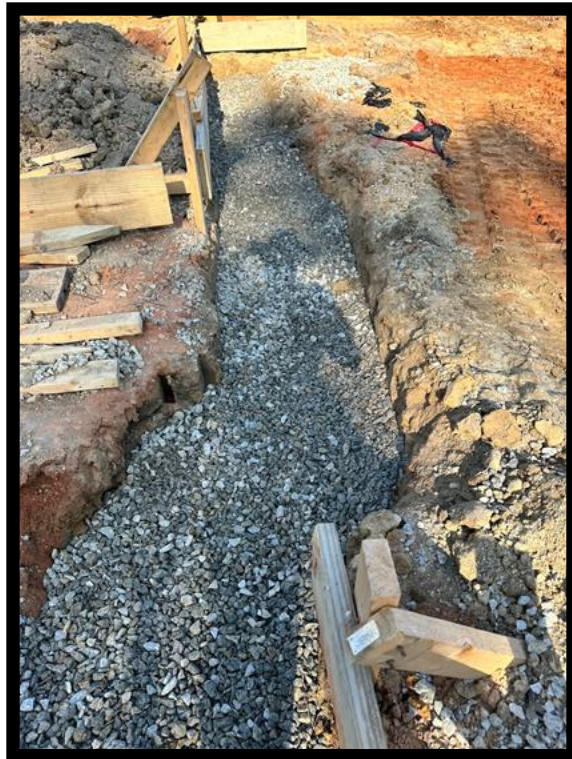
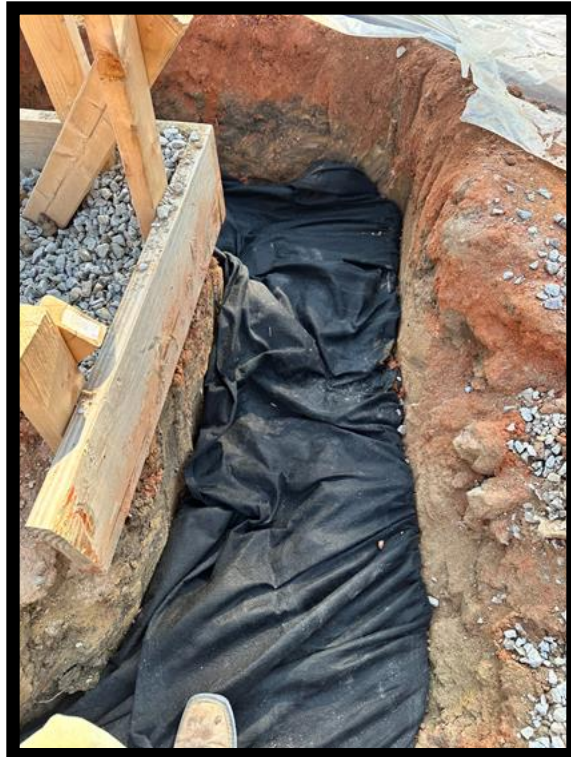
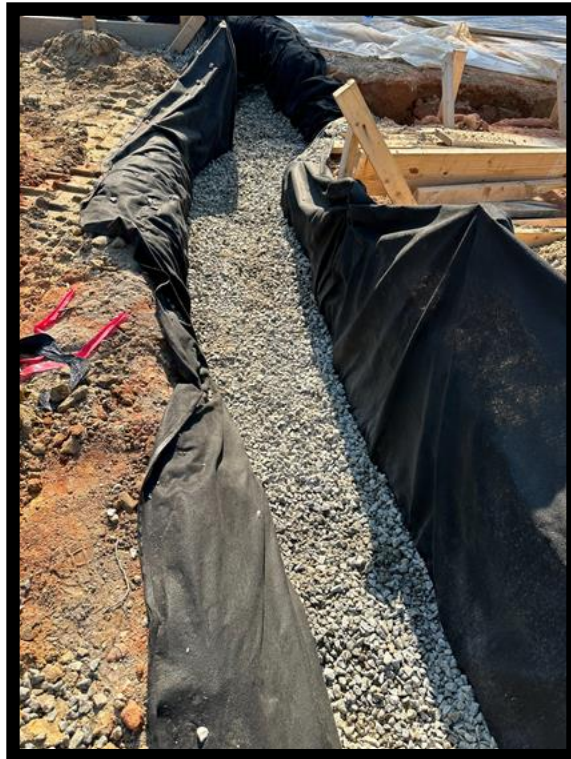
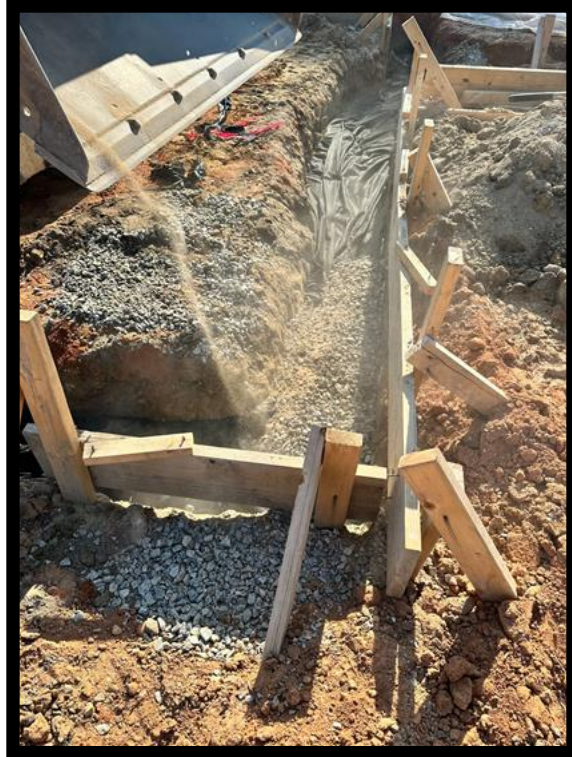
ECS arrived on site, as requested, to observe a portion of the garage footing that had ground water seepage. Upon arrival, ECS probed the footing throughout to determine the stability of the soils in place. Due to the soils being saturated, ECS spoke with Chandler Jones w/ Wellons Realty. ECS provide the recommendation of undercutting the soft and saturated soils down to 3 feet below the current footing subgrade. Once undercut, ECS recommended backfilling the footing with 57 stone and wrapping the stone with an engineering non-woven fabric. Please see the attached photos for the documented repairs.
