Lot 31  
 460 THOMAS GAGE Dr  
 Fuquay-Varina NC  
 truss AA

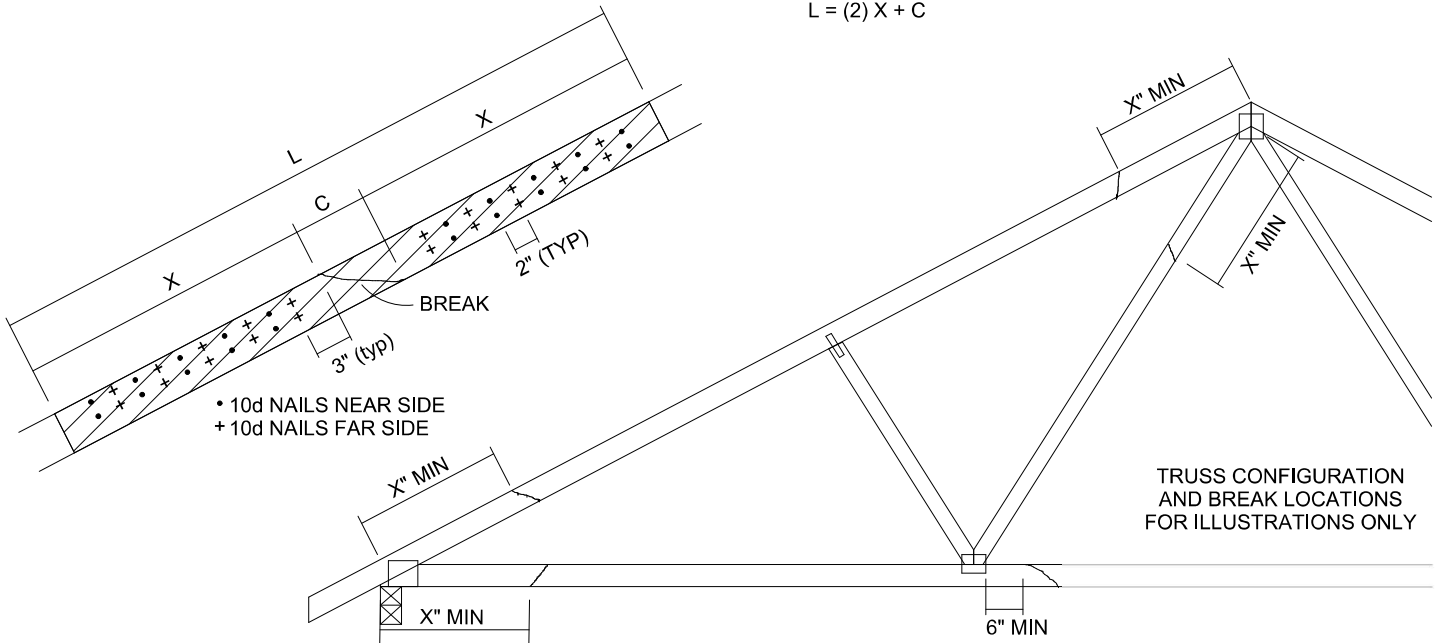
ATTACH 2x SCAB OF THE SAME SIZE AND GRADE AS THE BROKEN MEMBER TO EACH FACE OF THE TRUSS (CENTER ON BREAK OR SPLICE) WITH 10d (0.131" X 3") NAILS (TWO ROWS FOR 2x4, THREE ROWS FOR 2x6) SPACED 4" O.C. AS SHOWN. STAGGER NAIL SPACING FROM FRONT FACE AND BACK FACE FOR A NET 0-2-0 O.C. SPACING IN THE MAIN MEMBER. USE A MIN. 0-3-0 MEMBER END DISTANCE.

THE LENGTH OF THE BREAK (C) SHALL NOT EXCEED 12". (C=PLATE LENGTH FOR SPLICE REPAIRS)  
 THE MINIMUM OVERALL SCAB LENGTH REQUIRED (L) IS CALCULATED AS FOLLOWS:  
 $L = (2) X + C$

THE LOCATION OF THE BREAK MUST BE GREATER THAN OR EQUAL TO THE REQUIRED X DIMENSION FROM ANY PERIMETER BREAK OR HEEL JOINT AND A MINIMUM OF 6" FROM ANY INTERIOR JOINT (SEE SKETCH ABOVE)

TOTAL NUMBER OF NAILS EACH SIDE OF BREAK *		X INCHES	MAXIMUM FORCE (lbs) 15% LOAD DURATION							
			SP		DF		SPF		HF	
2x4	2x6		2x4	2x6	2x4	2x6	2x4	2x6	2x4	2x6
20	30	24"	1706	2559	1561	2342	1320	1980	1352	2028
26	39	30"	2194	3291	2007	3011	1697	2546	1738	2608
32	48	36"	2681	4022	2454	3681	2074	3111	2125	3187
38	57	42"	3169	4754	2900	4350	2451	3677	2511	3767
44	66	48"	3657	5485	3346	5019	2829	4243	2898	4347

DO NOT USE REPAIR FOR JOINT SPLICES
