TRUSS: A7

SUBDIVISION/MODEL: DUNCANS CROSSING

REPAIR ID: MII-REP01A1 (ATTACHED)

STANDARD REPAIR DETAIL FOR BROKEN CHORDS, WEBS AND DAMAGED OR MISSING CHORD SPLICE PLATES

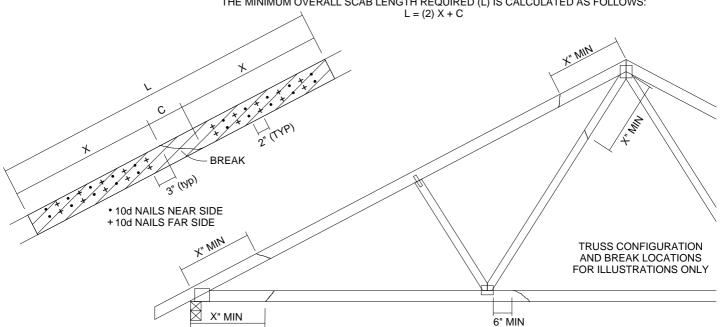
MII-REP01A1

ATTACH 2x_ SCAB OF THE SAME SIZE AND GRADE AS THE BROKEN MEMBER TO EACH FACE OF THE TRUSS (CENTER ON BREAK OR SPLICE) WITH 10d (0.131" X 3") NAILS (TWO ROWS FOR 2x4, THREE ROWS FOR 2x6) SPACED 4" O.C. AS SHOWN. STAGGER NAIL SPACING FROM FRONT FACE AND BACK FACE FOR A NET 0-2-0 O.C. SPACING IN THE MAIN MEMBER. USE A MIN. 0-3-0 MEMBER END DISTANCE.

THE LENGTH OF THE BREAK (C) SHALL NOT EXCEED 12". (C=PLATE LENGTH FOR SPLICE REPAIRS) THE MINIMUM OVERALL SCAB LENGTH REQUIRED (L) IS CALCULATED AS FOLLOWS:

THE LOCATION OF THE BREAK MUST BE GREATER THAN OR EQUAL TO THE REQUIRED X DIMENSION FROM ANY PERIMETER BREAK OR HEEL JOINT AND A MINIMUM OF 6" FROM ANY INTERIOR JOINT (SEE SKETCH ABOVE)

7	TOTAL NUMBER OF NAILS EACH SIDE OF BREAK *			MAXIMUM FORCE (lbs) 15% LOAD DURATION							
7			X INCHES	SP		DF		SPF		HF	
	2x4	2x6		2x4	2x6	2x4	2x6	2x4	2x6	2x4	2x6
	20	30	24"	1706	2559	1561	2342	1320	1980	1352	2028
	26	39	30"	2194	3291	2007	3011	1697	2546	1738	2608
	32	48	36"	2681	4022	2454	3681	2074	3111	2125	3187
	38	57	42"	3169	4754	2900	4350	2451	3677	2511	3767
	44	66	48"	3657	5485	3346	5019	2829	4243	2898	4347

* DIVIDE EQUALLY FRONT AND BACK

DO NOT USE REPAIR FOR JOINT SPLICES
