Re: ELV B TC EB Chesapeake; 628 - Lot 139 The Farm At Neill's Creek; 15 Barn Door Drive

Job	Truss	Truss Type	Qty	Ply	Chesapeake; 628 - Lot 139 The Farm At Neill's Creek; 15			
ELV B TC EB	A01T	Roof Special	2	1	I64042496 Job Reference (optional)

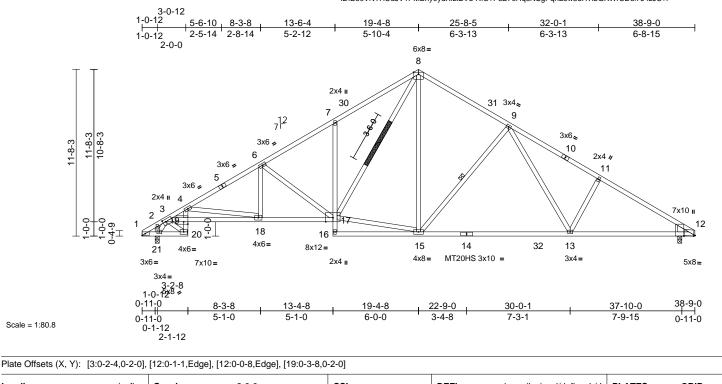
- Repair Condition: web has 0-6-0 long break centered at 5-5-8 below joint 8.
- Apply 42" long 2x4 SP No.2 scab to both side(s) of truss centered on damage located 5-5-8 below joint 8 with 2 row(s) of 10d (0.131"x3") nails spaced 4" o.c. from each face. Minimum 0-3-0 end distance.
   n/a
