Lot 157 Birchwood  
173 Robert Howe Dr.

ATTACH 2x\_ SCAB OF THE SAME SIZE AND GRADE AS THE BROKEN MEMBER TO EACH FACE OF THE TRUSS (CENTER ON BREAK OR SPLICE) WITH 10d (0.131" X 3") NAILS (TWO ROWS FOR 2x4, THREE ROWS FOR 2x6) SPACED 4" O.C. AS SHOWN. STAGGER NAIL SPACING FROM FRONT FACE AND BACK FACE FOR A NET 0-2-0 O.C. SPACING IN THE MAIN MEMBER. USE A MIN. 0-3-0 MEMBER END DISTANCE.

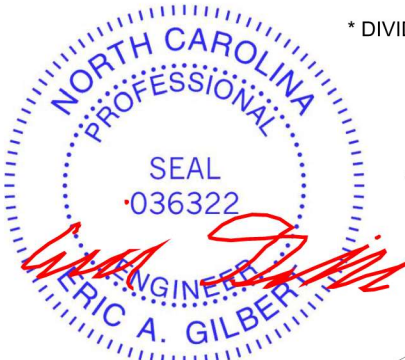
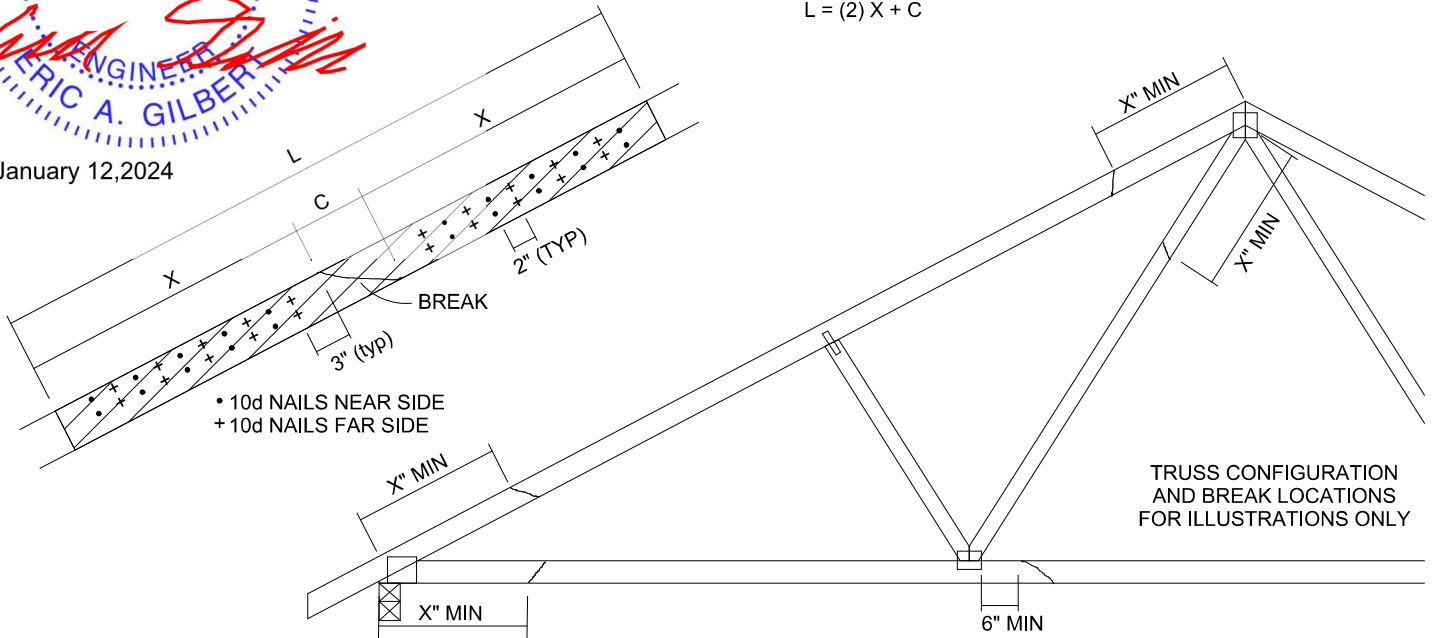
THE LENGTH OF THE BREAK (C) SHALL NOT EXCEED 12". (C=PLATE LENGTH FOR SPLICE REPAIRS)  
THE MINIMUM OVERALL SCAB LENGTH REQUIRED (L) IS CALCULATED AS FOLLOWS:  
 $L = (2) X + C$

THE LOCATION OF THE BREAK MUST BE GREATER THAN OR EQUAL TO THE REQUIRED X DIMENSION FROM ANY PERIMETER BREAK OR HEEL JOINT AND A MINIMUM OF 6" FROM ANY INTERIOR JOINT (SEE SKETCH ABOVE)

TOTAL NUMBER OF NAILS EACH SIDE OF BREAK *		X INCHES	MAXIMUM FORCE (lbs) 15% LOAD DURATION							
			SP		DF		SPF		HF	
2x4	2x6		2x4	2x6	2x4	2x6	2x4	2x6	2x4	2x6
20	30	24"	1706	2559	1561	2342	1320	1980	1352	2028
26	39	30"	2194	3291	2007	3011	1697	2546	1738	2608
32	48	36"	2681	4022	2454	3681	2074	3111	2125	3187
38	57	42"	3169	4754	2900	4350	2451	3677	2511	3767
44	66	48"	3657	5485	3346	5019	2829	4243	2898	4347

\* DIVIDE EQUALLY FRONT AND BACK

DO NOT USE REPAIR FOR JOINT SPLICES
