MISSING PLATE REPAIR DETAIL	MII WEB PLATE
--	------------------------------------	----------------------

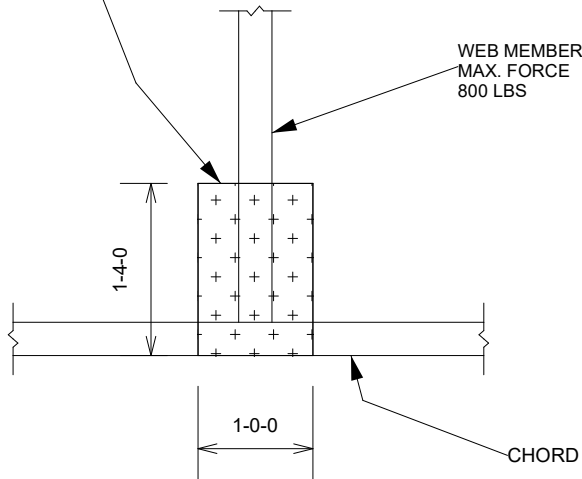
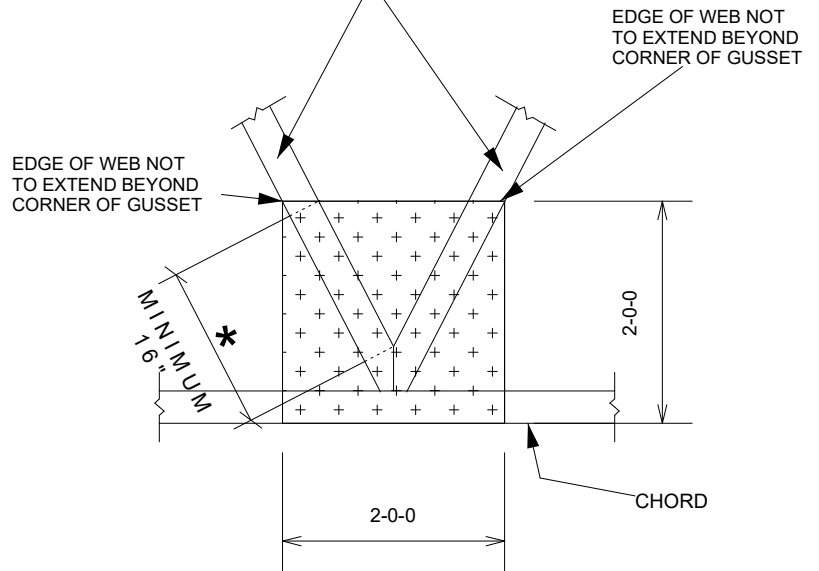
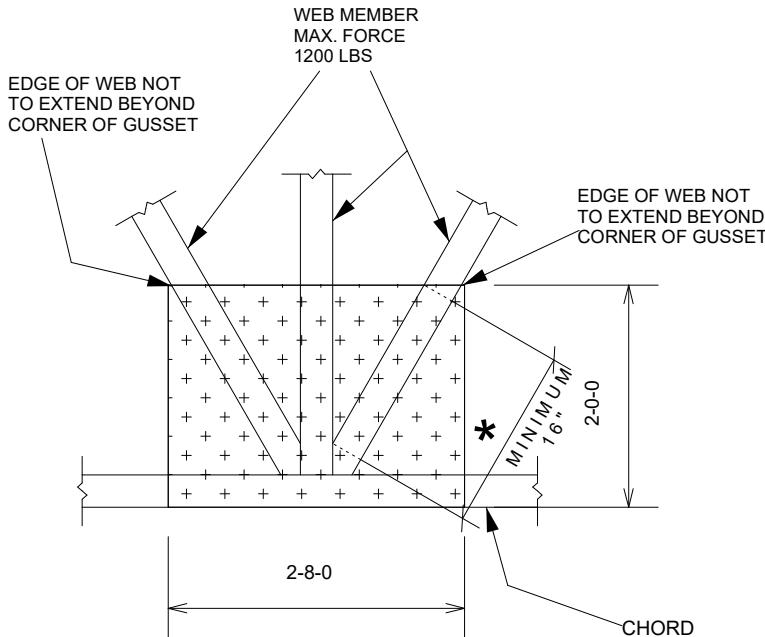
ATTACH 1/2" PLYWOOD OR OSB GUSSET (15/32" RATED SHEATHING 32/16 EXP 1) TO EACH FACE OF TRUSS WITH (0.131" X MIN 2.5") NAILS IN 3 ROWS SPACED @ 4" O.C. NAILS TO BE DRIVEN FROM BOTH FACES. STAGGER SPACING FROM FRONT TO BACK FACE FOR A NET 2" O.C. SPACING IN THE TRUSS. USE 2" MEMBER END DISTANCE.

EDGE OF WEB NOT TO EXTEND BEYOND CORNER OF GUSSET

WEB MEMBER MAX. FORCE 1200 LBS

* MEASUREMENT TAKEN AT POINTS WHERE WEB ACHIEVES FULL MEMBER DEPTH (AS MEASURED PERPENDICULAR TO WEB'S SAW-MILLED EDGE)

1. ALL MATERIAL IS 2x4
2. THIS DETAIL IS APPLICABLE FOR DESIGNS WITH DOLS. OF 1.15 OR 1.25 AND LUMBER SPECIES SP, DF, HF, OR SPF.
3. DETAIL SHALL BE USED FOR CONDITIONS OF A MISSING OR LOOSE CONNECTOR PLATE ONLY.
4. CHORD MATERIAL IS CONTINUOUS THROUGH JOINT, THERE IS NO MAXIMUM CHORD FORCE AND NO SPLICE PERMITTED.
5. REFER TO MITEK DESIGN DRAWING FOR WEB FORCES.
