STANDARD REPAIR DETAIL FOR BROKEN CHORDS, WEBS AND DAMAGED OR MISSING CHORD SPLICE PLATES	MII-REP01A1
--	---	-------------

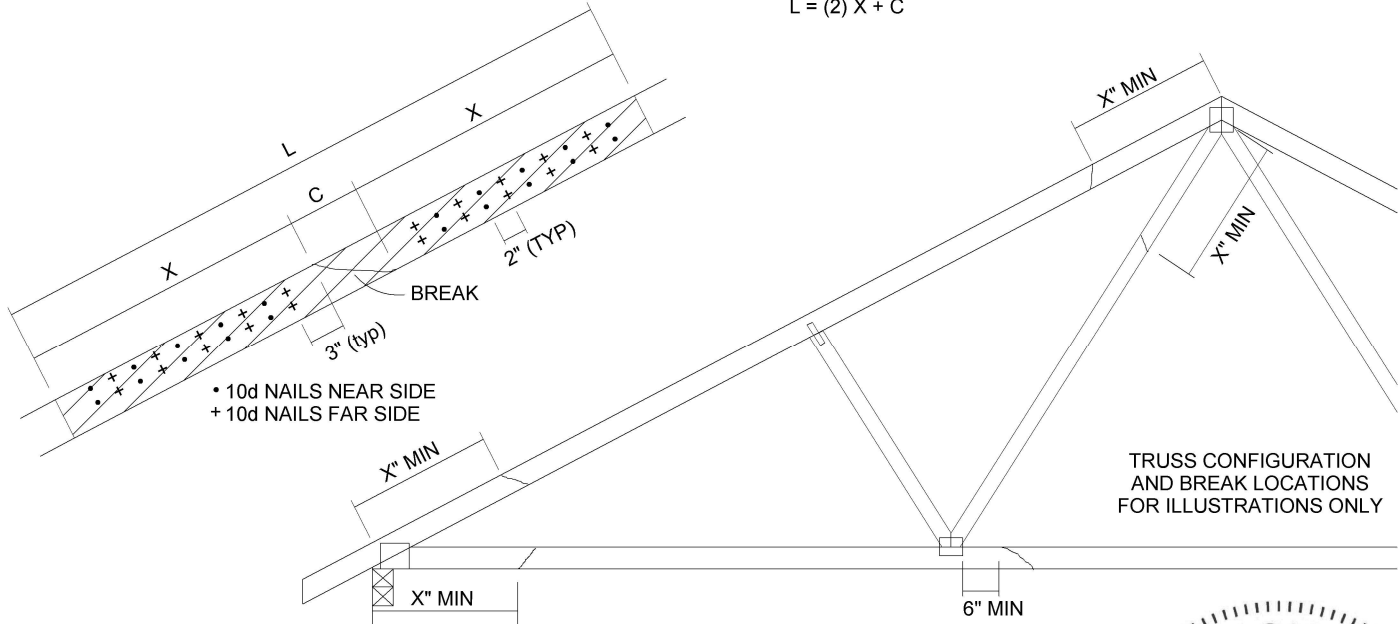
ATTACH 2x SCAB OF THE SAME SIZE AND GRADE AS THE BROKEN MEMBER TO EACH FACE OF THE TRUSS (CENTER ON BREAK OR SPLICE) WITH 10d (0.131" X 3") NAILS (TWO ROWS FOR 2x4, THREE ROWS FOR 2x6) SPACED 4" O.C. AS SHOWN. STAGGER NAIL SPACING FROM FRONT FACE AND BACK FACE FOR A NET 0-2-0 O.C. SPACING IN THE MAIN MEMBER. USE A MIN. 0-3-0 MEMBER END DISTANCE.

THE LENGTH OF THE BREAK (C) SHALL NOT EXCEED 12". (C=PLATE LENGTH FOR SPLICE REPAIRS)
 THE MINIMUM OVERALL SCAB LENGTH REQUIRED (L) IS CALCULATED AS FOLLOWS:
 $L = (2) X + C$

THE LOCATION OF THE BREAK MUST BE GREATER THAN OR EQUAL TO THE REQUIRED X DIMENSION FROM ANY PERIMETER BREAK OR HEEL JOINT AND A MINIMUM OF 6" FROM ANY INTERIOR JOINT (SEE SKETCH ABOVE)

TOTAL NUMBER OF NAILS EACH SIDE OF BREAK *		X INCHES	MAXIMUM FORCE (lbs) 15% LOAD DURATION							
			SP		DF		SPF		HF	
			2x4	2x6	2x4	2x6	2x4	2x6	2x4	2x6
20	30	24"	1706	2559	1561	2342	1320	1980	1352	2028
26	39	30"	2194	3291	2007	3011	1697	2546	1738	2608
32	48	36"	2681	4022	2454	3681	2074	3111	2125	3187
38	57	42"	3169	4754	2900	4350	2451	3677	2511	3767
44	66	48"	3657	5485	3346	5019	2829	4243	2898	4347

* DIVIDE EQUALLY FRONT AND BACK

DO NOT USE REPAIR FOR JOINT SPLICES
