Lot 22
Blrchwood Grove
454 John Stark Dr.

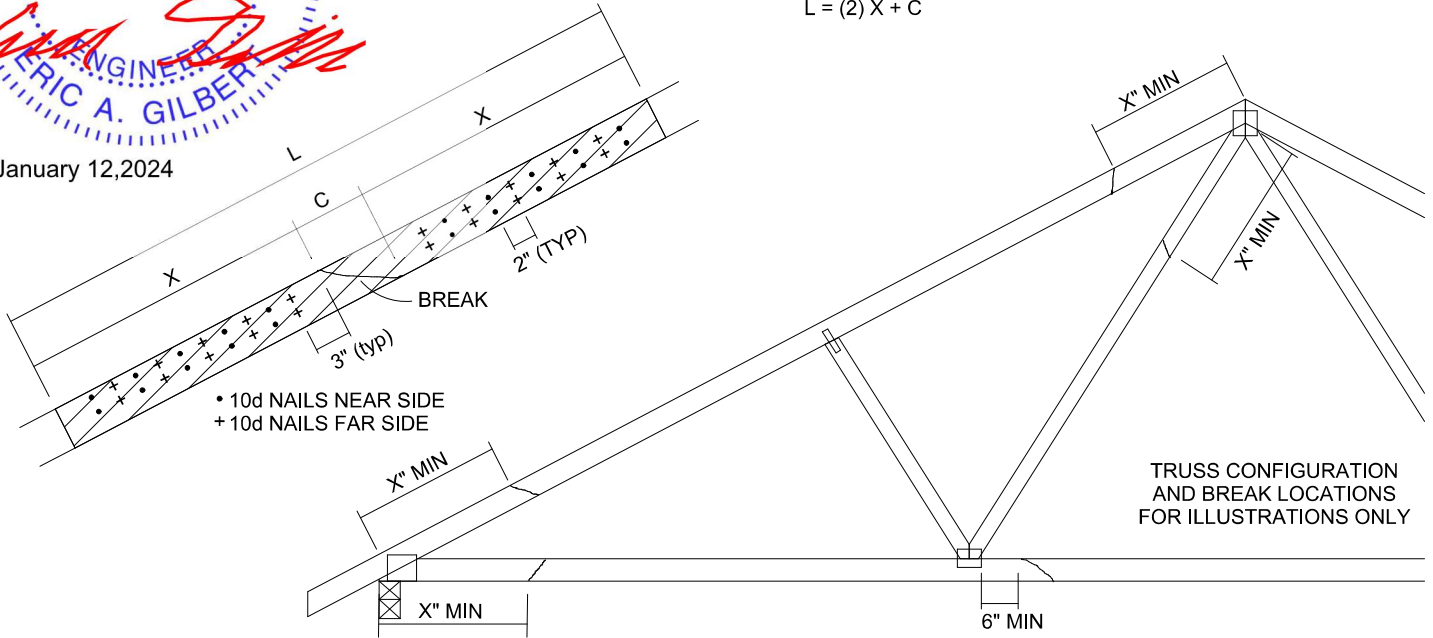
ATTACH 2x_ SCAB OF THE SAME SIZE AND GRADE AS THE BROKEN MEMBER TO EACH FACE OF THE TRUSS (CENTER ON BREAK OR SPLICE) WITH 10d (0.131" X 3") NAILS (TWO ROWS FOR 2x4, THREE ROWS FOR 2x6) SPACED 4" O.C. AS SHOWN. STAGGER NAIL SPACING FROM FRONT FACE AND BACK FACE FOR A NET 0-2-0 O.C. SPACING IN THE MAIN MEMBER. USE A MIN. 0-3-0 MEMBER END DISTANCE.

THE LENGTH OF THE BREAK (C) SHALL NOT EXCEED 12". (C=PLATE LENGTH FOR SPLICE REPAIRS)
THE MINIMUM OVERALL SCAB LENGTH REQUIRED (L) IS CALCULATED AS FOLLOWS:
 $L = (2) X + C$

THE LOCATION OF THE BREAK MUST BE GREATER THAN OR EQUAL TO THE REQUIRED X DIMENSION FROM ANY PERIMETER BREAK OR HEEL JOINT AND A MINIMUM OF 6" FROM ANY INTERIOR JOINT (SEE SKETCH ABOVE)

TOTAL NUMBER OF NAILS EACH SIDE OF BREAK *		X INCHES	MAXIMUM FORCE (lbs) 15% LOAD DURATION							
			SP		DF		SPF		HF	
2x4	2x6		2x4	2x6	2x4	2x6	2x4	2x6	2x4	2x6
20	30	24"	1706	2559	1561	2342	1320	1980	1352	2028
26	39	30"	2194	3291	2007	3011	1697	2546	1738	2608
32	48	36"	2681	4022	2454	3681	2074	3111	2125	3187
38	57	42"	3169	4754	2900	4350	2451	3677	2511	3767
44	66	48"	3657	5485	3346	5019	2829	4243	2898	4347

* DIVIDE EQUALLY FRONT AND BACK

DO NOT USE REPAIR FOR JOINT SPLICES
