Lot 27 Birchwood  
445 Thomas Gage Dr

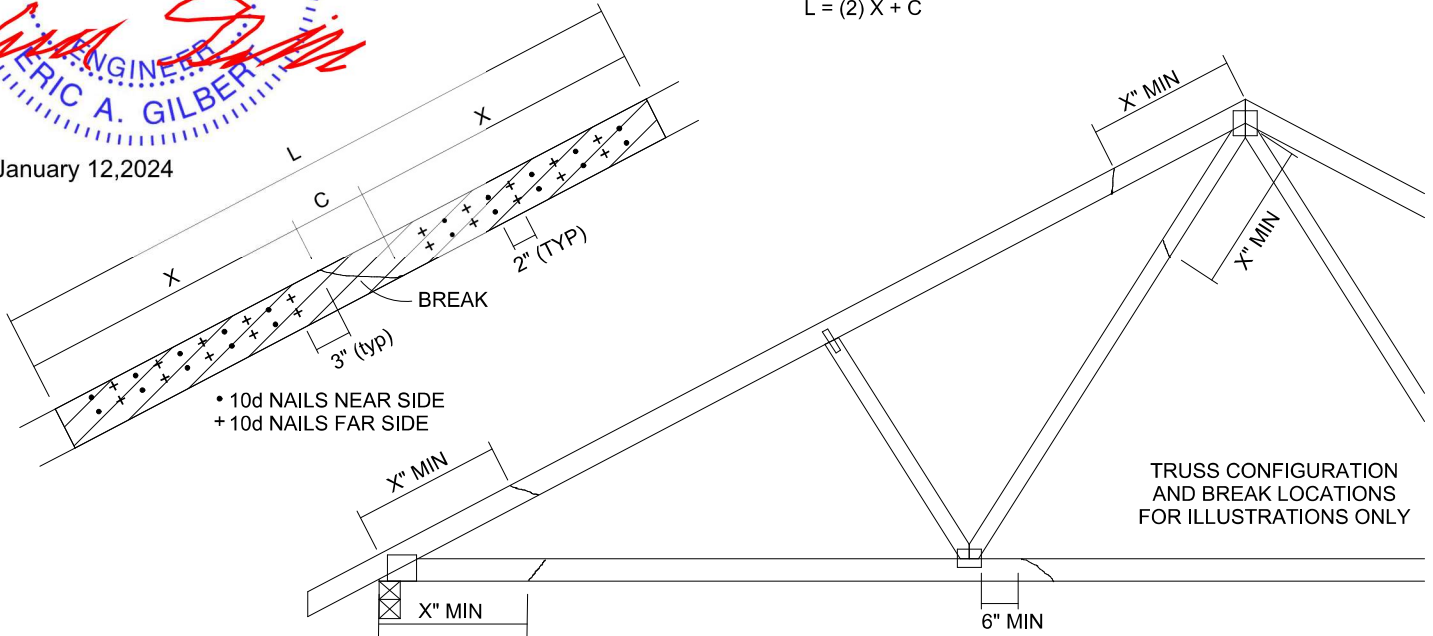
ATTACH 2x\_ SCAB OF THE SAME SIZE AND GRADE AS THE BROKEN MEMBER TO EACH FACE OF THE TRUSS (CENTER ON BREAK OR SPLICE) WITH 10d (0.131" X 3") NAILS (TWO ROWS FOR 2x4, THREE ROWS FOR 2x6) SPACED 4" O.C. AS SHOWN. STAGGER NAIL SPACING FROM FRONT FACE AND BACK FACE FOR A NET 0-2-0 O.C. SPACING IN THE MAIN MEMBER. USE A MIN. 0-3-0 MEMBER END DISTANCE.

THE LENGTH OF THE BREAK (C) SHALL NOT EXCEED 12". (C=PLATE LENGTH FOR SPLICE REPAIRS)  
THE MINIMUM OVERALL SCAB LENGTH REQUIRED (L) IS CALCULATED AS FOLLOWS:  
 $L = (2) X + C$

THE LOCATION OF THE BREAK MUST BE GREATER THAN OR EQUAL TO THE REQUIRED X DIMENSION FROM ANY PERIMETER BREAK OR HEEL JOINT AND A MINIMUM OF 6" FROM ANY INTERIOR JOINT (SEE SKETCH ABOVE)

TOTAL NUMBER OF NAILS EACH SIDE OF BREAK *		X INCHES	MAXIMUM FORCE (lbs) 15% LOAD DURATION							
			SP		DF		SPF		HF	
2x4	2x6		2x4	2x6	2x4	2x6	2x4	2x6	2x4	2x6
20	30	24"	1706	2559	1561	2342	1320	1980	1352	2028
26	39	30"	2194	3291	2007	3011	1697	2546	1738	2608
32	48	36"	2681	4022	2454	3681	2074	3111	2125	3187
38	57	42"	3169	4754	2900	4350	2451	3677	2511	3767
44	66	48"	3657	5485	3346	5019	2829	4243	2898	4347

\* DIVIDE EQUALLY FRONT AND BACK

DO NOT USE REPAIR FOR JOINT SPLICES
