RE: Daily Field Report for 06/15/2024
Lot 461 Colonies at Lexington (CMT) Cameron, NC
Building & Earth Project No : RD240407

Field Observations Report

1 : Foundation Inspection

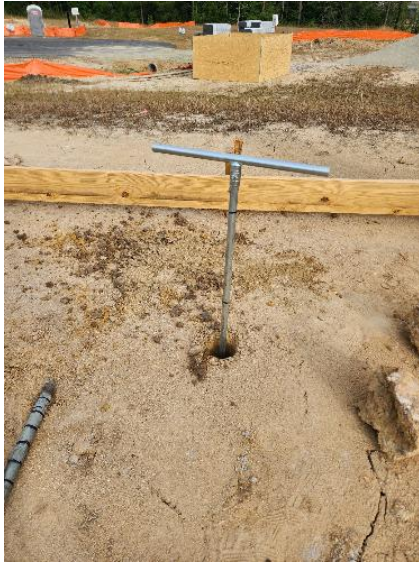
Picture ID	Hand auger	
85925

The following information provides the results of our hand auger borings and DCP testing:

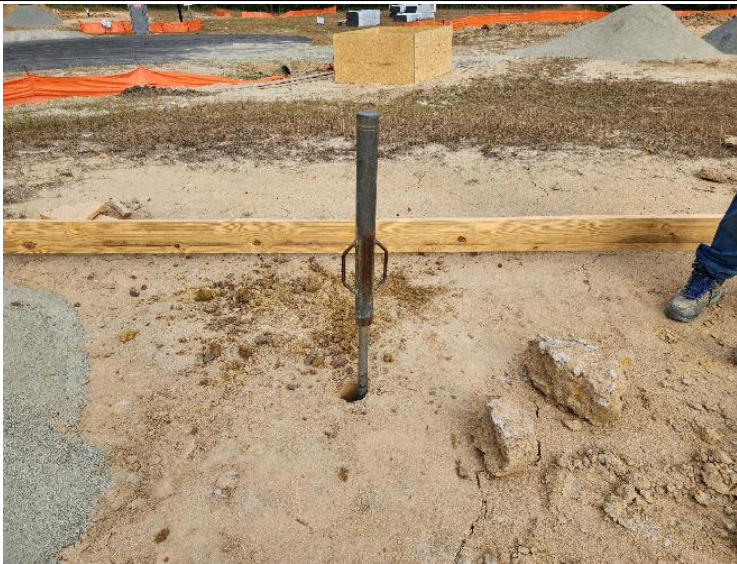
Picture ID	DCP	
85926

DCP Testing: Our representative performed Dynamic Cone Penetration (DCP) testing in general accordance with ASTM STP-399 at four representative locations to a depth of 36 inches. Our representative did not observe water within the DCP boreholes as noted below.
