## ProjectWondertown LotsLocationErwin, NCClientPoP Homes - RDU, LLCContractorPoP Homes - RDU, LLC

## FIELD REPORT

ECS arrived on site, as requested, to check the bearing capacity of soils via hand auger/DCP method (ASTM STP-399) for a monolithic slab for lot 611. Please see the attached sketch and data sheet for details.

## **Report of Spread Footing - Foundation Observations**

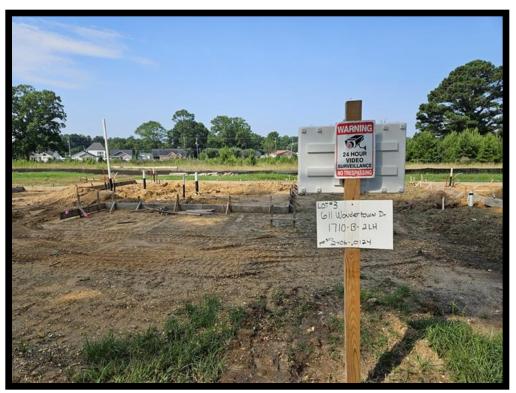
Figure 1

A total of 4 hand auger/DCP evaluations were performed to a depth of approximately 3 feet below the current footing sub grade elevation. Test results indicated that the materials in place (at the locations and elevations tested) did appear to be suitable to support the design bearing capacity of 2,000 psf.

Lot 611
