ATTACH 2x SCAB OF THE SAME SIZE AND GRADE AS THE BROKEN MEMBER TO EACH FACE OF THE TRUSS (CENTER ON BREAK OR SPLICE) WITH 10d (0.131" X 3") NAILS (TWO ROWS FOR 2x4, THREE ROWS FOR 2x6) SPACED 4" O.C. AS SHOWN. STAGGER NAIL SPACING FROM FRONT FACE AND BACK FACE FOR A NET 0-2-0 O.C. SPACING IN THE MAIN MEMBER. USE A MIN. 0-3-0 MEMBER END DISTANCE.

WARNING - Verify design parameters and READ NOTES ON THIS AND INCLUDED MITEK REFERENCE PAGE MII-7473 rev. 5/19/2020 BEFORE USE.

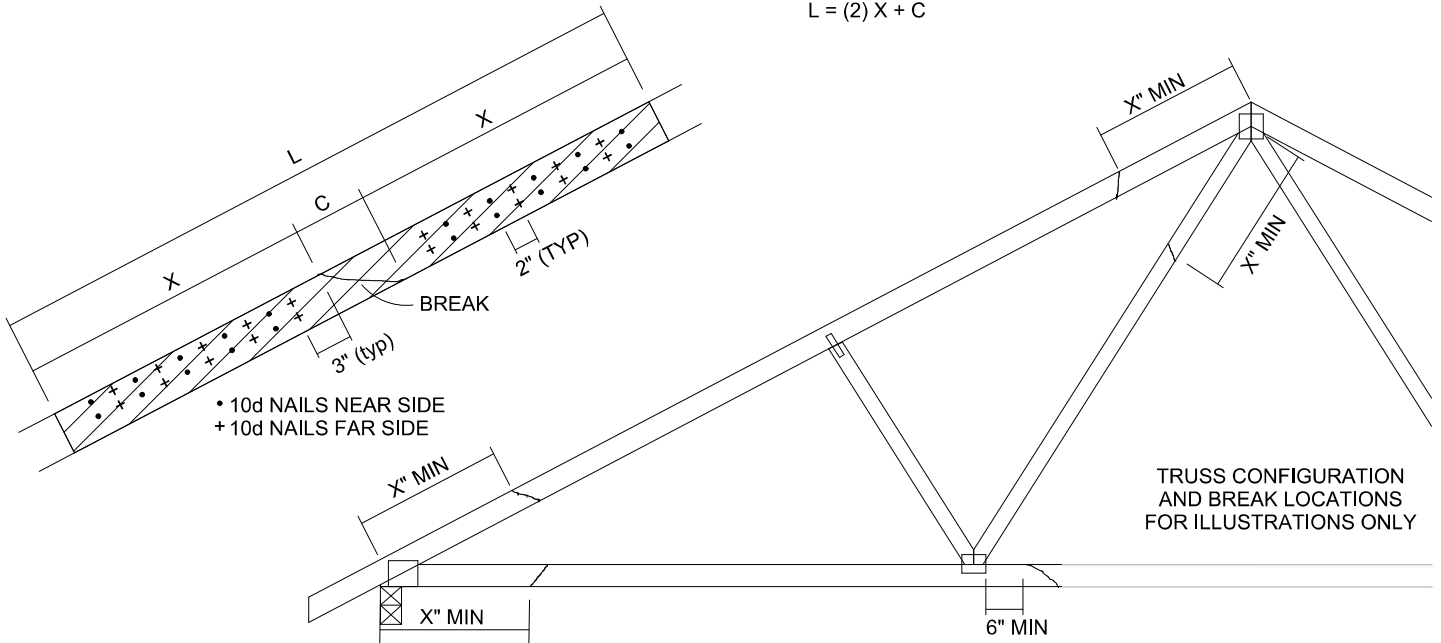
THE LENGTH OF THE BREAK (C) SHALL NOT EXCEED 12". (C=PLATE LENGTH FOR SPLICE REPAIRS)
 THE MINIMUM OVERALL SCAB LENGTH REQUIRED (L) IS CALCULATED AS FOLLOWS:
 $L = (2) X + C$

THE LOCATION OF THE BREAK MUST BE GREATER THAN OR EQUAL TO THE REQUIRED X DIMENSION FROM ANY PERIMETER BREAK OR HEEL JOINT AND A MINIMUM OF 6" FROM ANY INTERIOR JOINT (SEE SKETCH ABOVE)

TOTAL NUMBER OF NAILS EACH SIDE OF BREAK *		X INCHES	MAXIMUM FORCE (lbs) 15% LOAD DURATION							
			SP		DF		SPF		HF	
2x4	2x6		2x4	2x6	2x4	2x6	2x4	2x6	2x4	2x6
20	30	24"	1706	2559	1561	2342	1320	1980	1352	2028
26	39	30"	2194	3291	2007	3011	1697	2546	1738	2608
32	48	36"	2681	4022	2454	3681	2074	3111	2125	3187
38	57	42"	3169	4754	2900	4350	2451	3677	2511	3767
44	66	48"	3657	5485	3346	5019	2829	4243	2898	4347

* DIVIDE EQUALLY FRONT AND BACK

DO NOT USE REPAIR FOR JOINT SPLICES
