ATTACH 2x SCAB OF THE SAME SIZE AND GRADE AS THE BROKEN MEMBER TO EACH FACE OF THE TRUSS (CENTER ON BREAK OR SPLICE) WITH 10d (0.131" X 3") NAILS (TWO ROWS FOR 2x4, THREE ROWS FOR 2x6) SPACED 4" O.C. AS SHOWN. STAGGER NAIL SPACING FROM FRONT FACE AND BACK FACE FOR A NET 0-2-0 O.C. SPACING IN THE MAIN MEMBER. USE A MIN. 0-3-0 MEMBER END DISTANCE.

DO NOT USE REPAIR FOR JOINT SPLICES

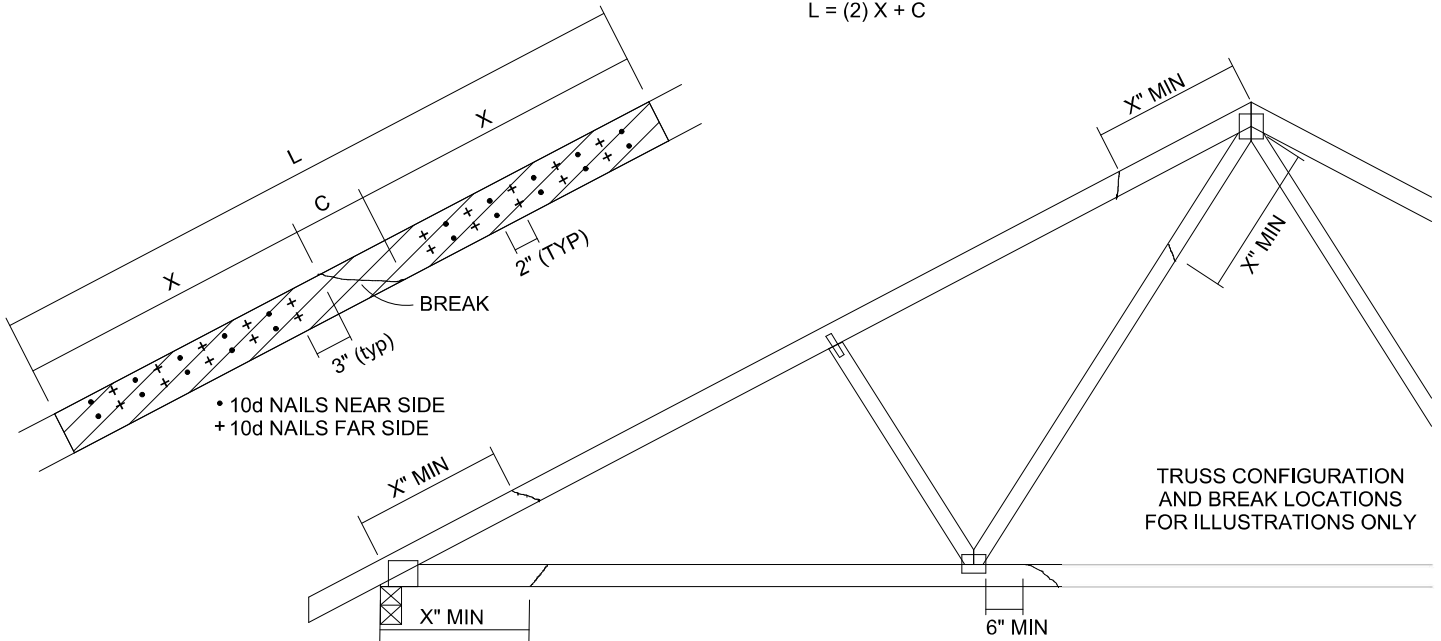
THE LENGTH OF THE BREAK (C) SHALL NOT EXCEED 12". (C=PLATE LENGTH FOR SPLICE REPAIRS)  
 THE MINIMUM OVERALL SCAB LENGTH REQUIRED (L) IS CALCULATED AS FOLLOWS:  
 $L = (2) X + C$

THE LOCATION OF THE BREAK MUST BE GREATER THAN OR EQUAL TO THE REQUIRED X DIMENSION FROM ANY PERIMETER BREAK OR HEEL JOINT AND A MINIMUM OF 6" FROM ANY INTERIOR JOINT (SEE SKETCH ABOVE)

TOTAL NUMBER OF NAILS EACH SIDE OF BREAK *		X INCHES	MAXIMUM FORCE (lbs) 15% LOAD DURATION							
			SP		DF		SPF		HF	
2x4	2x6		2x4	2x6	2x4	2x6	2x4	2x6	2x4	2x6
20	30	24"	1706	2559	1561	2342	1320	1980	1352	2028
26	39	30"	2194	3291	2007	3011	1697	2546	1738	2608
32	48	36"	2681	4022	2454	3681	2074	3111	2125	3187
38	57	42"	3169	4754	2900	4350	2451	3677	2511	3767
44	66	48"	3657	5485	3346	5019	2829	4243	2898	4347

\* DIVIDE EQUALLY FRONT AND BACK
