RE: Daily Field Report for 11/11/2024
Lot 22 Watson Ridge (CMT) Sanford, NC
Building & Earth Project No : RD240919

Field Observations Report

Project Name:	Lot 22 Watson Ridge (CMT) Sanford, NC	Project Number:	RD240919
Client Name:	Dream Finders Homes-Carolinas	Placement#:	FO-1
Contractor:	Dream Finders Homes-Carolinas	Technician:	Eric T. Moore
Monitoring:	DCP

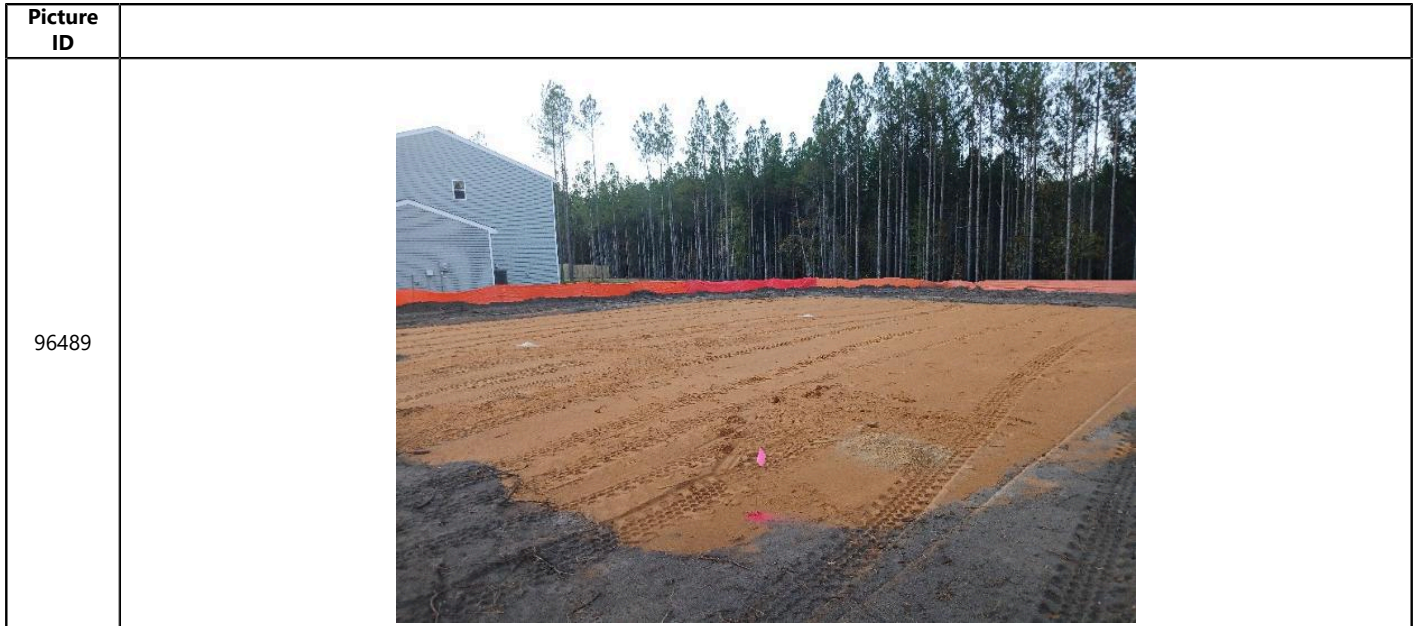
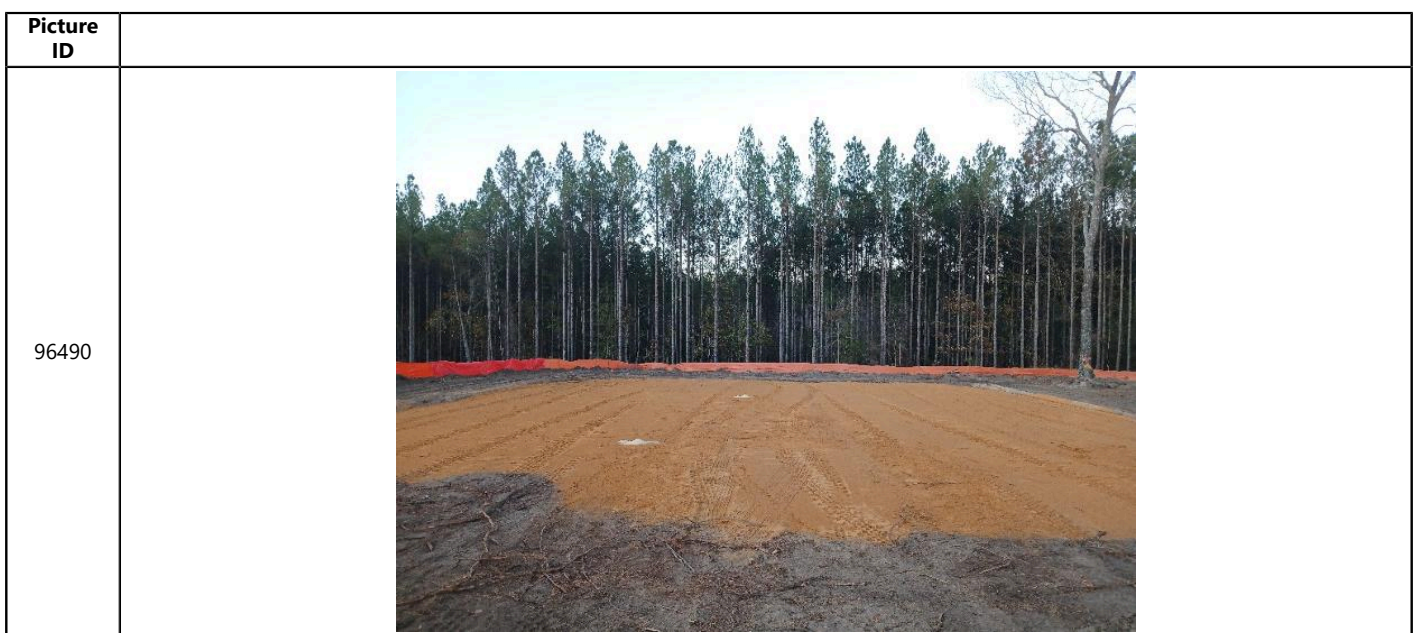
Photographs

We arrived onsite to evaluate the building pad area for this residential lot. We understand the residence has been designed to be supported on a monolithic slab foundation. Upon arrival, the contractor had not finished excavating the footings. Our evaluation as documented in this report includes:

The site has been stripped of surface cover and topsoil.

Structural fill has been placed at the site to level the building pad. Based on our observations, we understand the pad has been filled according to the following:

To minimize the potential for future softening of the bearing materials due to water infiltration, the surface soils should be protected from construction traffic and inclement weather. The construction of the footings and structure should commence without delay. In the event that the subgrade soils become wet, or otherwise compromised from their current condition, should be observed and retested as necessary by Building and Earth Sciences.
