**RE:** Daily Field Report for 10/21/2024  
Lot 467 Colony at Lexington (CMT) Cameron, NC  
Building & Earth Project No : RD240868

## Field Observations Report

### 1 : Foundation Inspection

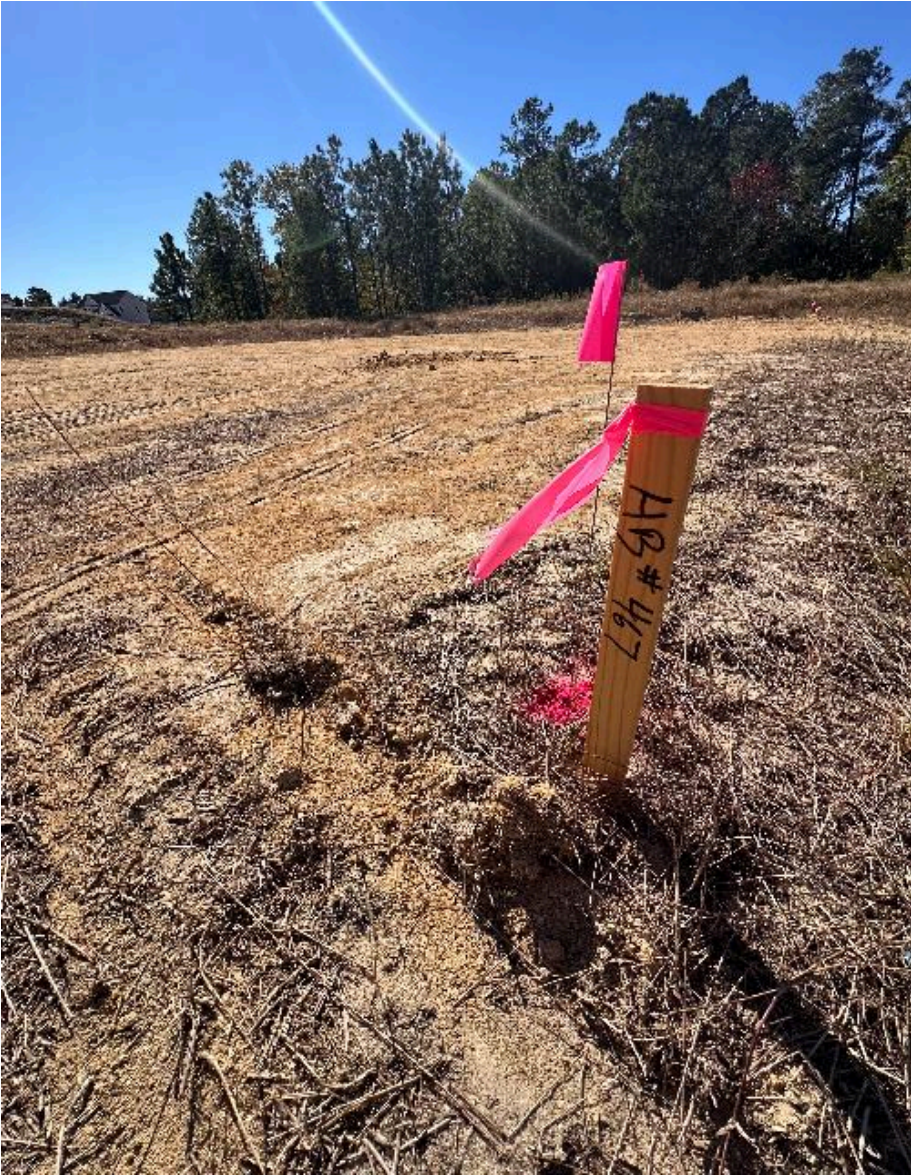
Picture ID	Lot 467
95269

We arrived onsite to evaluate the building pad area for this residential lot. We understand the residence has been designed to be supported on a monolithic slab foundation. Upon arrival, the contractor had not finished excavating the footings. Our evaluation as documented in this report includes:

The lot is relatively flat. Building locations are referenced from the street looking at the front of the residence. Surface water runoff appears to drain rear sides.

The site has been stripped of surface cover and topsoil.
