Lot 142 Birchwood Grove  
565 Thomas Gage Rd  
A03

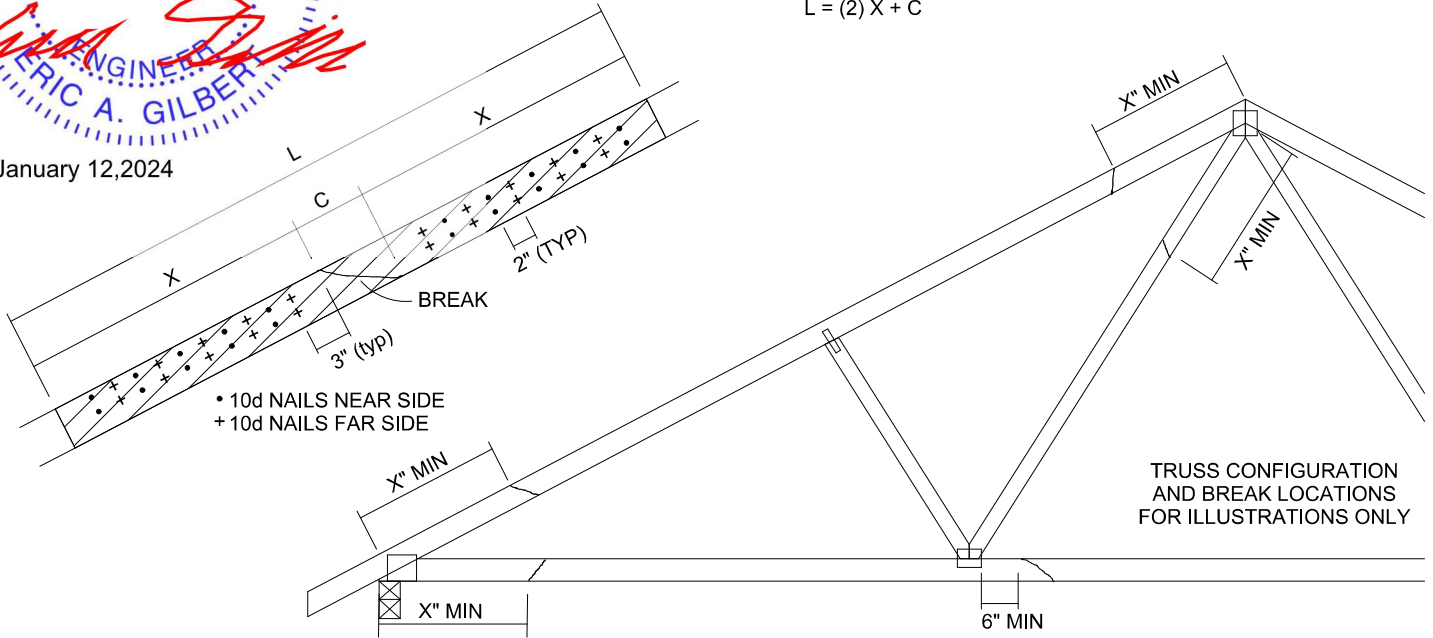
ATTACH 2x\_ SCAB OF THE SAME SIZE AND GRADE AS THE BROKEN MEMBER TO EACH FACE OF THE TRUSS (CENTER ON BREAK OR SPLICE) WITH 10d (0.131" X 3") NAILS (TWO ROWS FOR 2x4, THREE ROWS FOR 2x6) SPACED 4" O.C. AS SHOWN. STAGGER NAIL SPACING FROM FRONT FACE AND BACK FACE FOR A NET 0-2-0 O.C. SPACING IN THE MAIN MEMBER. USE A MIN. 0-3-0 MEMBER END DISTANCE.

THE LENGTH OF THE BREAK (C) SHALL NOT EXCEED 12". (C=PLATE LENGTH FOR SPLICE REPAIRS)  
THE MINIMUM OVERALL SCAB LENGTH REQUIRED (L) IS CALCULATED AS FOLLOWS:  
 $L = (2) X + C$

THE LOCATION OF THE BREAK MUST BE GREATER THAN OR EQUAL TO THE REQUIRED X DIMENSION FROM ANY PERIMETER BREAK OR HEEL JOINT AND A MINIMUM OF 6" FROM ANY INTERIOR JOINT (SEE SKETCH ABOVE)

DO NOT USE REPAIR FOR JOINT SPLICES

TOTAL NUMBER OF NAILS EACH SIDE OF BREAK *		X INCHES	MAXIMUM FORCE (lbs) 15% LOAD DURATION							
			SP		DF		SPF		HF	
2x4	2x6		2x4	2x6	2x4	2x6	2x4	2x6	2x4	2x6
20	30	24"	1706	2559	1561	2342	1320	1980	1352	2028
26	39	30"	2194	3291	2007	3011	1697	2546	1738	2608
32	48	36"	2681	4022	2454	3681	2074	3111	2125	3187
38	57	42"	3169	4754	2900	4350	2451	3677	2511	3767
44	66	48"	3657	5485	3346	5019	2829	4243	2898	4347

\* DIVIDE EQUALLY FRONT AND BACK
