Lot 142 Birchwood Grove  
565 Thomas Gage Rd  
A04

ATTACH 2x\_ SCAB OF THE SAME SIZE AND GRADE AS THE BROKEN MEMBER TO EACH FACE OF THE TRUSS (CENTER ON BREAK OR SPLICE) WITH 10d (0.131" X 3") NAILS (TWO ROWS FOR 2x4, THREE ROWS FOR 2x6) SPACED 4" O.C. AS SHOWN. STAGGER NAIL SPACING FROM FRONT FACE AND BACK FACE FOR A NET 0-2-0 O.C. SPACING IN THE MAIN MEMBER. USE A MIN. 0-3-0 MEMBER END DISTANCE.

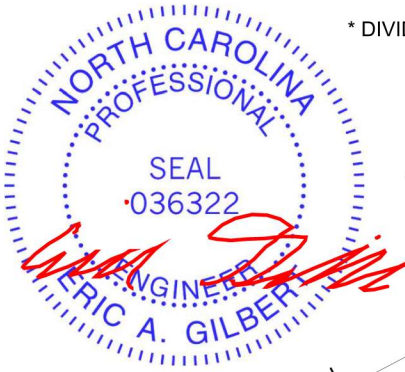
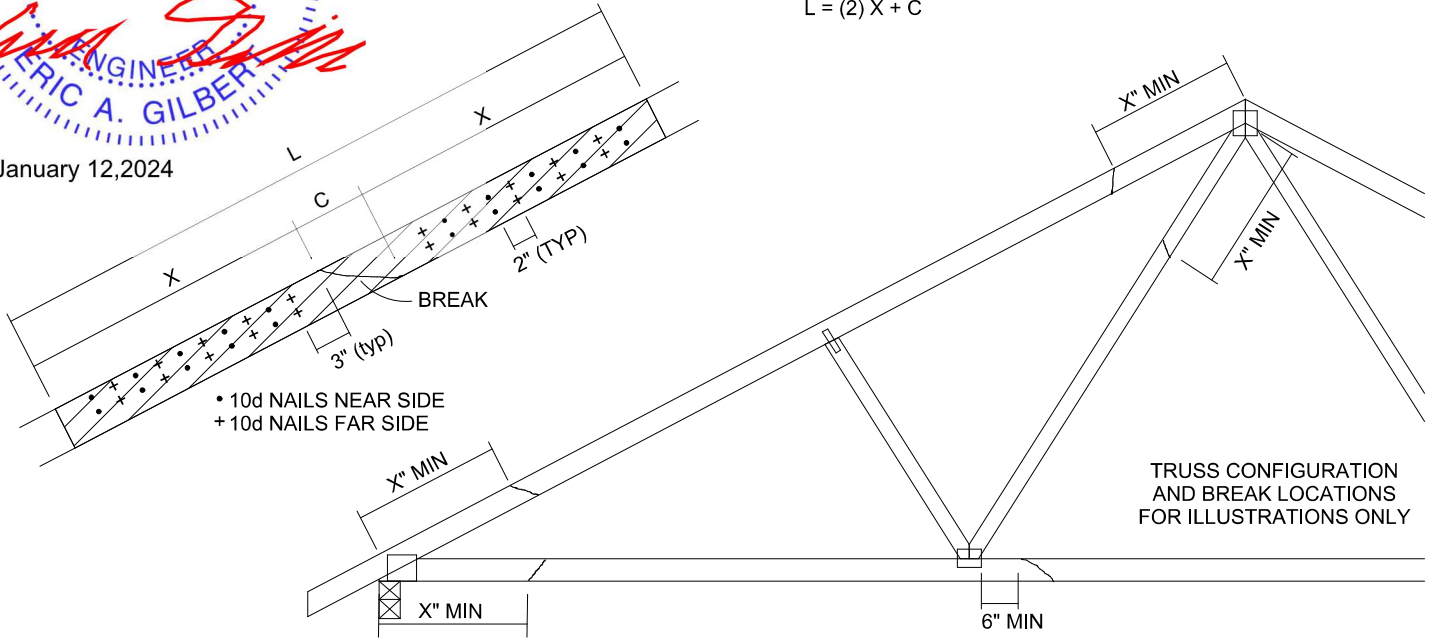
THE LENGTH OF THE BREAK (C) SHALL NOT EXCEED 12". (C=PLATE LENGTH FOR SPLICE REPAIRS)  
THE MINIMUM OVERALL SCAB LENGTH REQUIRED (L) IS CALCULATED AS FOLLOWS:  
 $L = (2) X + C$

THE LOCATION OF THE BREAK MUST BE GREATER THAN OR EQUAL TO THE REQUIRED X DIMENSION FROM ANY PERIMETER BREAK OR HEEL JOINT AND A MINIMUM OF 6" FROM ANY INTERIOR JOINT (SEE SKETCH ABOVE)

TOTAL NUMBER OF NAILS EACH SIDE OF BREAK *		X INCHES	MAXIMUM FORCE (lbs) 15% LOAD DURATION							
			SP		DF		SPF		HF	
2x4	2x6		2x4	2x6	2x4	2x6	2x4	2x6	2x4	2x6
20	30	24"	1706	2559	1561	2342	1320	1980	1352	2028
26	39	30"	2194	3291	2007	3011	1697	2546	1738	2608
32	48	36"	2681	4022	2454	3681	2074	3111	2125	3187
38	57	42"	3169	4754	2900	4350	2451	3677	2511	3767
44	66	48"	3657	5485	3346	5019	2829	4243	2898	4347

\* DIVIDE EQUALLY FRONT AND BACK

DO NOT USE REPAIR FOR JOINT SPLICES
