HH HUNT OF RALEIGH

TRUSS:	A2T
JOB ID:	72432400
DELIVERY DATE:	1/2/2025
REQUESTED BY:	Coombs, Ryan
EMAIL:	rgcoombs@hhhunthomes.com
REQUESTED ON:	1/24/2025
REQUESTED BY:	Coombs, Ryan
EMAIL:	rgcoombs@hhhunthomes.com
REQUESTED ON:	1/24/2025
SUBDIVISION/MODEL:	MAGNOLIA ACRES
LOT #:	3
DELIVERY ADDRESS:	352 MAGNOLIA ACRES FUQUAY VARINA, NC 27526
REPAIR ID:	MII-REP01A1 (ATTACHED)

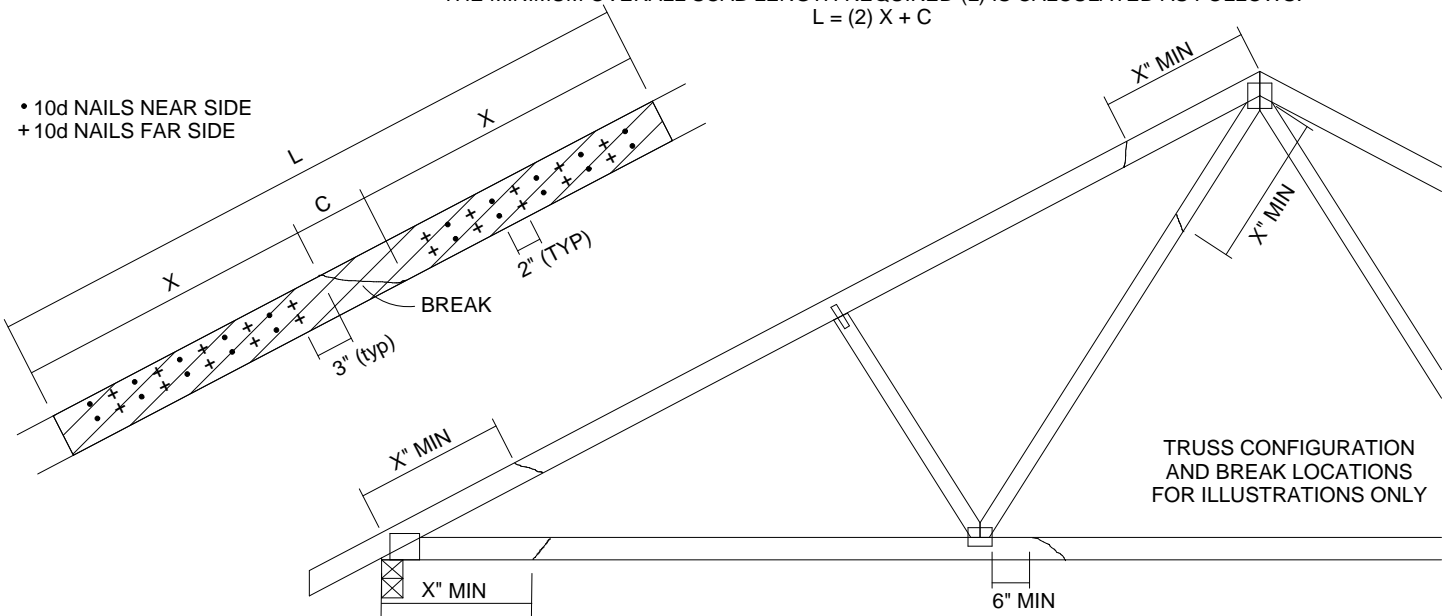
ATTACH 2x SCAB OF THE SAME SIZE AND GRADE AS THE BROKEN MEMBER TO EACH FACE OF THE TRUSS (CENTER ON BREAK OR SPLICE) WITH 10d (0.131" X 3") NAILS (TWO ROWS FOR 2x4, THREE ROWS FOR 2x6) SPACED 4" O.C. AS SHOWN. STAGGER NAIL SPACING FROM FRONT FACE AND BACK FACE FOR A NET 0-2-0 O.C. SPACING IN THE MAIN MEMBER. USE A MIN. 0-3-0 MEMBER END DISTANCE.

THE LENGTH OF THE BREAK (C) SHALL NOT EXCEED 12". (C=PLATE LENGTH FOR SPLICE REPAIRS)

THE MINIMUM OVERALL SCAB LENGTH REQUIRED (L) IS CALCULATED AS FOLLOWS:

$L = (2) \times X + C$

THE LOCATION OF THE BREAK MUST BE GREATER THAN OR EQUAL TO THE REQUIRED X DIMENSION FROM ANY PERIMETER BREAK OR HEEL JOINT AND A MINIMUM OF 6" FROM ANY INTERIOR JOINT (SEE SKETCH ABOVE)

DO NOT USE REPAIR FOR JOINT SPLICES

TOTAL NUMBER OF NAILS EACH SIDE OF BREAK *		X INCHES	MAXIMUM FORCE (lbs) 15% LOAD DURATION							
			SP		DF		SPF		HF	
			2x4	2x6	2x4	2x6	2x4	2x6	2x4	2x6
20	30	24"	1706	2559	1561	2342	1320	1980	1352	2028
26	39	30"	2194	3291	2007	3011	1697	2546	1738	2608
32	48	36"	2681	4022	2454	3681	2074	3111	2125	3187
38	57	42"	3169	4754	2900	4350	2451	3677	2511	3767
44	66	48"	3657	5485	3346	5019	2829	4243	2898	4347

* DIVIDE EQUALLY FRONT AND BACK
