**Birchwood Grove Lot 44**  
**20 Robert Howe Drive**  
**Truss A05**

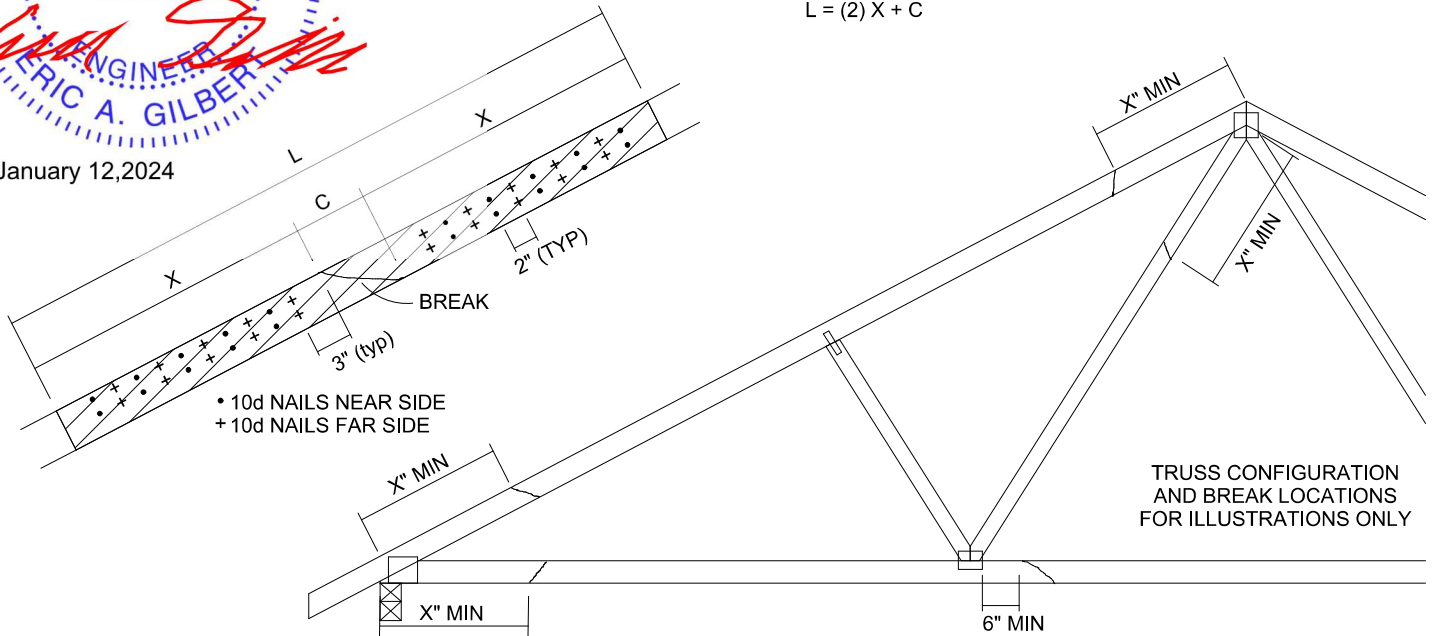
ATTACH 2x SCAB OF THE SAME SIZE AND GRADE AS THE BROKEN MEMBER TO EACH  
FACE OF THE TRUSS (CENTER ON BREAK OR SPLICE) WITH 10d (0.131" X 3") NAILS  
(TWO ROWS FOR 2x4, THREE ROWS FOR 2x6) SPACED 4" O.C. AS SHOWN.  
STAGGER NAIL SPACING FROM FRONT FACE AND BACK FACE FOR A NET 0-2-0 O.C.  
SPACING IN THE MAIN MEMBER. USE A MIN. 0-3-0 MEMBER END DISTANCE.

THE LENGTH OF THE BREAK (C) SHALL NOT EXCEED 12". (C=PLATE LENGTH FOR SPLICE REPAIRS)  
THE MINIMUM OVERALL SCAB LENGTH REQUIRED (L) IS CALCULATED AS FOLLOWS:  
 $L = (2) X + C$

THE LOCATION OF THE BREAK MUST BE GREATER THAN OR EQUAL TO THE REQUIRED X DIMENSION FROM ANY  
PERIMETER BREAK OR HEEL JOINT AND A MINIMUM OF 6" FROM ANY INTERIOR JOINT (SEE SKETCH ABOVE)
