# Birchwood Grove Lot 139

## 40 Brodhead Drive

### Truss D01

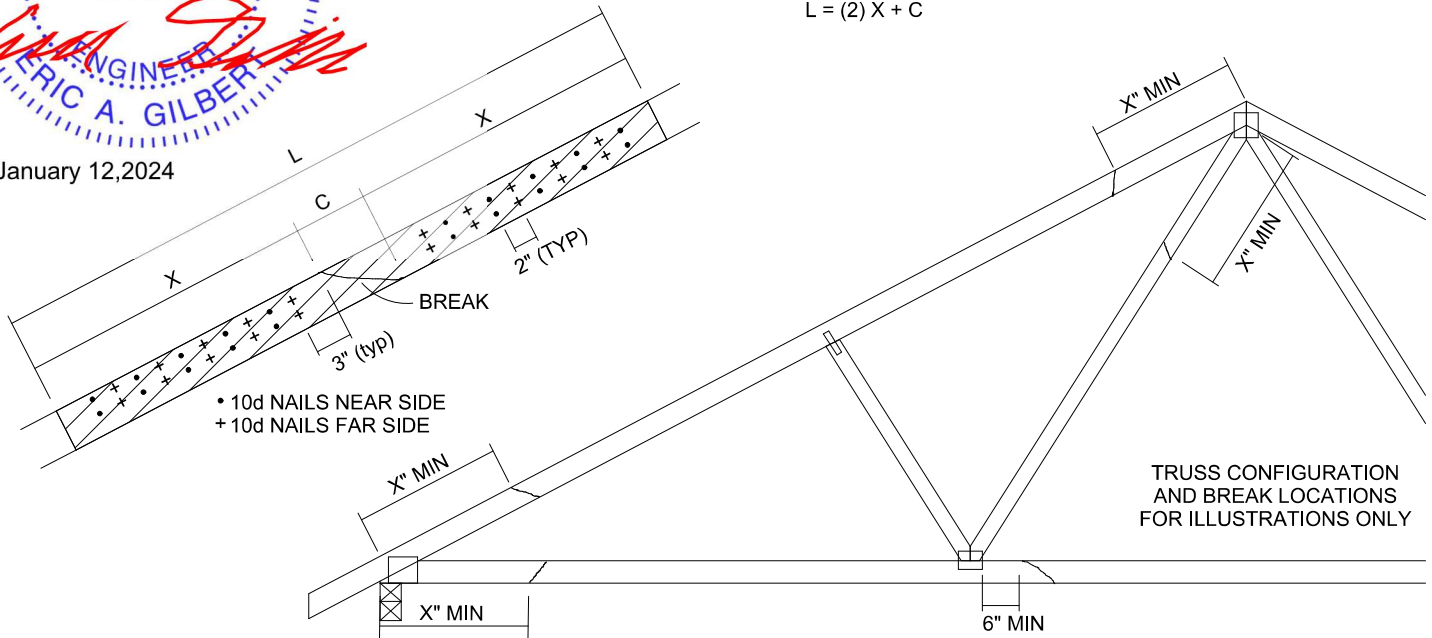
ATTACH 2x SCAB OF THE SAME SIZE AND GRADE AS THE BROKEN MEMBER TO EACH FACE OF THE TRUSS (CENTER ON BREAK OR SPLICE) WITH 10d (0.131" X 3") NAILS (TWO ROWS FOR 2x4, THREE ROWS FOR 2x6) SPACED 4" O.C. AS SHOWN. STAGGER NAIL SPACING FROM FRONT FACE AND BACK FACE FOR A NET 0-2-0 O.C. SPACING IN THE MAIN MEMBER. USE A MIN. 0-3-0 MEMBER END DISTANCE.

THE LENGTH OF THE BREAK (C) SHALL NOT EXCEED 12". (C=PLATE LENGTH FOR SPLICE REPAIRS)  
THE MINIMUM OVERALL SCAB LENGTH REQUIRED (L) IS CALCULATED AS FOLLOWS:  
 $L = (2) X + C$

THE LOCATION OF THE BREAK MUST BE GREATER THAN OR EQUAL TO THE REQUIRED X DIMENSION FROM ANY PERIMETER BREAK OR HEEL JOINT AND A MINIMUM OF 6" FROM ANY INTERIOR JOINT (SEE SKETCH ABOVE)

TOTAL NUMBER OF NAILS EACH SIDE OF BREAK *		X INCHES	MAXIMUM FORCE (lbs) 15% LOAD DURATION							
			SP		DF		SPF		HF	
2x4	2x6		2x4	2x6	2x4	2x6	2x4	2x6	2x4	2x6
20	30	24"	1706	2559	1561	2342	1320	1980	1352	2028
26	39	30"	2194	3291	2007	3011	1697	2546	1738	2608
32	48	36"	2681	4022	2454	3681	2074	3111	2125	3187
38	57	42"	3169	4754	2900	4350	2451	3677	2511	3767
44	66	48"	3657	5485	3346	5019	2829	4243	2898	4347

\* DIVIDE EQUALLY FRONT AND BACK

DO NOT USE REPAIR FOR JOINT SPLICES
