MUNGO HOMES OF NC

TRUSS:	A3
JOB ID:	72439471
DELIVERY DATE:	3/7/2025
REQUESTED BY:	Parker, Jarrett
EMAIL:	jparker@mungo.com
REQUESTED ON:	4/4/2025
SUBDIVISION/MODEL:	LANGDON PRESERVE
LOT #:	17
DELIVERY ADDRESS:	84 GROVE TOWNSHIP WAY ANGIER, NC 27501
REPAIR ID:	MII-WEB-PLATE (ATTACHED)

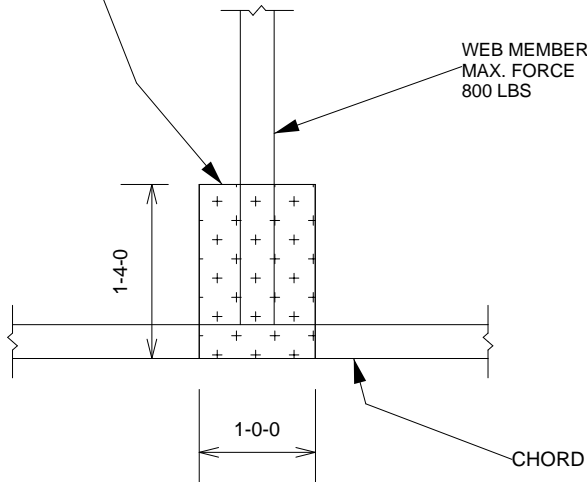
EDGE OF WEB NOT TO EXTEND BEYOND CORNER OF GUSSET

WEB MEMBER
MAX. FORCE
800 LBS

ATTACH 1/2" PLYWOOD OR OSB GUSSET (15/32" RATED SHEATHING 32/16 EXP 1) TO EACH FACE OF TRUSS WITH (0.131" X MIN 2.5") NAILS IN 3 ROWS SPACED @ 4" O.C. NAILS TO BE DRIVEN FROM BOTH FACES. STAGGER SPACING FROM FRONT TO BACK FACE FOR A NET 2" O.C. SPACING IN THE TRUSS. USE 2" MEMBER END DISTANCE.

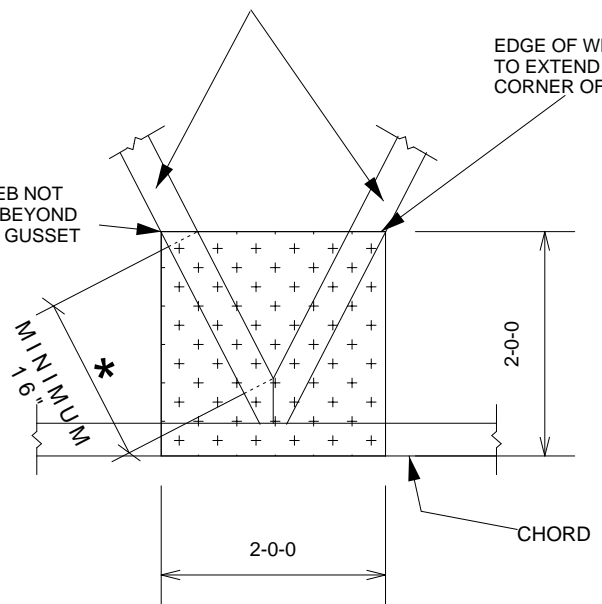
WEB MEMBER
MAX. FORCE
1200 LBS

EDGE OF WEB NOT TO EXTEND BEYOND CORNER OF GUSSET

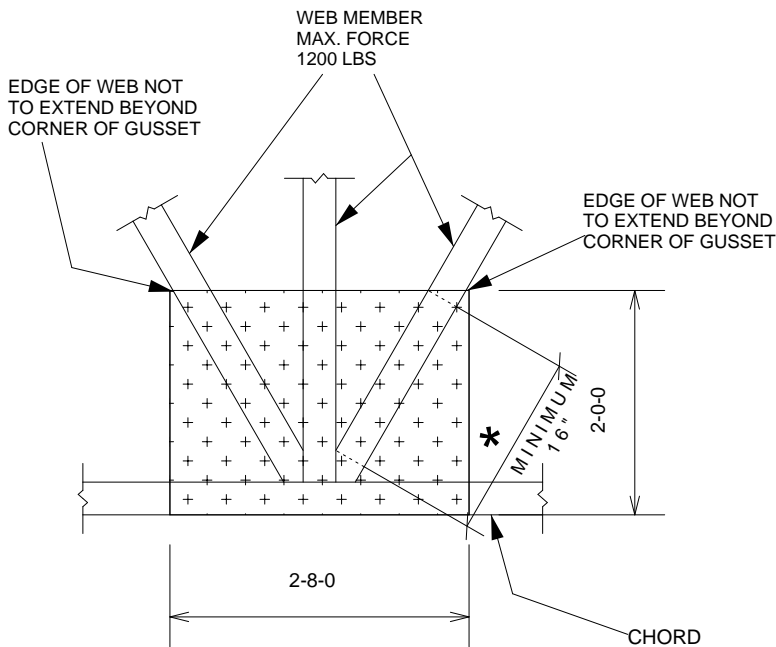
EDGE OF WEB NOT TO EXTEND BEYOND CORNER OF GUSSET

WEB MEMBER
MAX. FORCE
1200 LBS
